PROPOSED NEW BUTLER GALLERY AT  
**EVAN'S** ALMS HOUSE,  
BARRACK LANE, KILKENNY

VOLUME 2  
EXTERNAL CONDITION SURVEY  
RECOMMENDATIONS

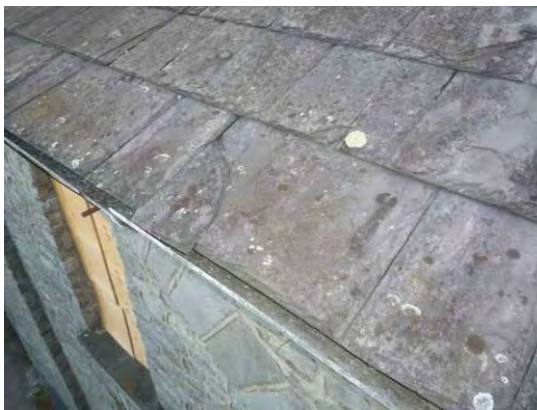
Fig.1: Cracked slate to the west pitch of the south wing.

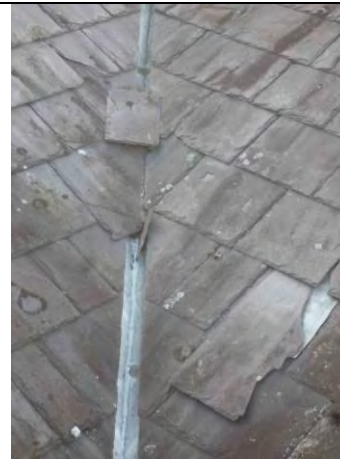
Fig.2: Slipped slate to the valley junction between the main block and the south wing.

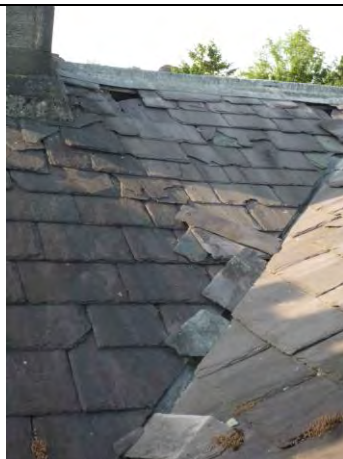
Fig.3: Notable failure of the roof to the north wing. Note the concentration of slipped slates and hole exposing roofing timbers.

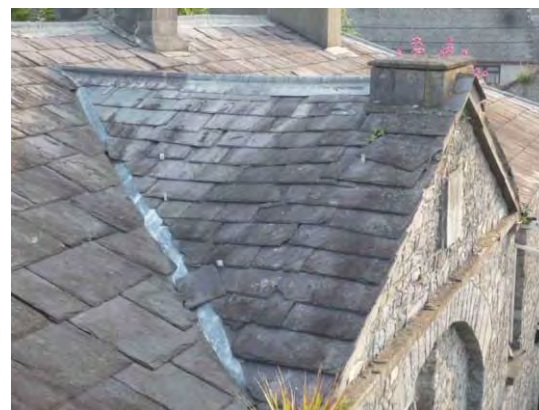
Fig.4: Deflection in the roofing plane of the south wing. Note the slipped slate as a result.

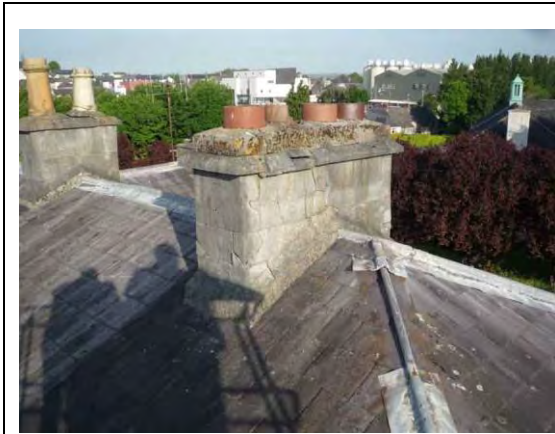
Fig.5: Missing section of lead ridge capping exposing underlying timber.

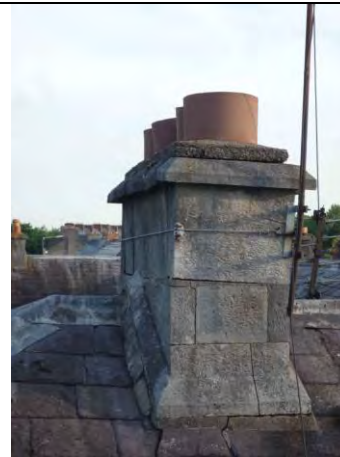
Fig.6: Cracked and failed mortar fillet to the base of chimney stacks.

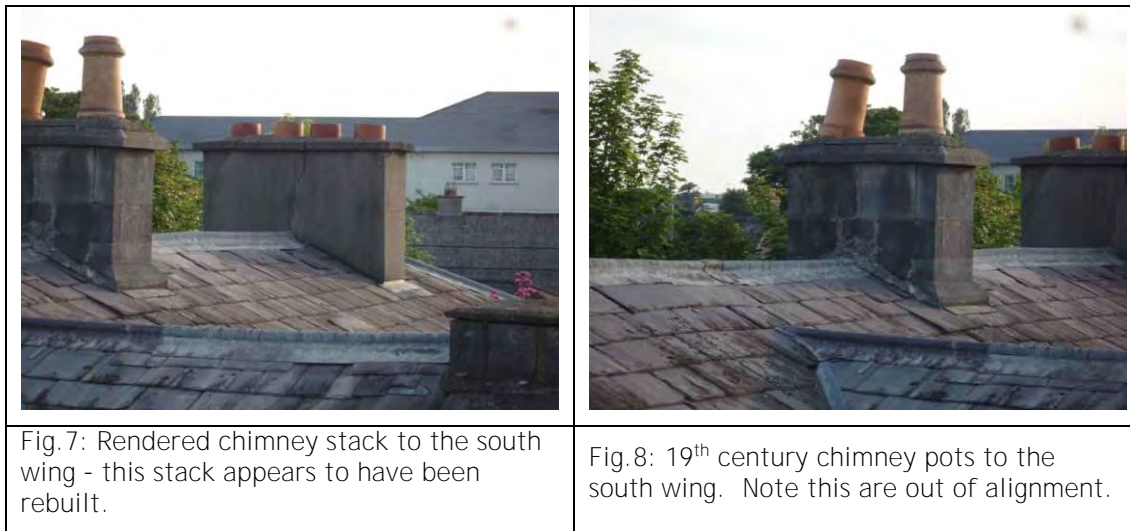
#### 2.4 Rainwater Goods

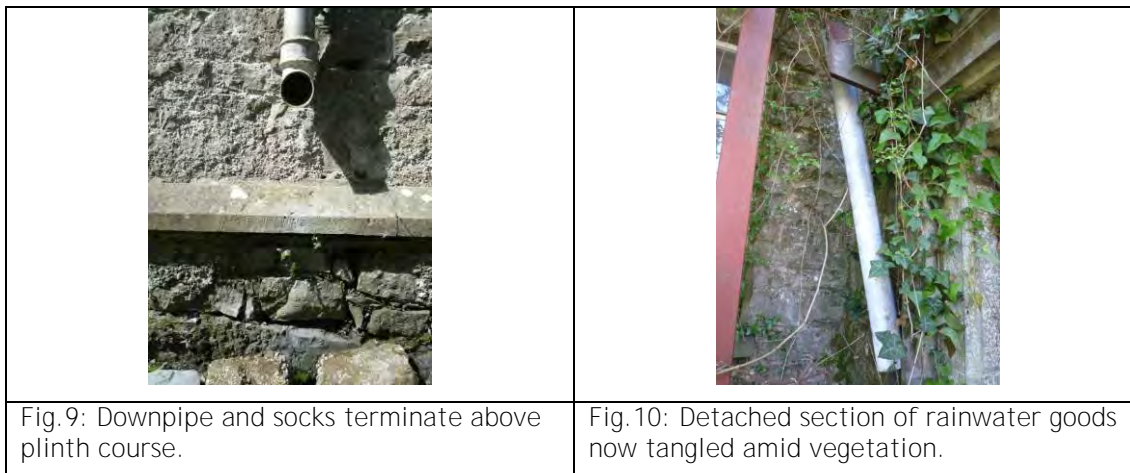
uPVC soil pipes have been insensitively installed to all elevations with little regard for the buildings architectural composition.

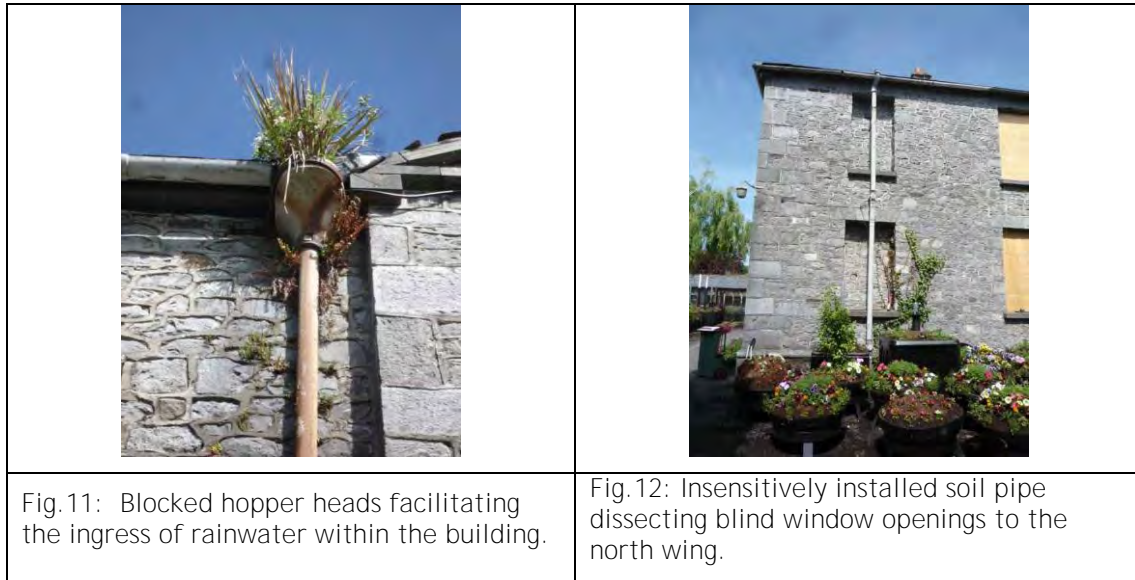
### 2.5 Ground Drainage

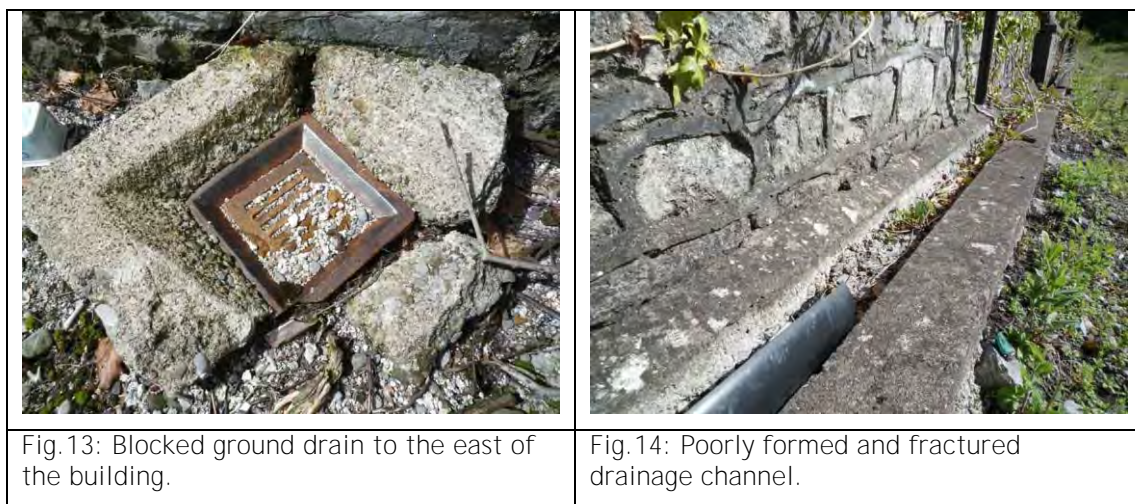
### 2.6 Blocking Course

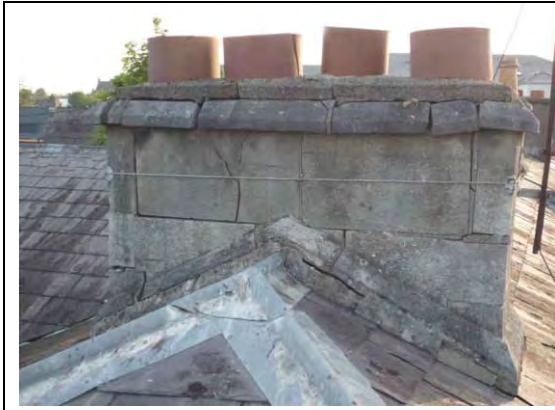
Fig.15: Fracturing of stonework to chimneys likely to have been caused by corrosion jacking of the masonry.

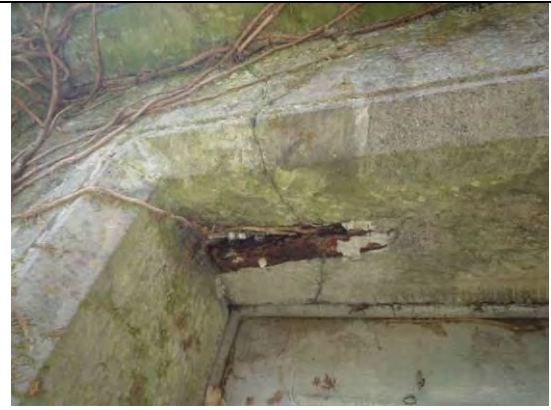
Fig.16: Fracturing of lintel to west door surround caused by corrosion jacking - note the exposed corroded metal cramp.

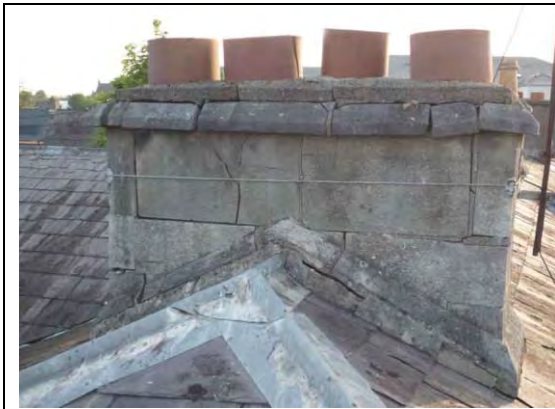
Fig.17: Significant fracturing of masonry to chimney stacks as a result of corrosion jacking.

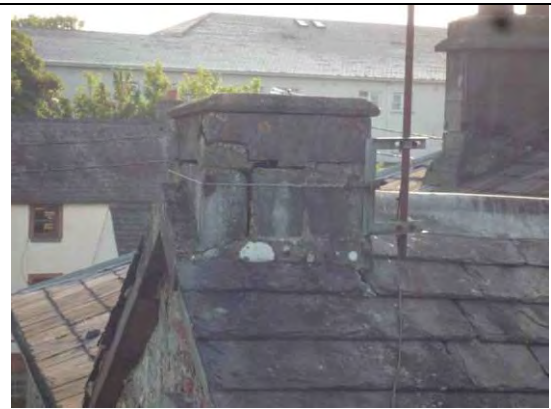
Fig.18: Fracturing of blocking course rising over the north pedimented breakfront.

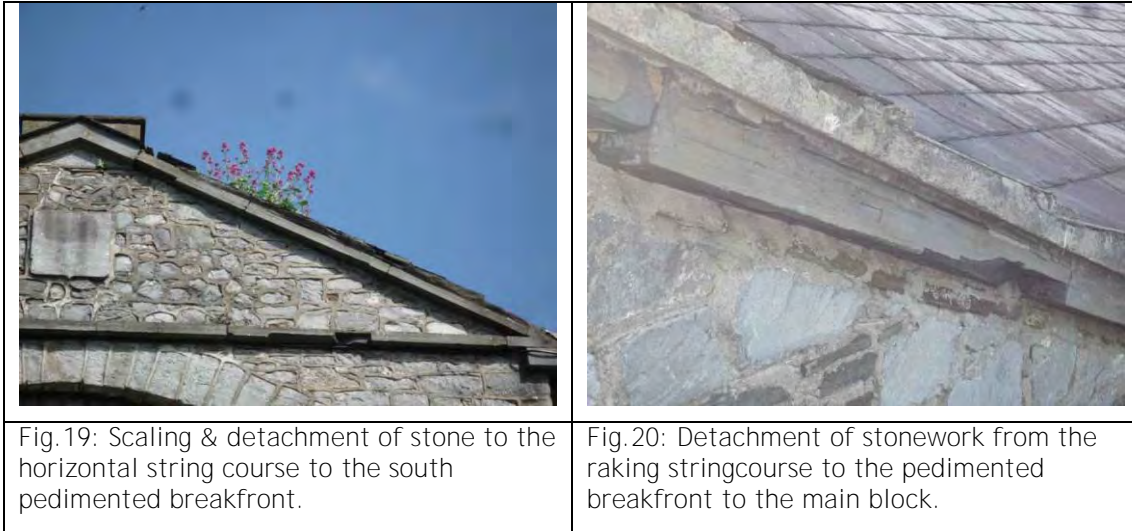
### 2.9 Mechanical Damage of Stone

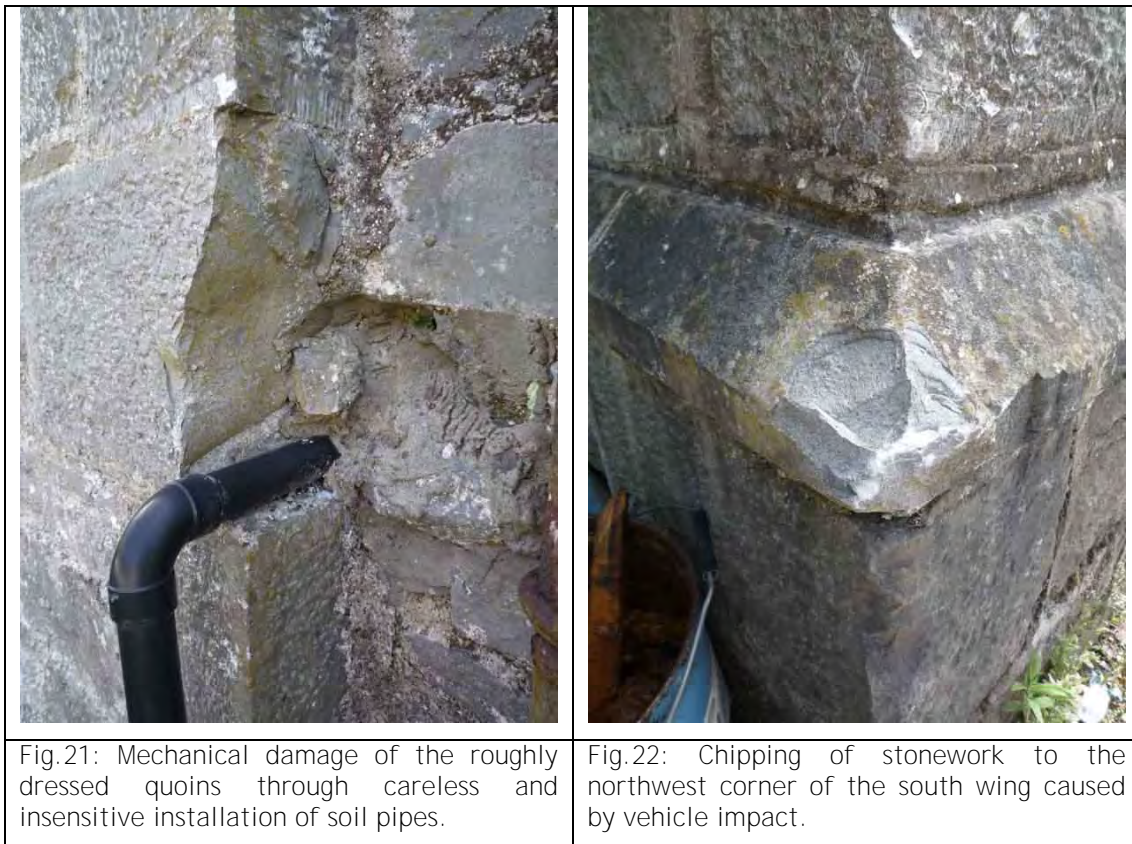
Mechanical damage has occurred where the crude installation of uPVC soil pipes has resulted in the chipping of the surrounding material. Further damage is recorded to the southwest corner of north wing and the northwest corner of the south wing where vehicle impact has occurred.

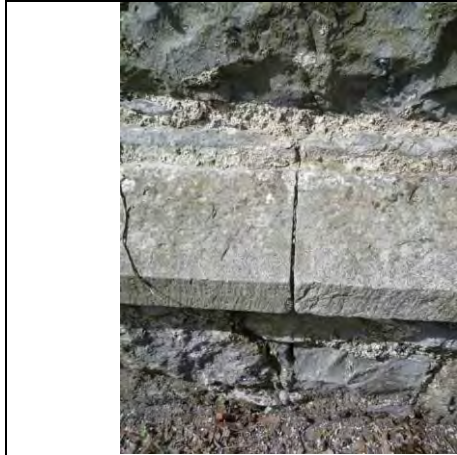
Fig.23: Open-joint to the plinth course of the west elevation.

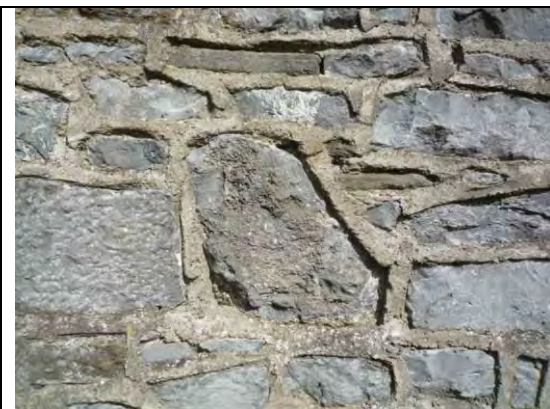
Fig.25: Cementitious strap pointing to the south elevation of the south wing.

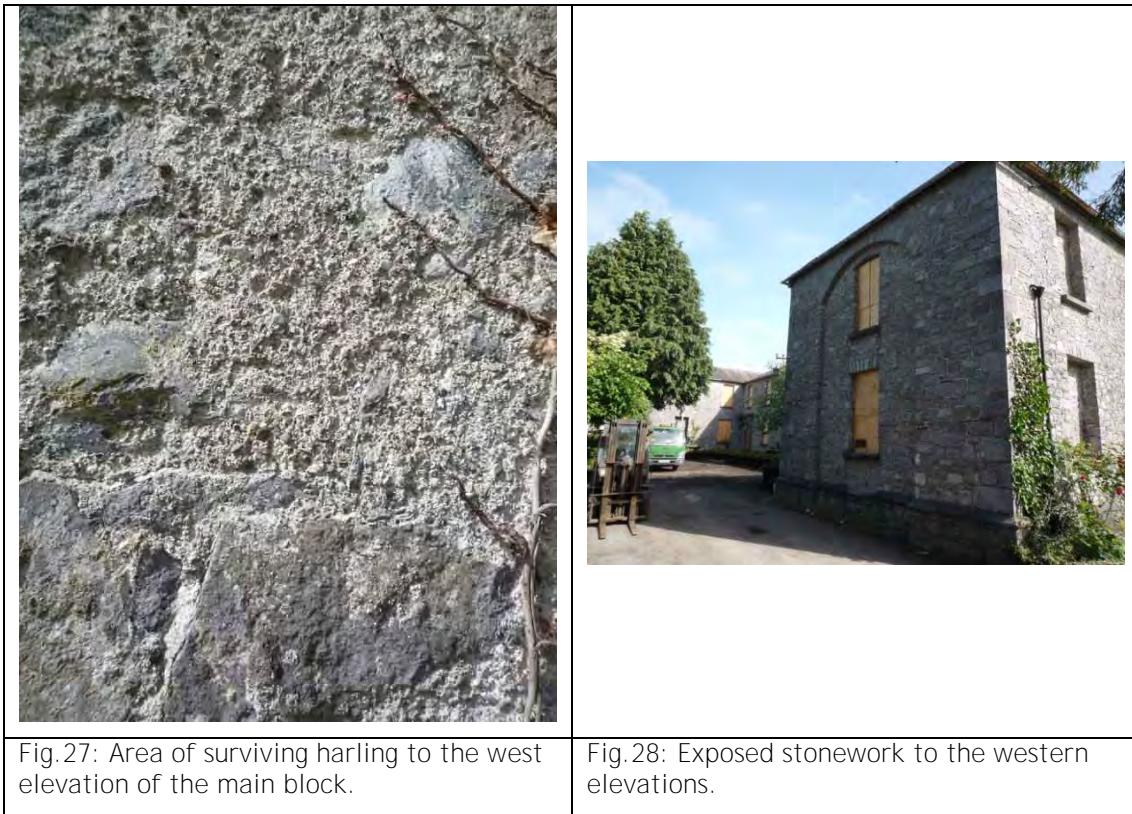
### 2.13 Biological Growth

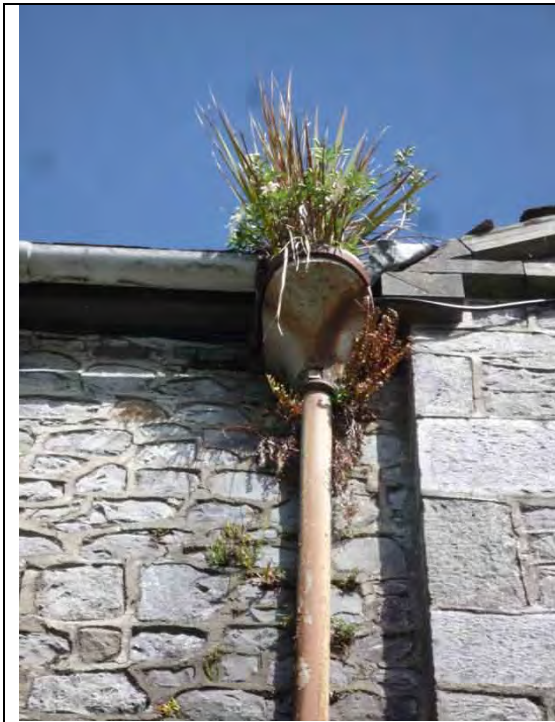
Fig.29: Plantlife to hopper located at the south elevation.

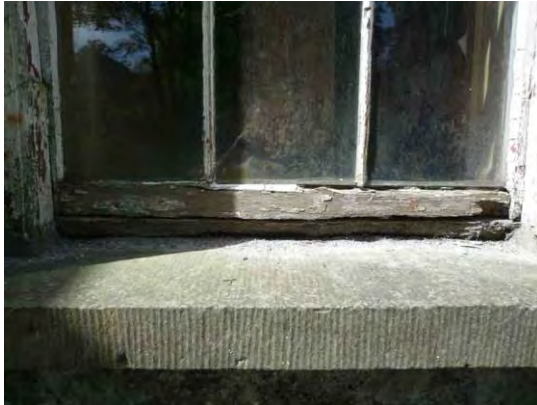
Fig.33: Localised timber decay to early sash window.

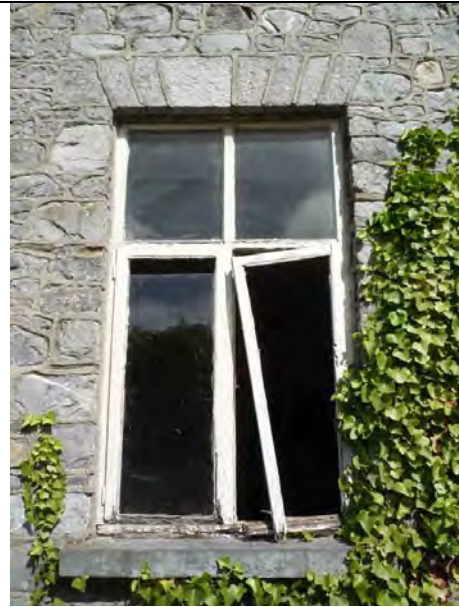
Fig.34: Complete failure of the timber casement windows.

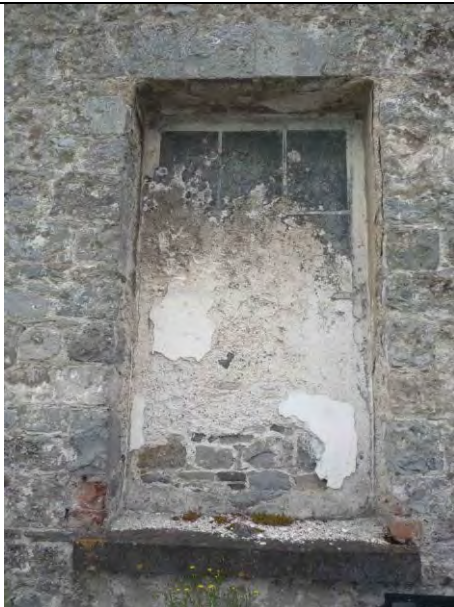
Fig.35: Blind window opening with trace remains of trompe-l'oeil window to ground floor (east) of north elevation.

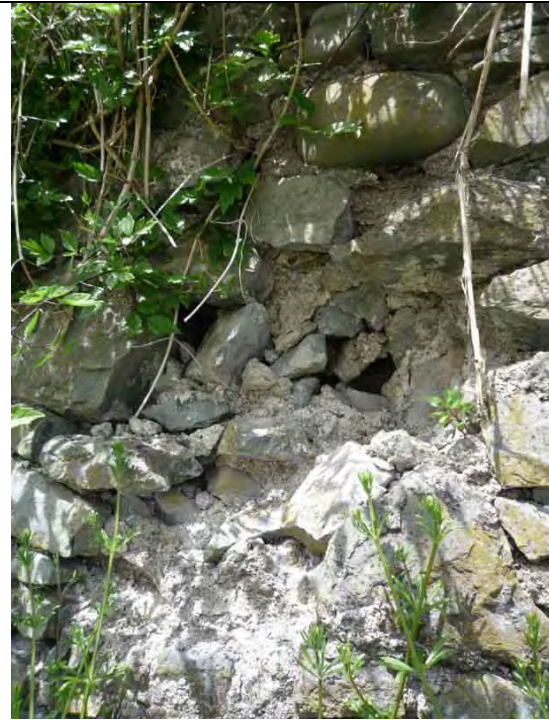
Fig.40: Pocket of missing and loose masonry to the northern boundary wall.

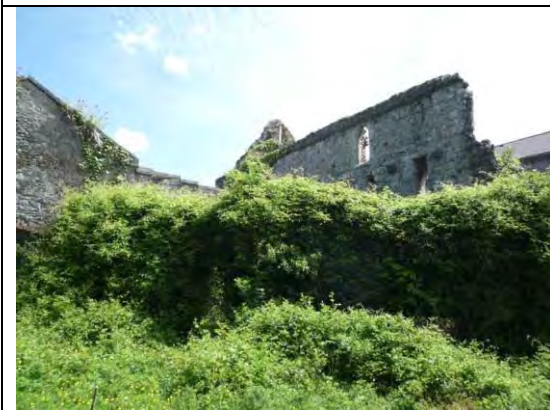
Fig.41: Blanket vegetation to the outdoor sanitary block to the southeast of site.

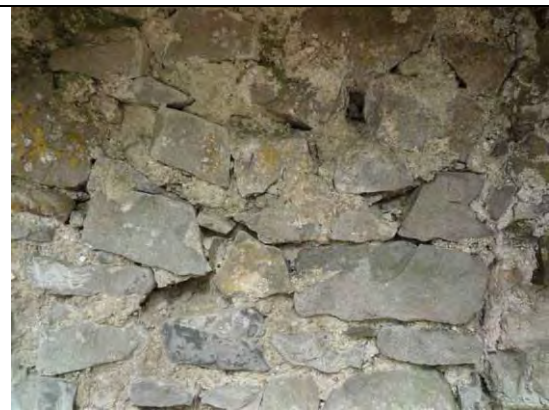
Fig.42: Open-joints to northern boundary wall.

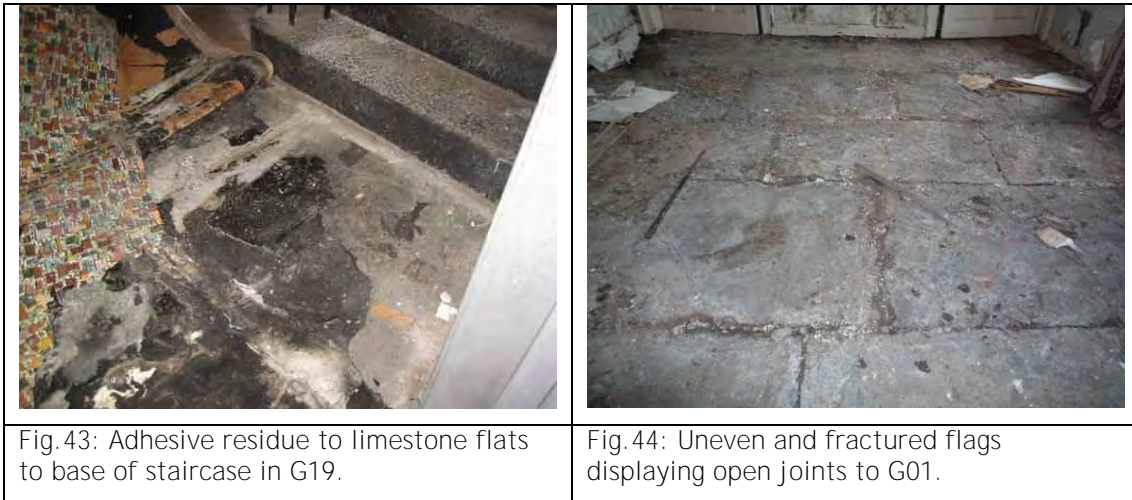
Localised areas of missing floorboards are the most common condition recorded to the first floor. In most cases these boards have been removed to facilitate previous surveys. Areas of missing floorboards present a health and safety risk for building users.

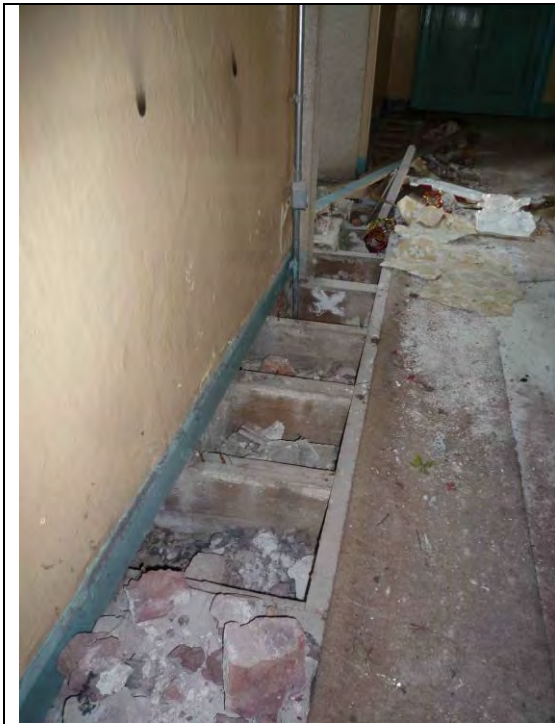
Fig.45: Section of missing floorboards to F08.

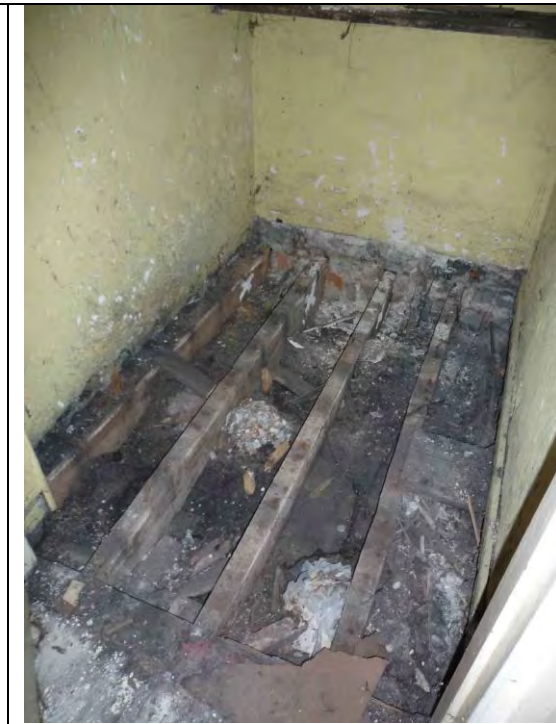
Fig.46: Missing floorboards to F06.

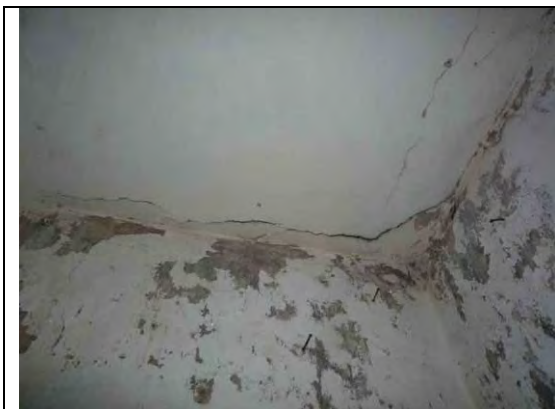
Fig.47: Cracking of ceiling plasterwork to G10.

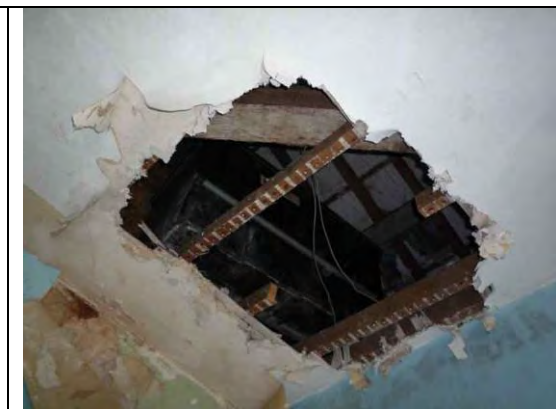
Fig.48: Significant hole in ceiling plaster over F01.

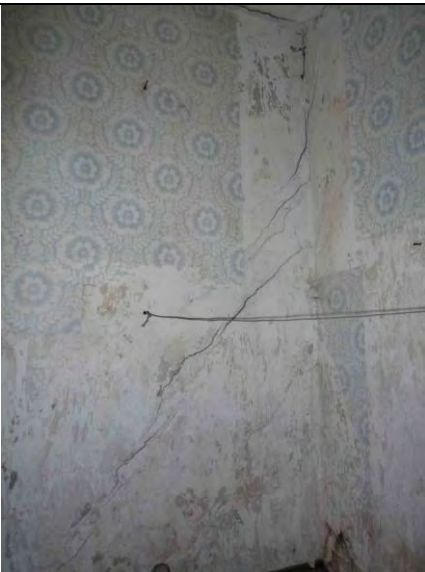
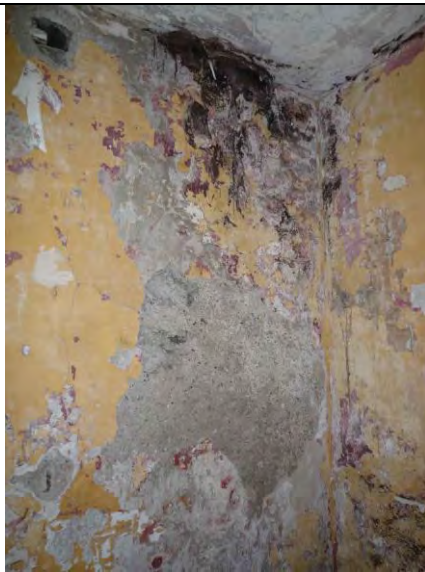
<p>Fig.49: Cracking of plaster to the north wall of G01 corresponding with cracking to the external wall.</p>	<p>Fig.50: Plaster failure to room G27.</p>

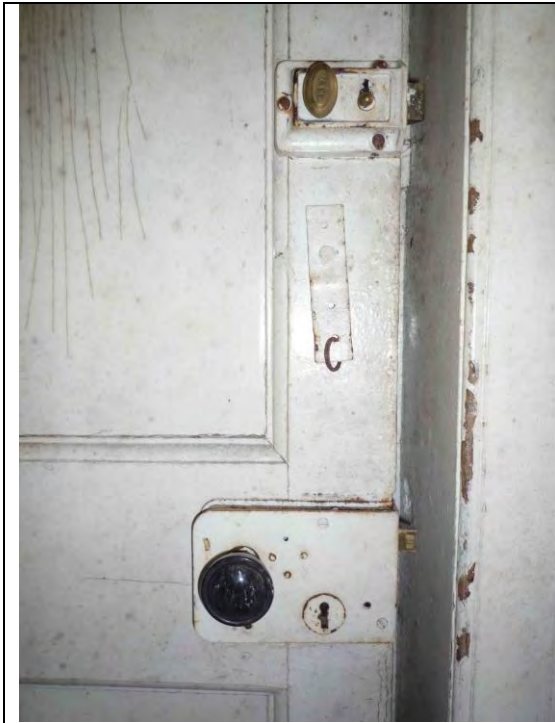
Fig.51: Door furniture to G01.

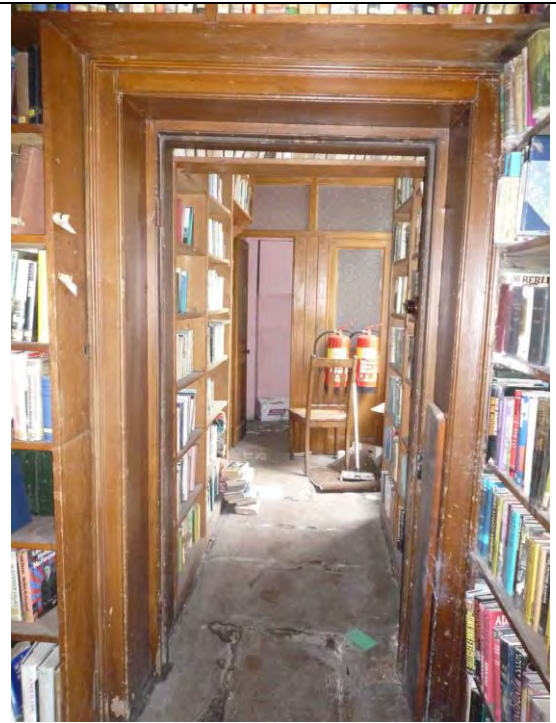
Fig.52: Missing door leaf to opening giving access from G15 to G16.

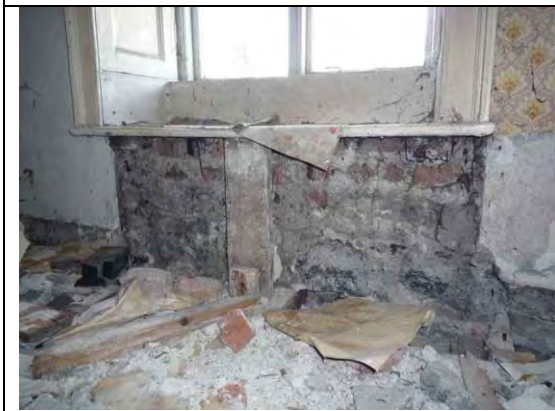
Fig.53: Missing apron panel to window opening at F07.

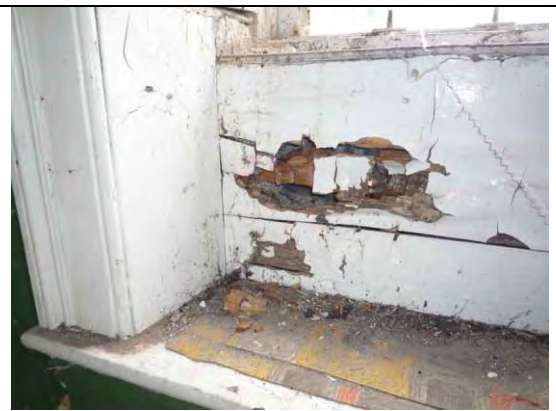
Fig.54: Timber decay of window back to west window opening of F11.

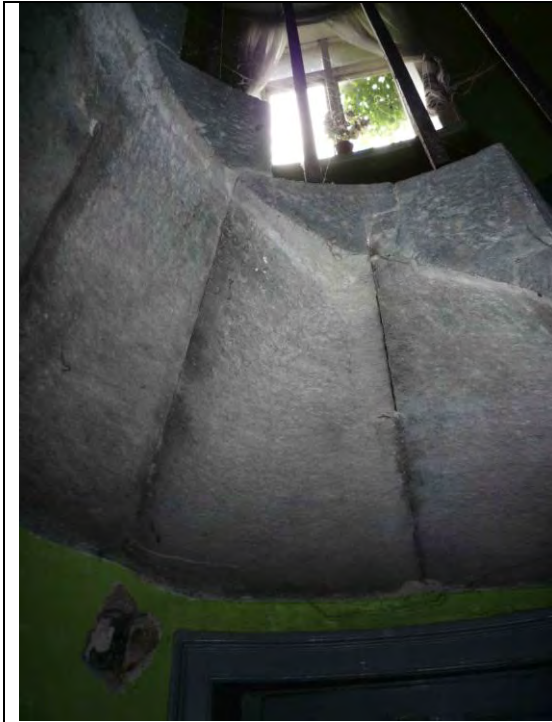
Fig.55: Open joints to undercarriage of staircase located in G19.

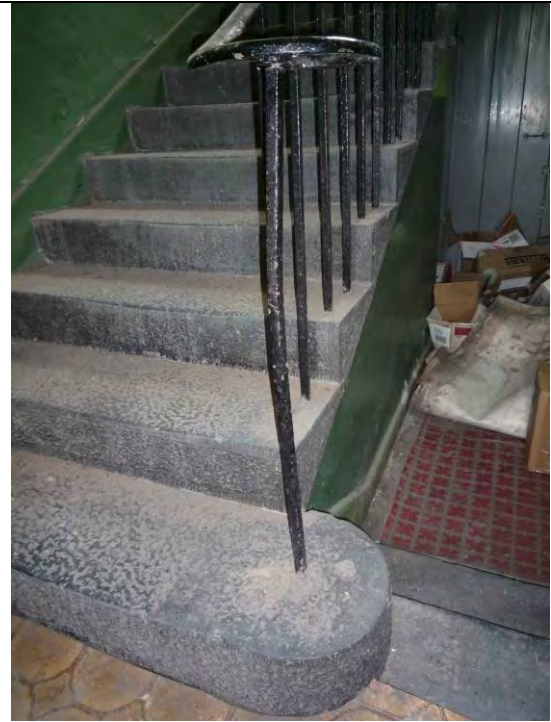
Fig.56: Missing wrought-iron balusters newel post of staircase to G11.

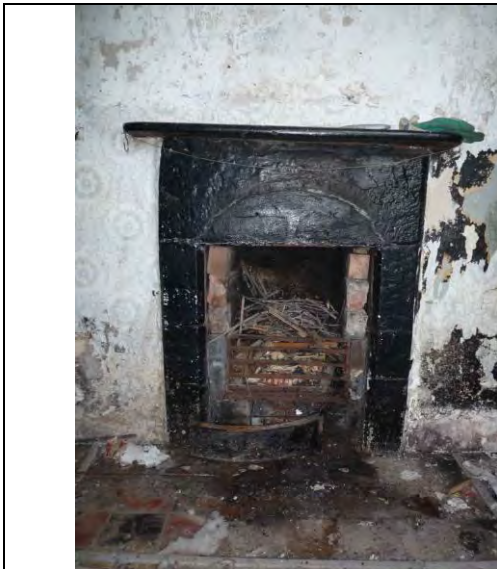
Fig.57: Over-painted stone fireplace to G01.

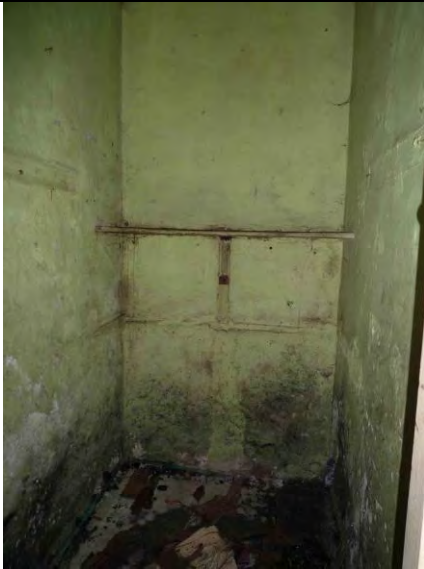
Fig.59: Plaster failure at low level as a result of rising damp to G20.

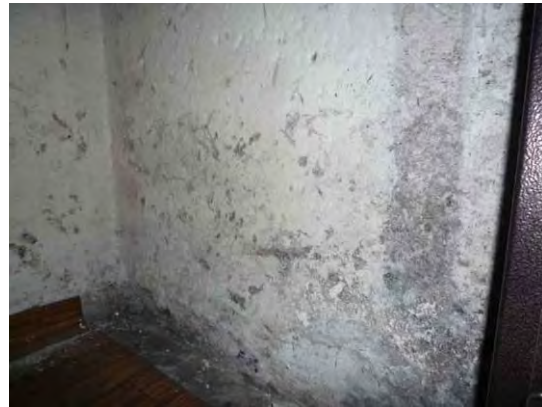
Fig.60: Rising damp to the west wall of G24.

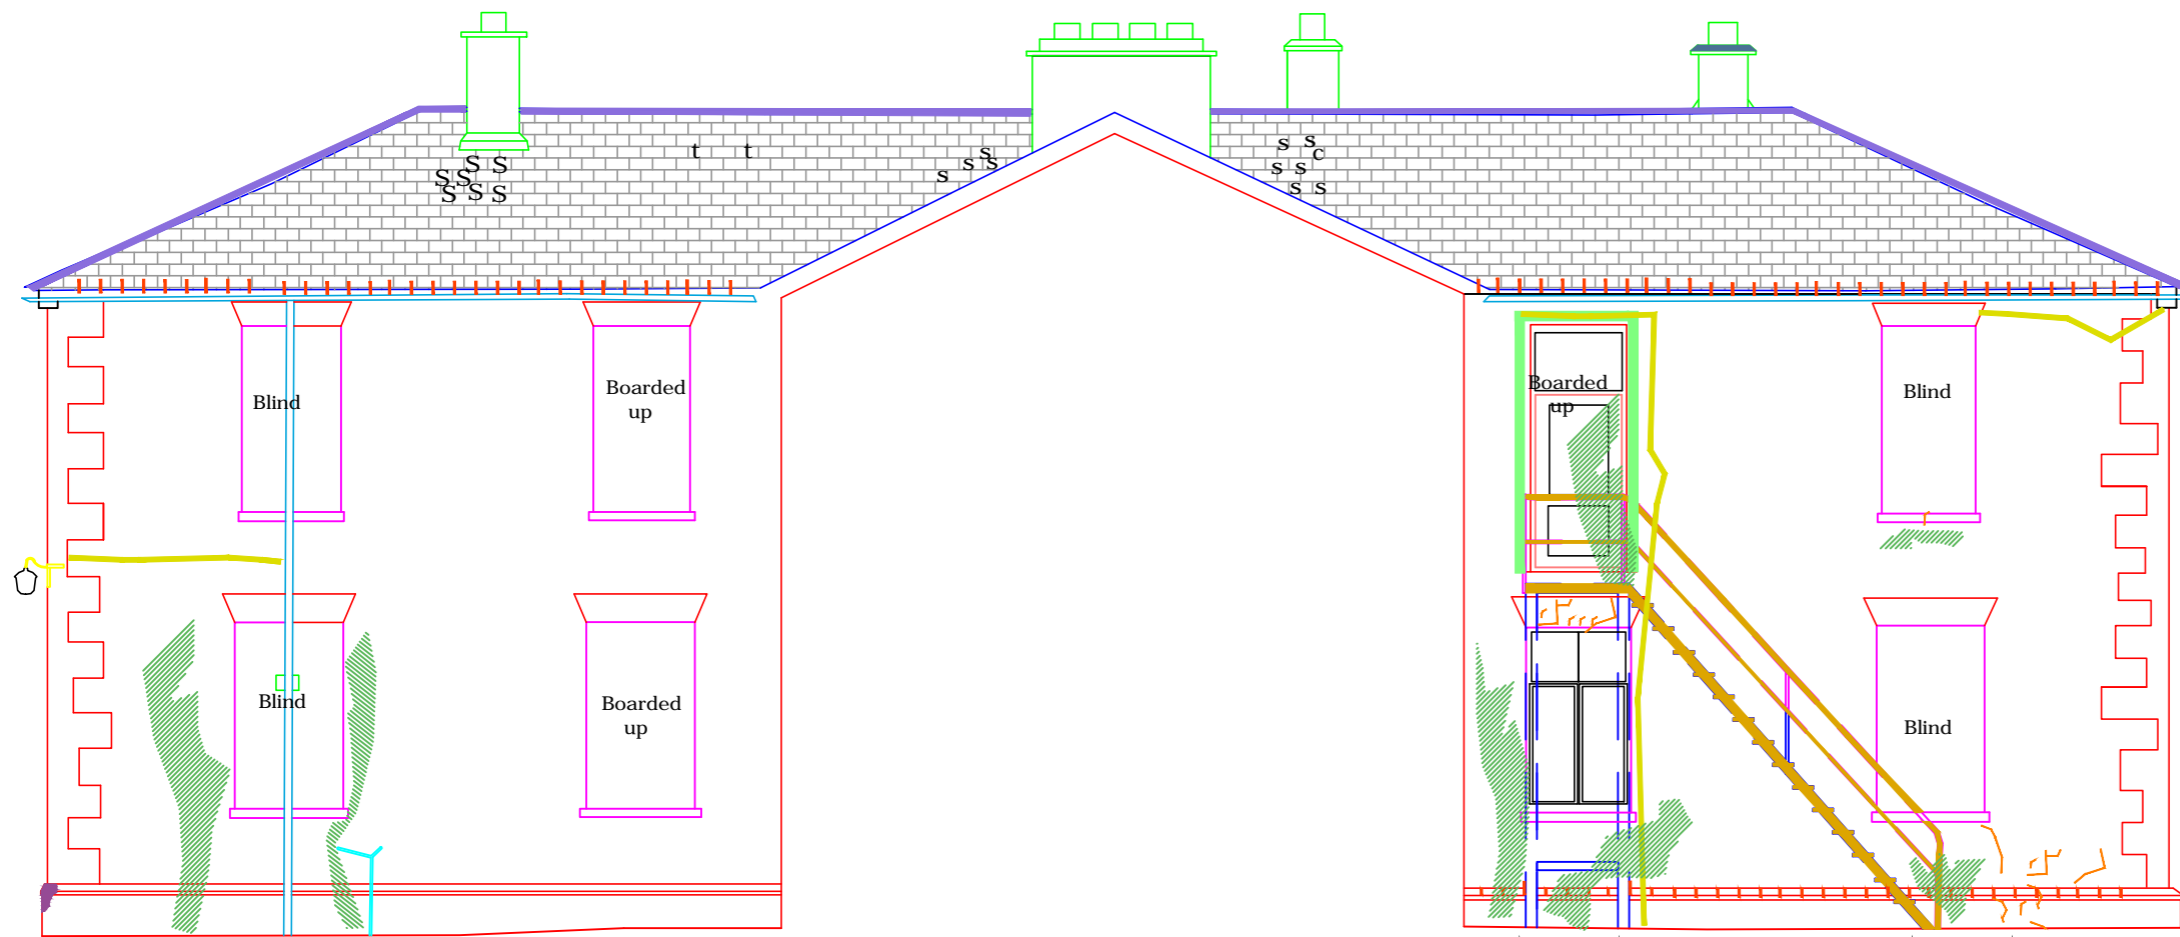
Cement based strap pointing to this section of elevation

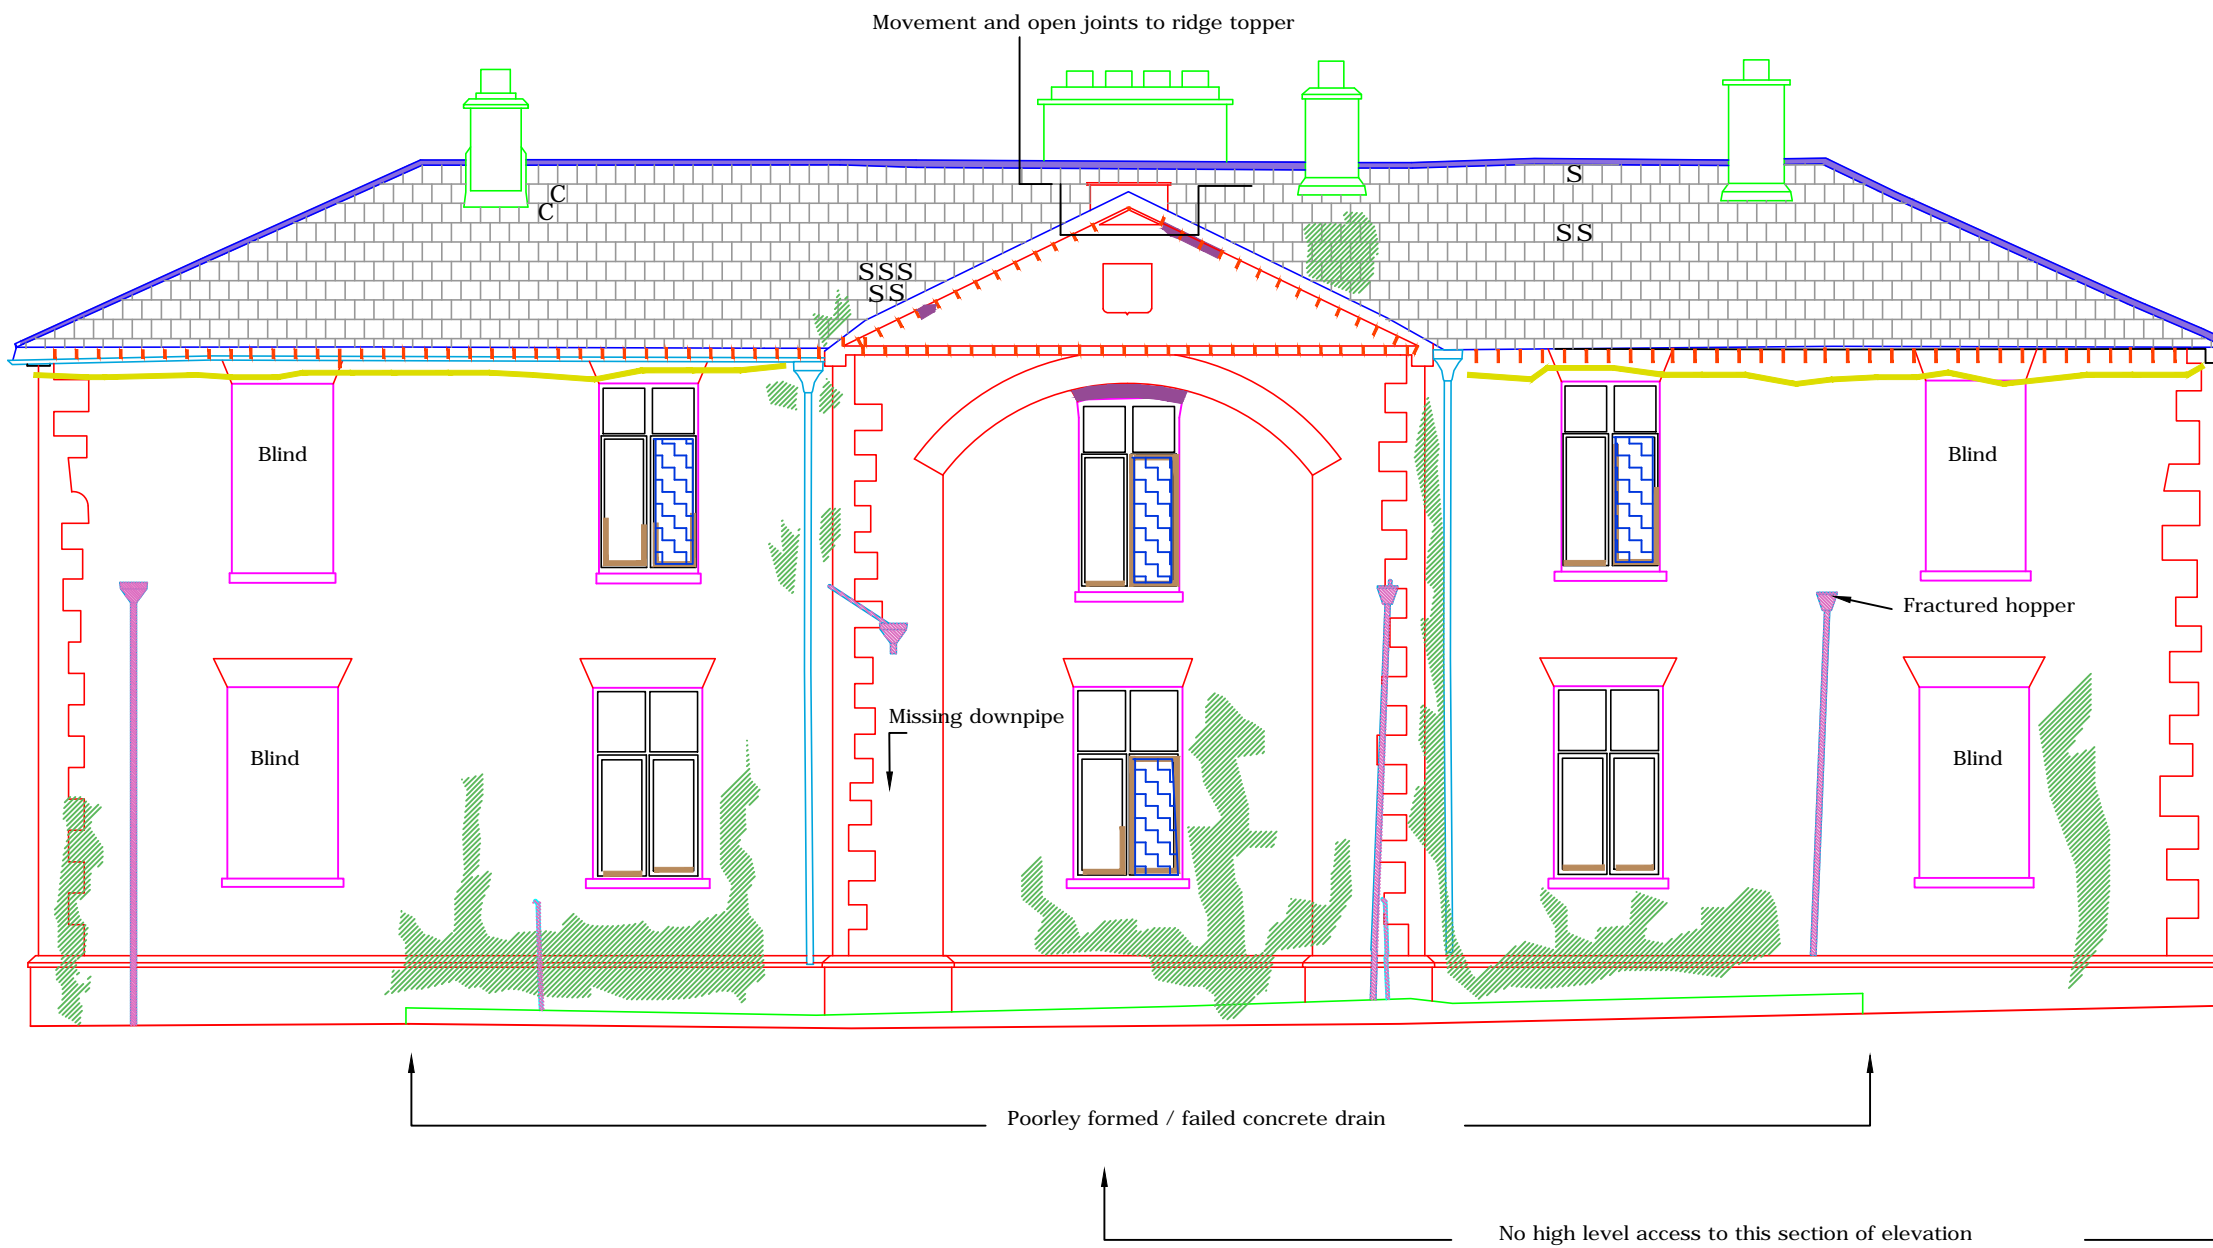
EAST ELEVATION (EAST WING)

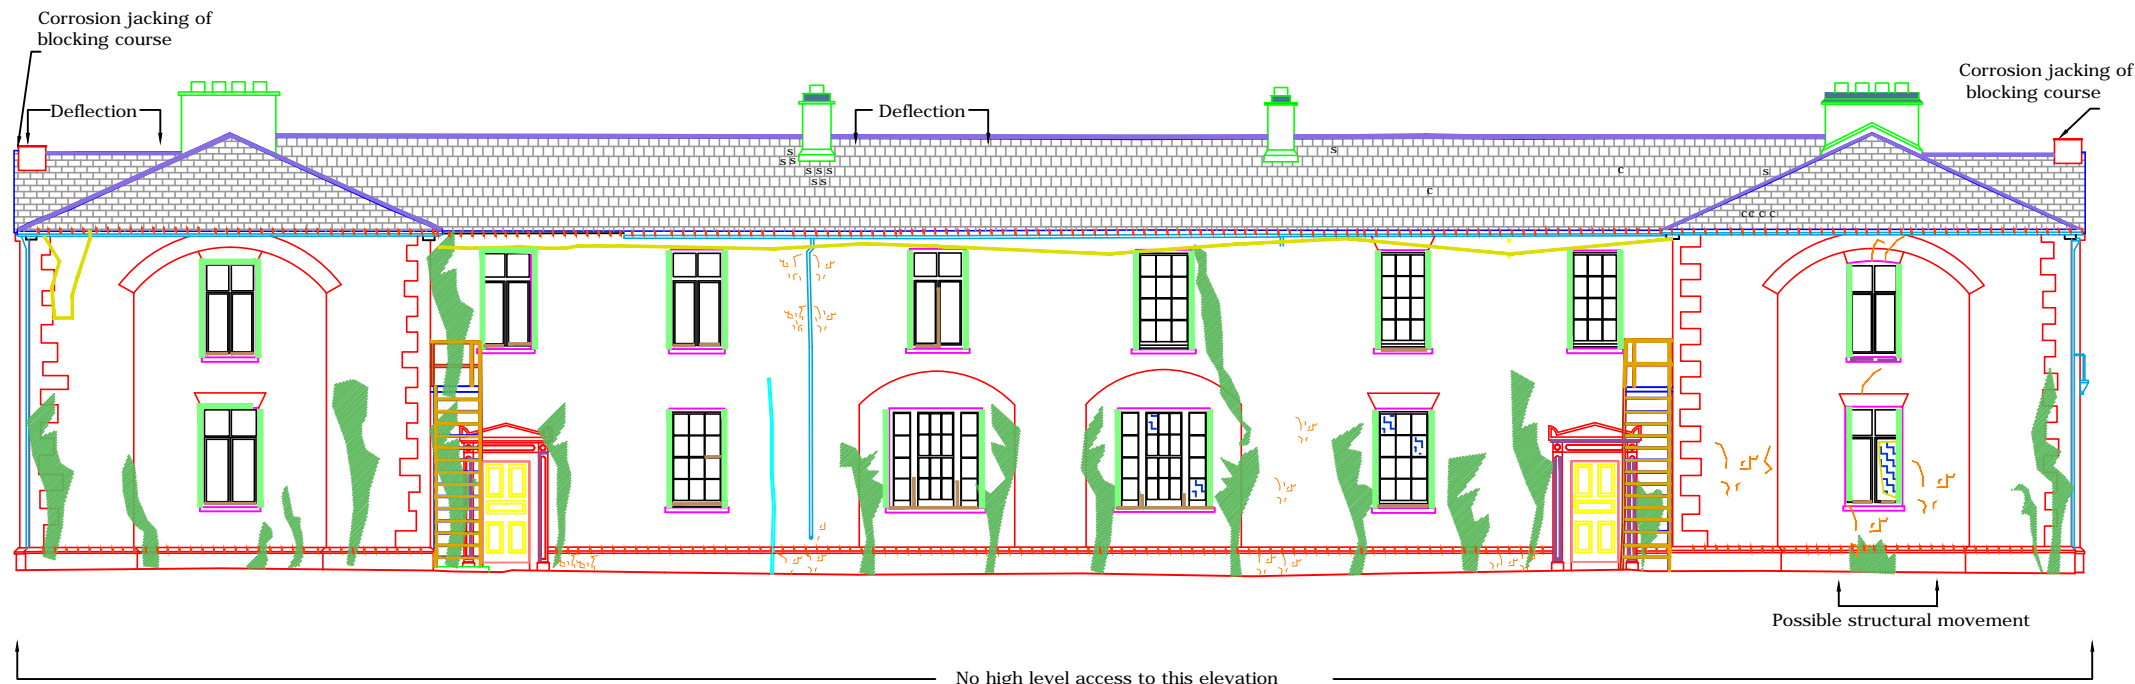
DRAWN JB	CHK PC	PASS	REVISION NO. Rev 1
DATE 19-09-12	SCALE nts		
PROJECT NUMBER 09054	DRAWING NUMBER C-06

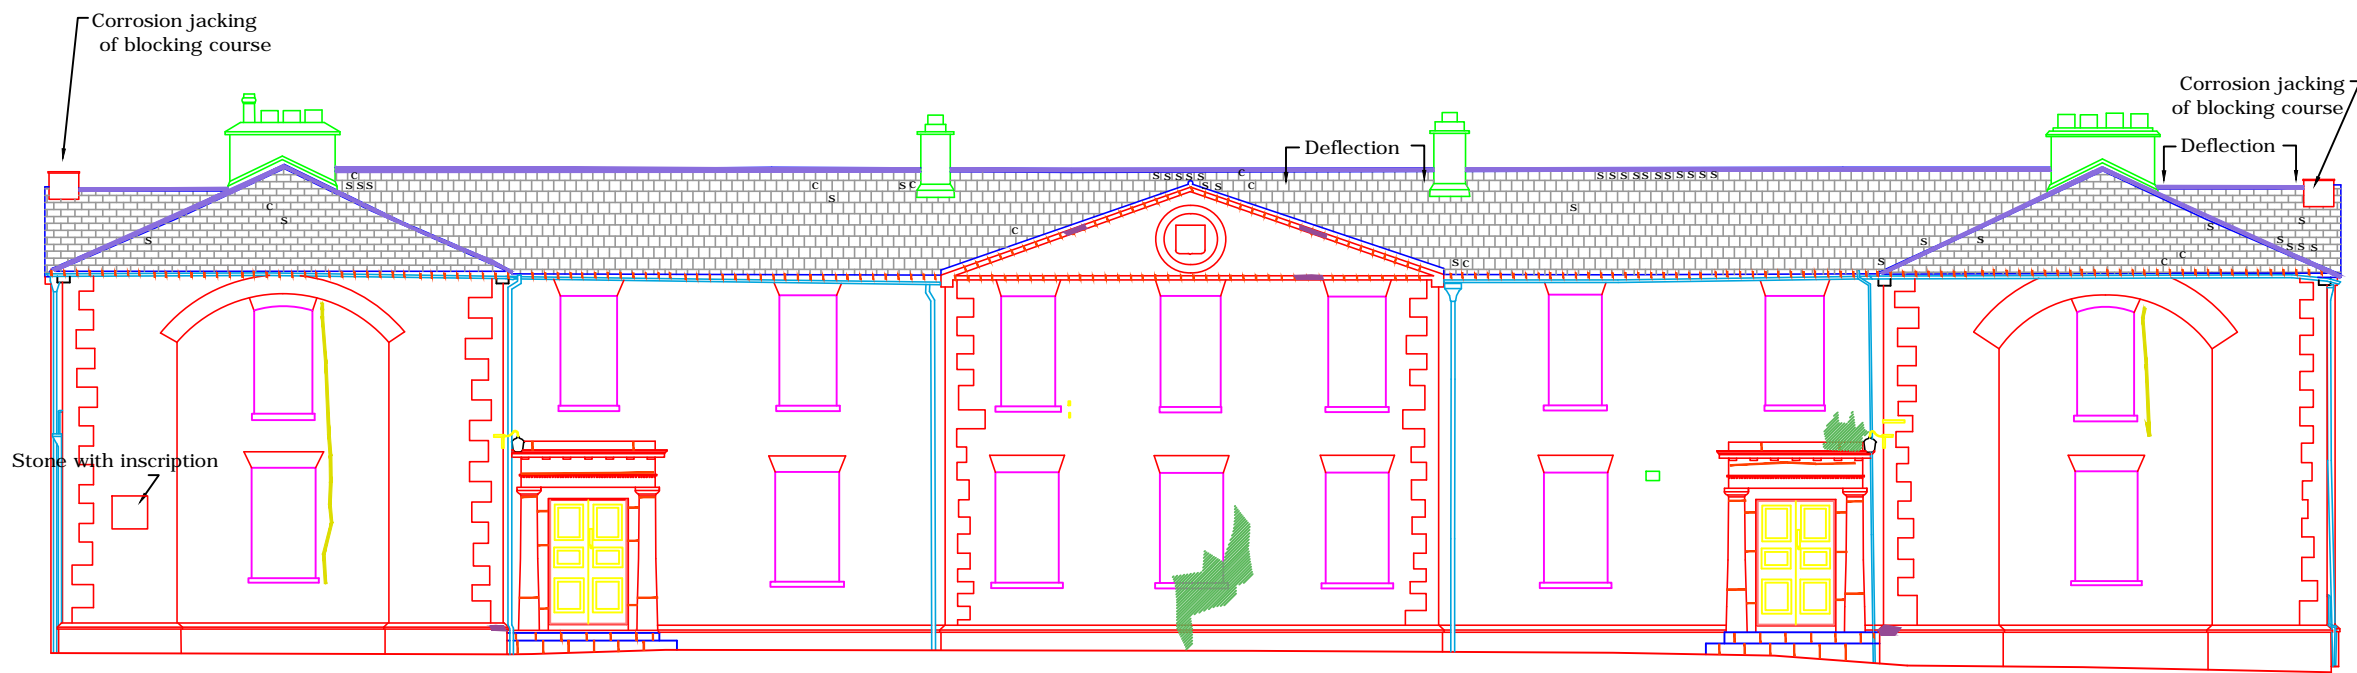
DRAWN JB	CHK CC	PASS	REVISION NO. Rev 1
DATE 19-09-12	SCALE nts		
PROJECT NUMBER 09054	DRAWING NUMBER C-07
