PROPOSED NEW BUTLER GALLERY AT  
**EVAN'S** ALMS HOUSE,  
BARRACK LANE, KILKENNY

VOLUME 2  
EXTERNAL CONDITION SURVEY  
RECOMMENDATIONS

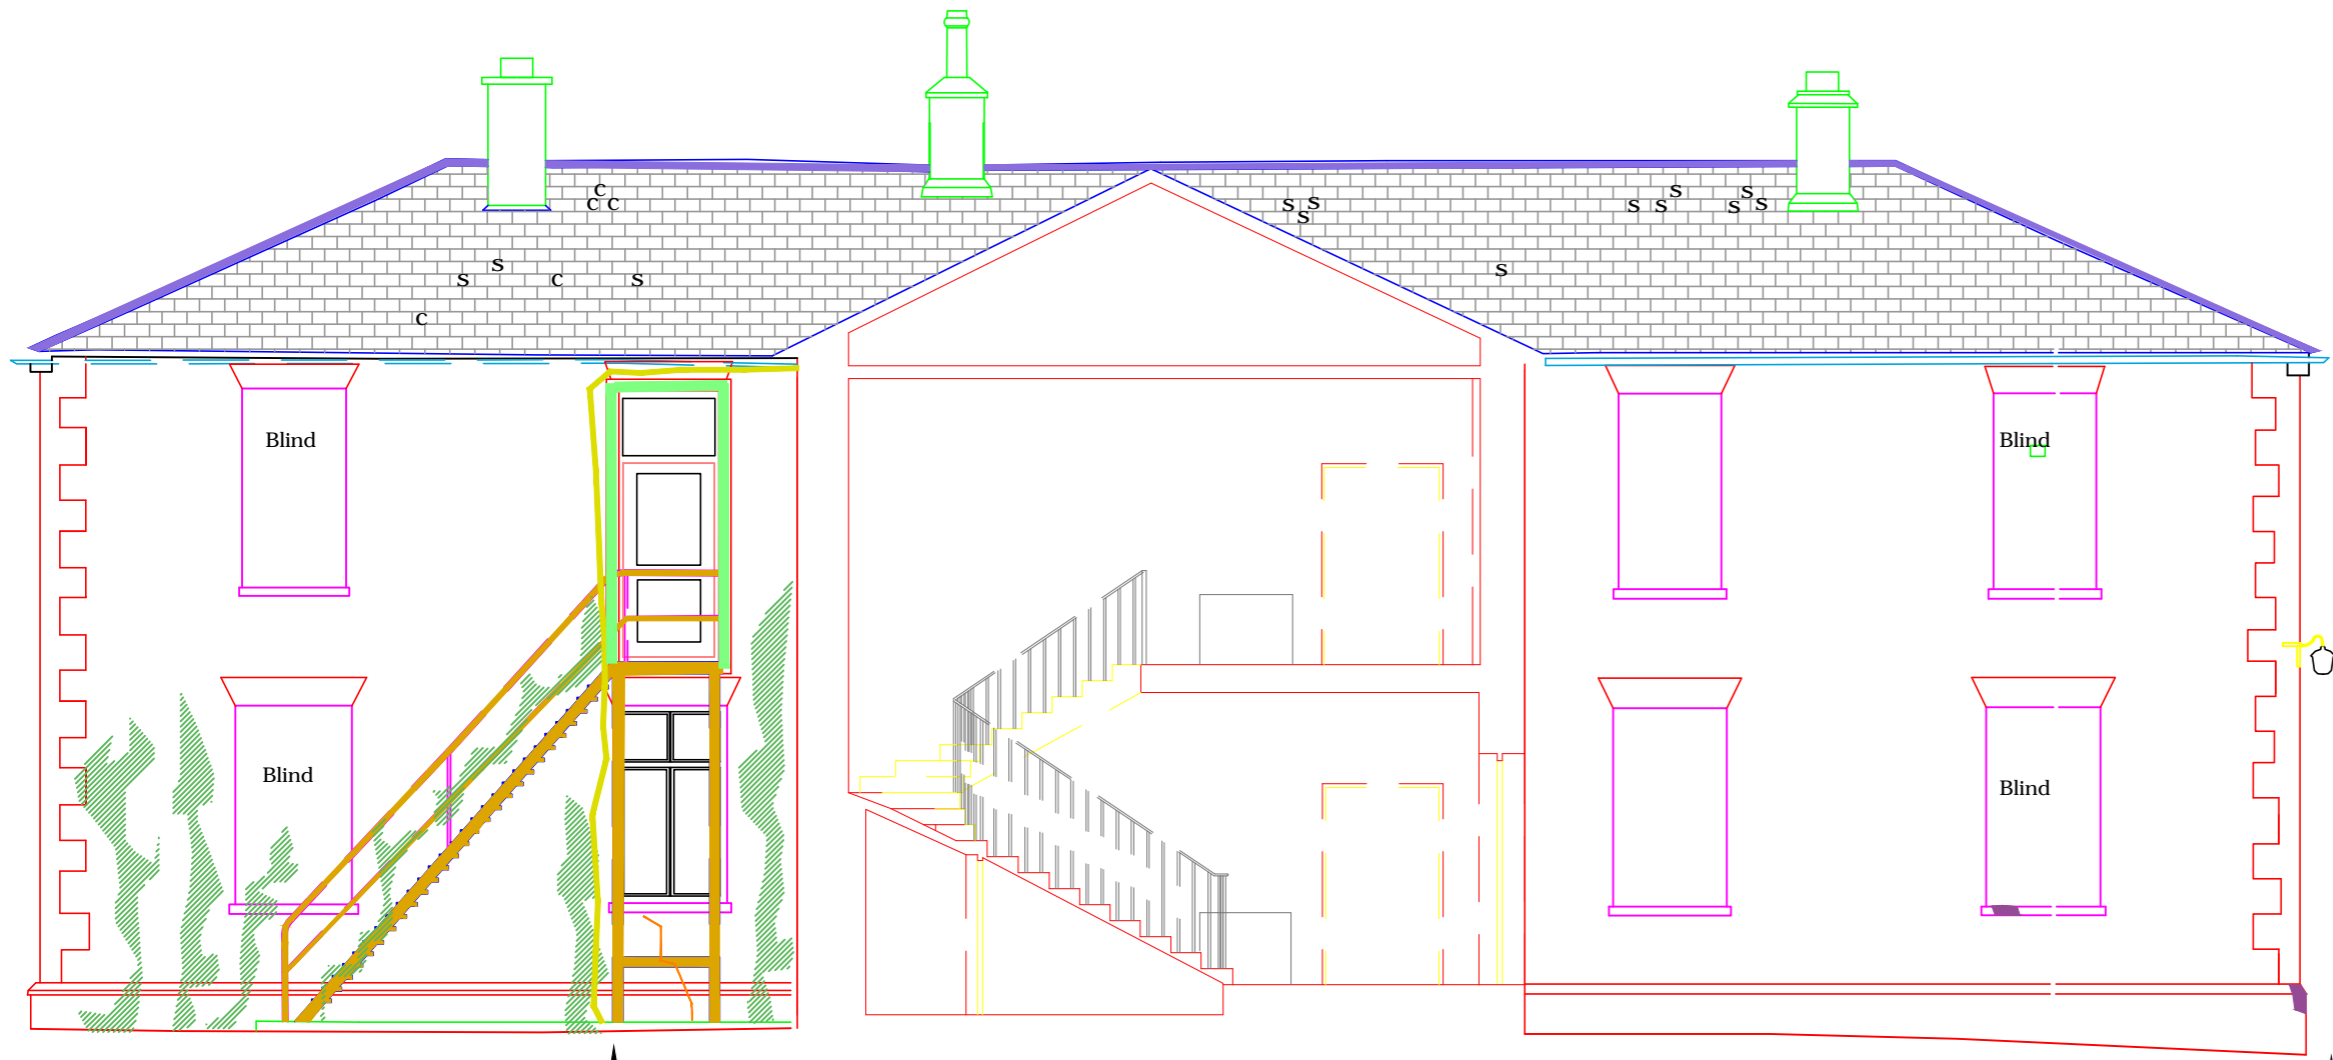
DRAWN JB	CHK PC	PASS	REVISION NO. Rev 1
DATE 19-09-12	SCALE nts		
PROJECT NUMBER 09054	DRAWING NUMBER C-03

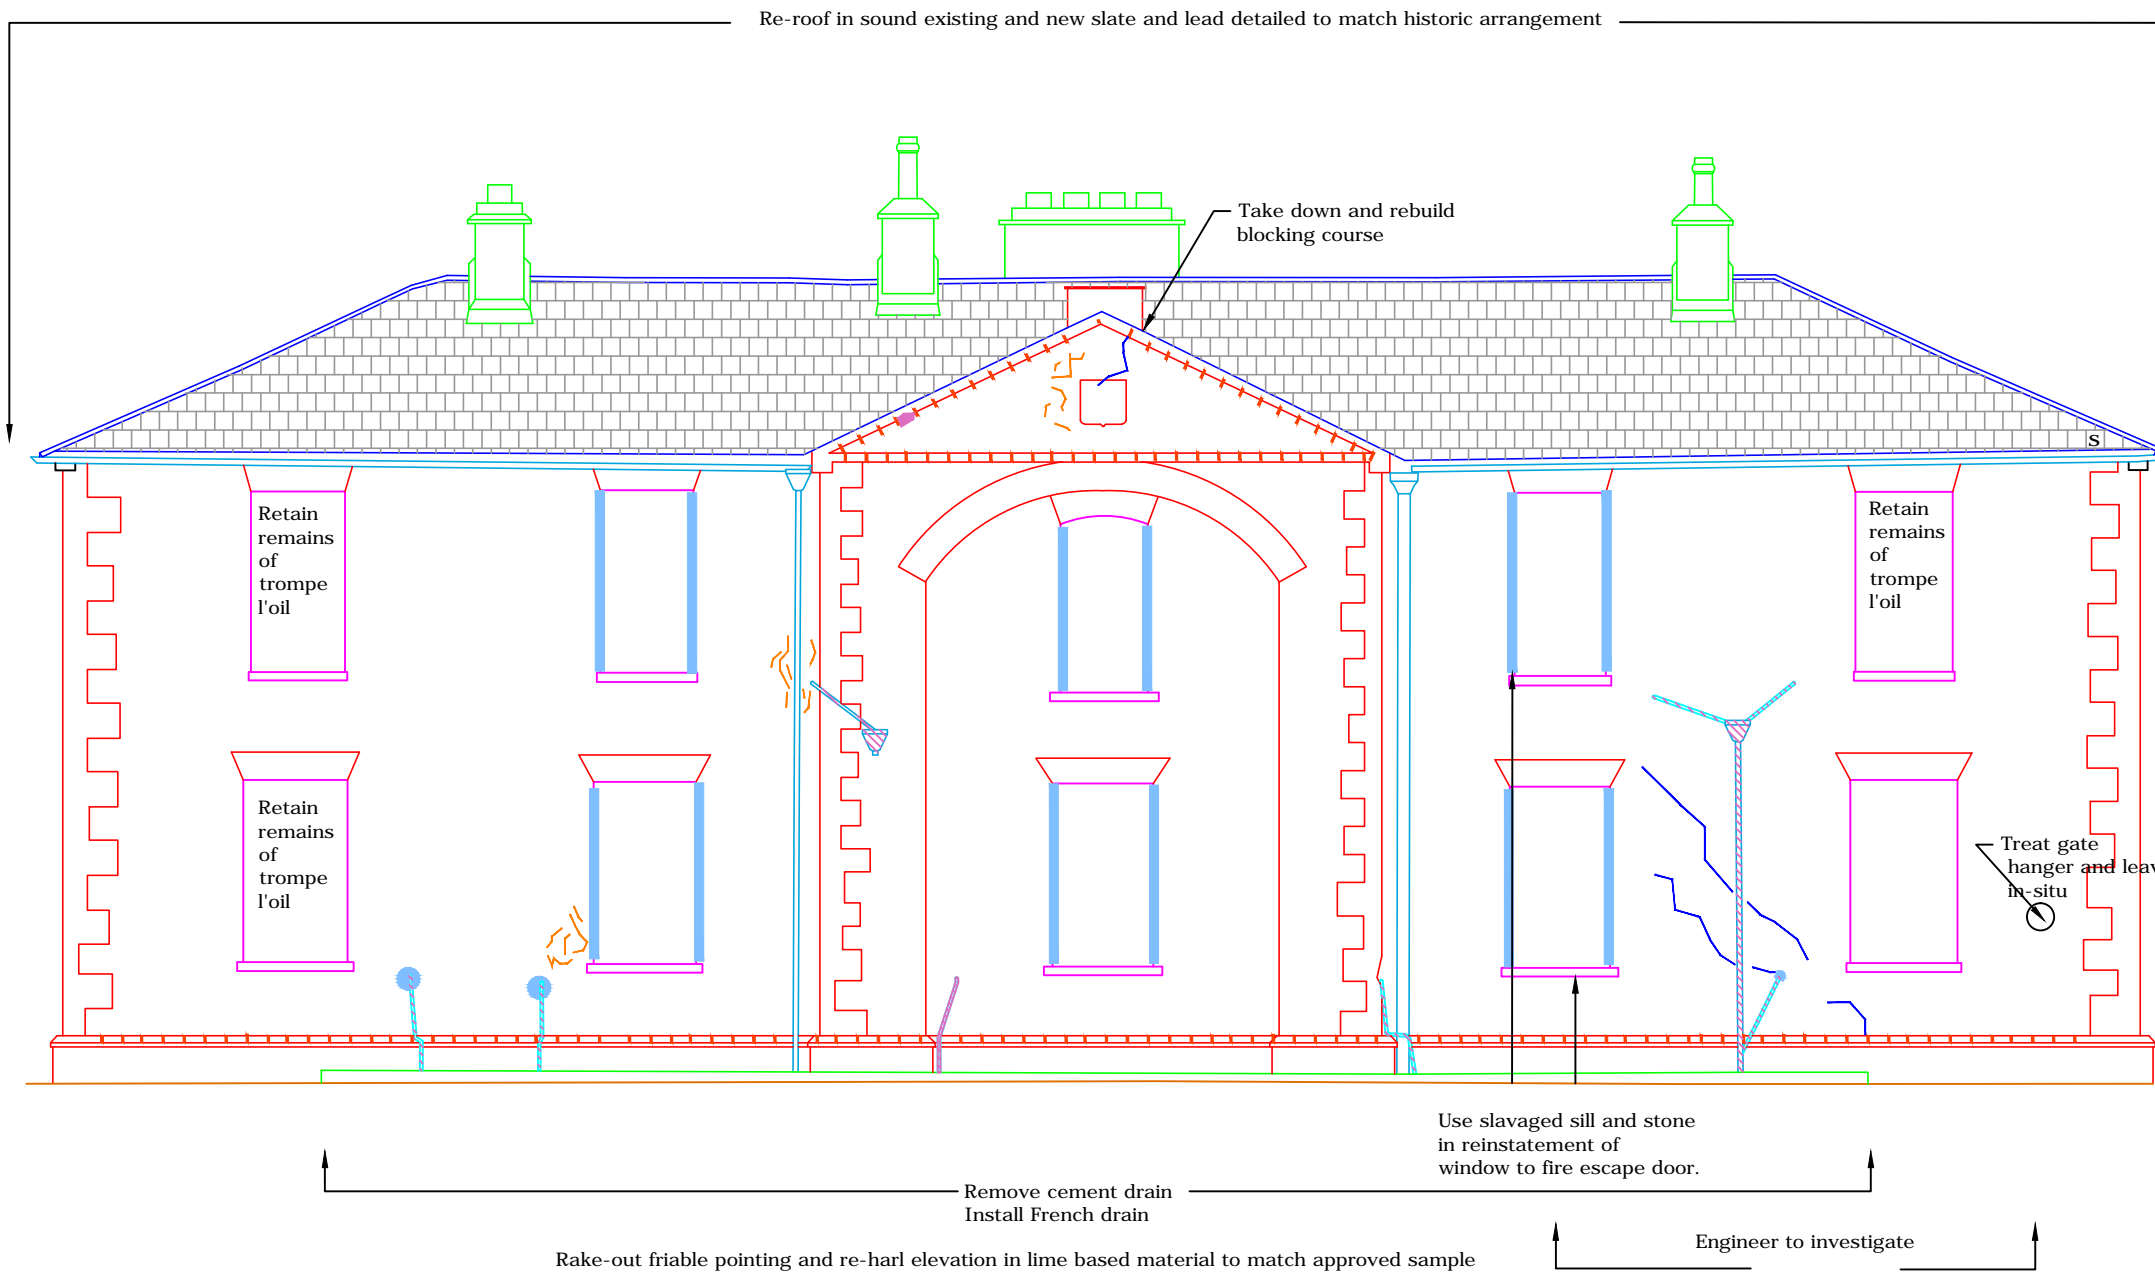
## APPENDIX 2 - RECOMMENDATION DRAWINGS

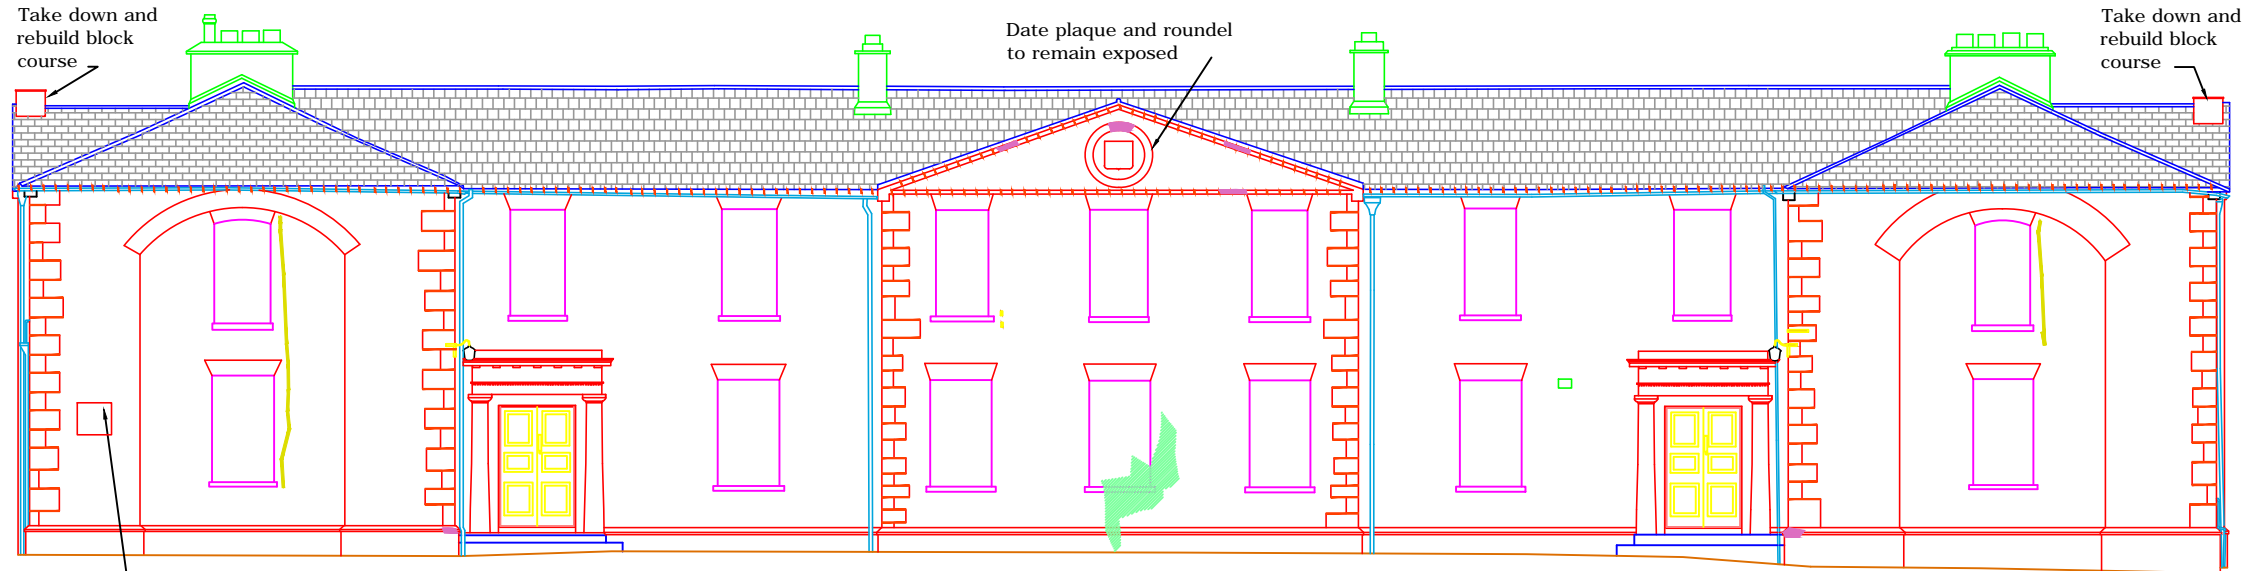
Great care to be taken in removal of cement pointing from stone plaque. Plaque to be exposed
