For: KILKENNY COUNTY
COUNCIL

Issue: 3/1/2019

CONSERVATION REPORT

THE THOLSEL, CITY HALL, HIGH STREET, KILKENNY

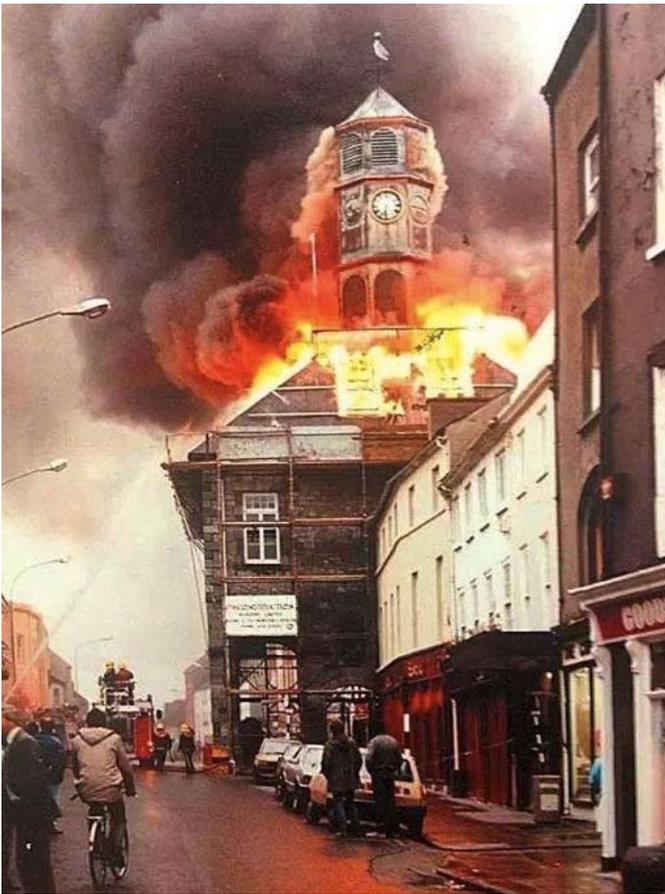
Photo showing the Tholsel on fire, 20 Sept 1985, taken by Oliver Dunphy.

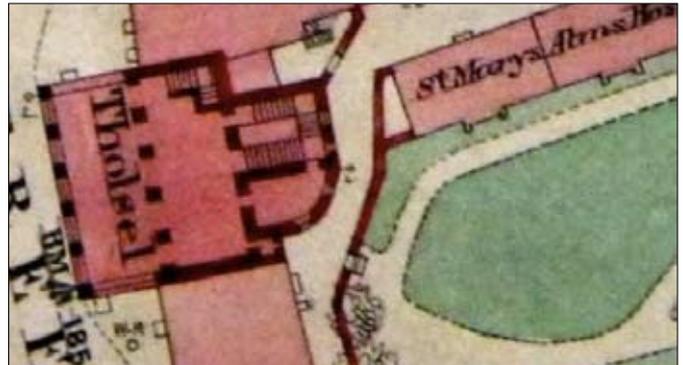
Extract from the 1871 Ordnance Survey coloured Town Map of Kilkenny. This map clearly shows a stairs in the return that is very similar to the proposed stair. It also shows a room rather than a stairway in the curved extension. The proposal thus restores an earlier internal arrangement.
