**PROJECT REPORT
&
ARCHITECTURAL HERITAGE IMPACT ASSESSMENT**

**RESTRUCTURING AND RENOVATION OF THE SESSIONS HOUSE, LOGAN STREET,
THOMASTOWN**

On the instructions of Kilkenny County Council

March 2020

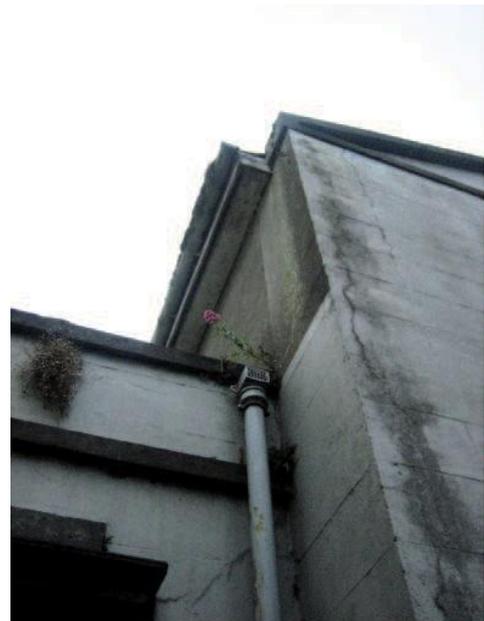
6. Crack in hard cement plaster, vegetation. This will be removed and the façade rendered with insulated breathable lime plaster

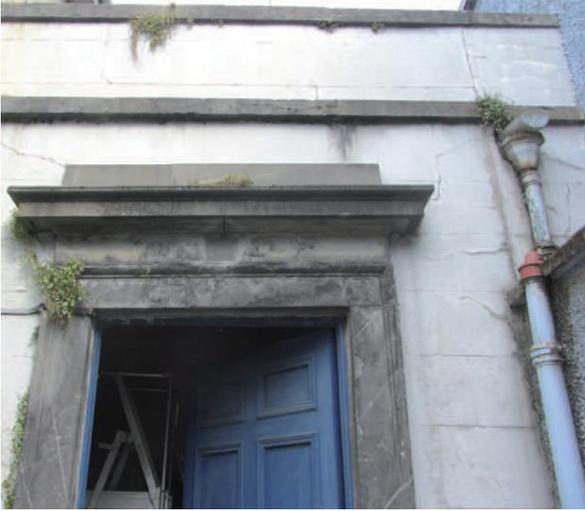
7. Carved limestone surround to Entrance. Vegetation and cracks in plaster

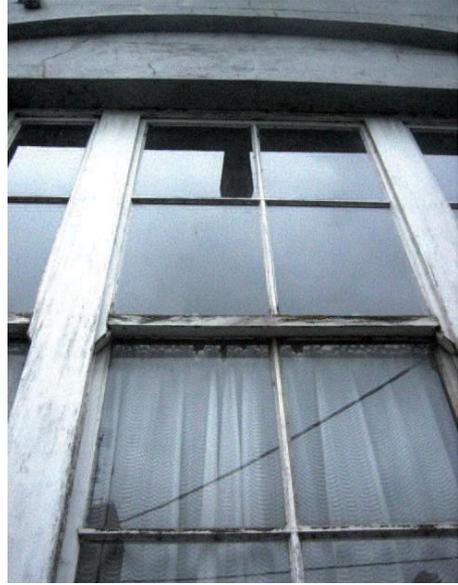
8. 1980s window to front elevation is in poor condition

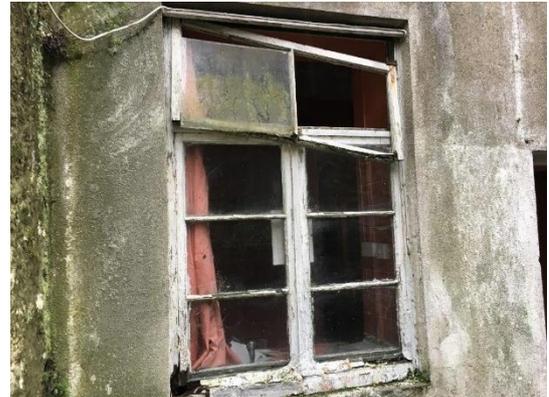
10. 1920s casement window to rear elevation is in poor condition

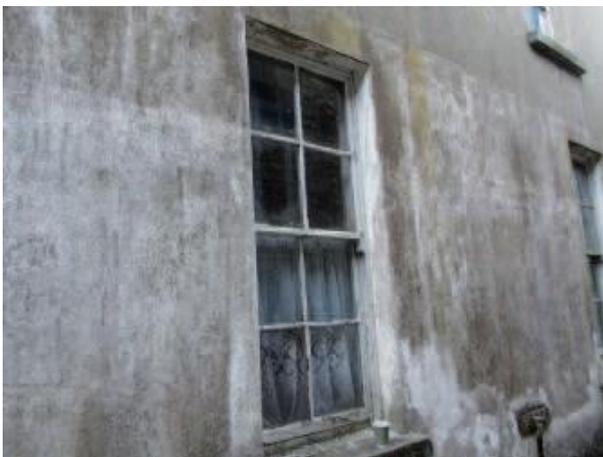
11. Sash window, rear elevation. Possibly predates the 1926 rebuild.

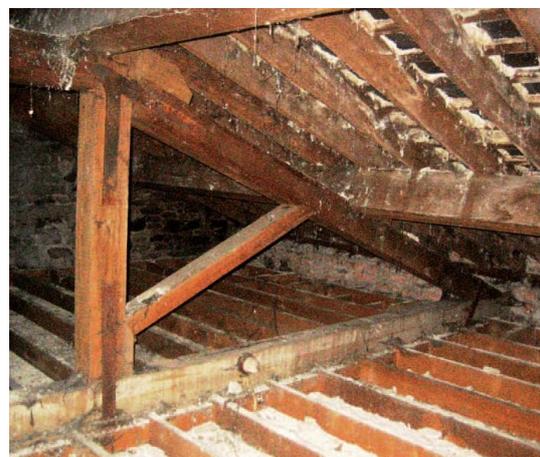
12. The court room roof structure is in good condition but is not insulated

The roofs to the court room and to the two-storey block to the rear are to be retained, and insulated, with eaves and valleys checked, and timbers repaired or replaced where necessary, and new cast iron rain water goods installed. The low roofs over the entrance lobbies will be renewed to the existing profiles.

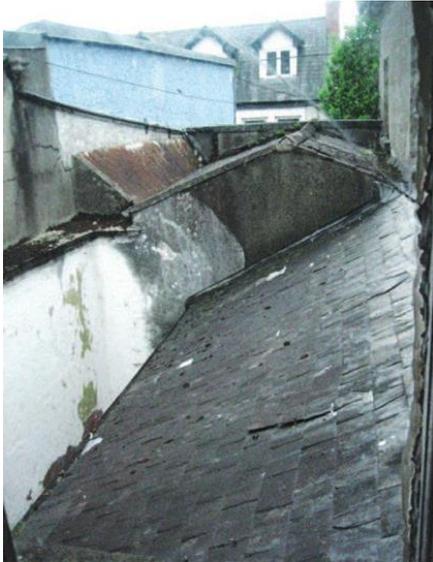
13. The roof above the south corridor will be partly removed to facilitate construction of upper level extension

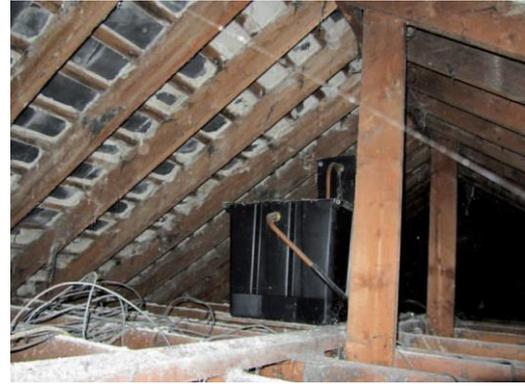
14. The roof structure to the rear two-storey block is in good condition but is not insulated

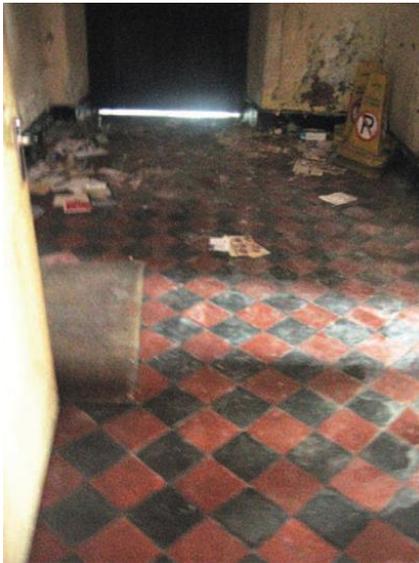
15. South entrance lobby; original tiled floor finish remains largely intact.

The tiled floors in both entrance lobbies will be retained and cleaned. Fortunately, the sewer running below the southern lobby is in good condition and need not be opened up. Otherwise, service ducts will be routed via the new floor in the court room rather than via the lobbies and great care will be taken in excavating or drilling below the front external wall to Logan Street.

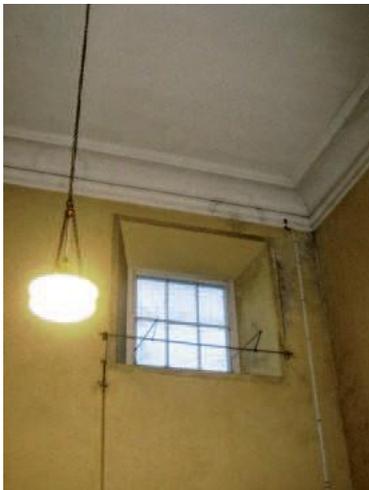
17. Clerestory window and opening mechanism. Mould growth due to condensation.

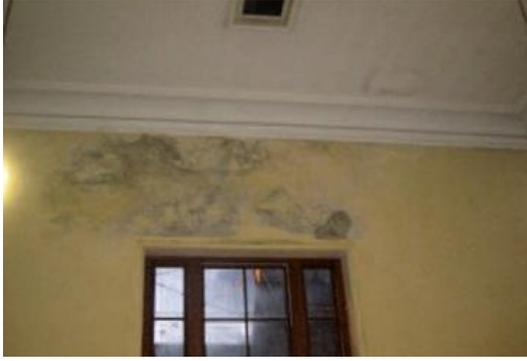
19. Damp and plaster deterioration above main window due to water ingress via cracks in the external cement render

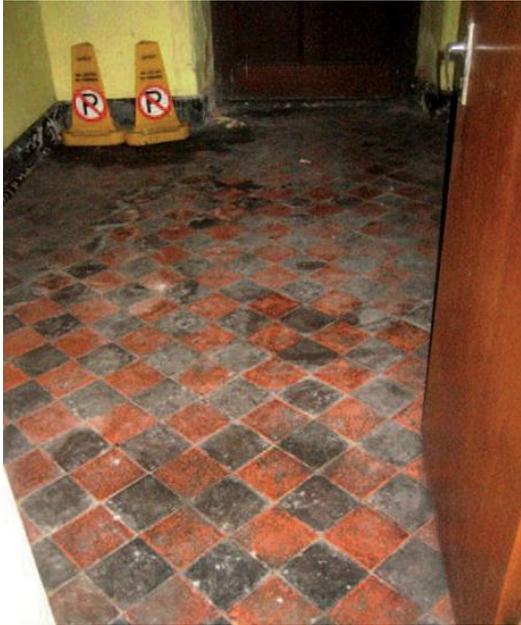
21. Original tiled floor finish survives

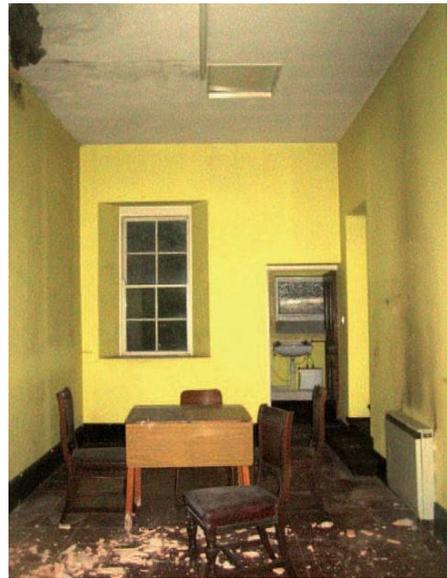
22. The jury room has a later door opening to the court room, right.

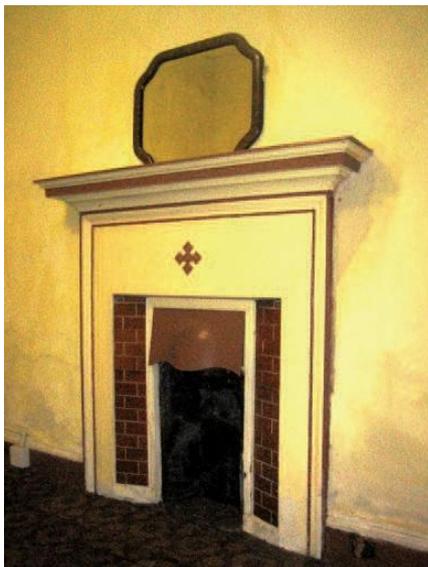
23. The fireplace in the judge's room will be retained

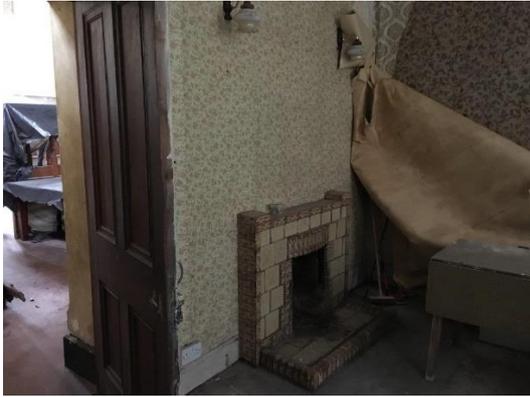
25. Fireplace in caretakers drawing room

WORKS ITEM	POTENTIAL ADVERSE EFFECTS	POTENTIAL NEUTRAL EFFECTS	POTENTIAL POSITIVE EFFECTS	MITIGATING MEASURES
					design
	<ul style="list-style-type: none"> Remove or lower hearth within the caretaker's drawing room. Ref. Photo No.25 	Small loss to "story" of building.		Elimination of trip hazard within the new layout.	Record prior to alteration
	<ul style="list-style-type: none"> Remove crosswall between the Drawing Room and the Judge's Room to create Classroom 	Alteration to plan form. some loss of historic masonry fabric		Improves flexibility of use of the building	Record opening up. Make good masonry using lime mortar and salvaged brick or stone. Express former plan form in ceiling downstand.
	<ul style="list-style-type: none"> Remove 20th Century partitions between bedrooms and corridor at upper level to form a single workshop space 	Removal of 1920s wall	Removal of mid-20 th Century wall to corridor	Return to likely original plan form	Retain cornices to tell "story" of changes

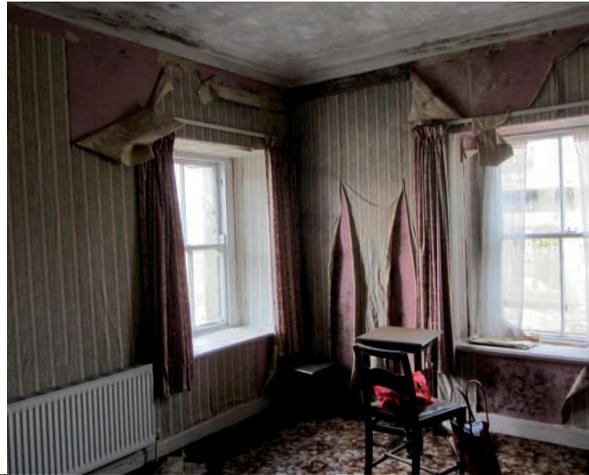
26. Wall paper lifting upstairs due to condensation

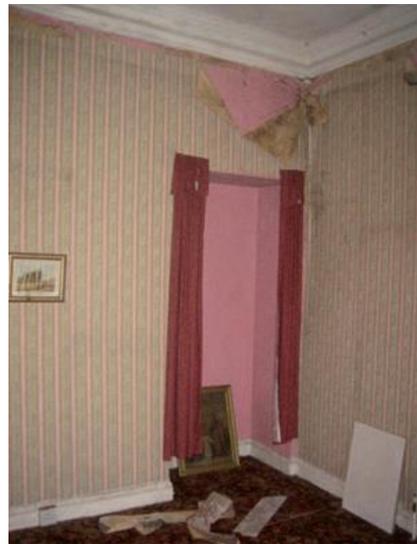
28. Recess may originally have been an access to the court room for the judge
