2023-21006-02	
South East Greenway Linkage		
Design - Glenmore		
ROAD SAFETY AUDIT STAGE 1		
luby 2022		
July 2023		
	Ray Butler	
	Consultant 087 261 6252

- 1.1 This report describes a Stage 1 Road Safety Audit carried out at Slieverue and Glenmore on the South East Greenway Linkage. The audit was carried out on 27 January 2023.

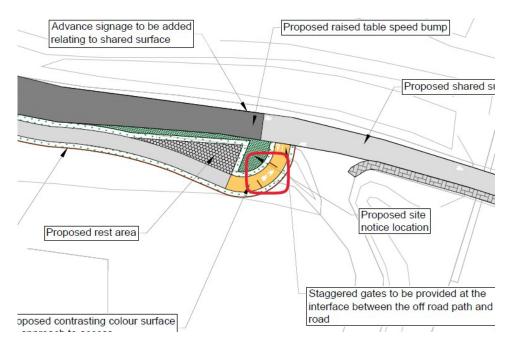
2.2 Problem

The staggered gates layout shown on the drawings is incorrect. The gate on the left side of the greenway should precede the gate on the right side. The layout shown will have little impact on the reduction of cyclist speed on the approach to the junction and may result in cyclists overshooting the yield/stop line into the path of oncoming traffic.

Provide correct gate stagger where it is deemed that this layout is necessary to reduce cyclist speed.
