SECTION IV: UNDERSTANDING THE MONUMENTS & BUILDINGS

4.1 THE MASTERPLAN AREA

4.2 DESCRIPTION OF THE BUILDINGS AND FABRIC

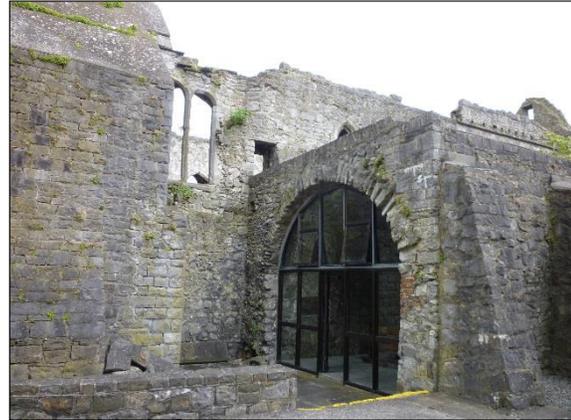
The sacristy is a single cell masonry structure that has been considerably repaired and reconstructed in the last fifty years (Plates 38 and 40). It was restored as an oratory by Smithwicks⁴. There is one door in the west wall. This structure will be retained as part of the Masterplan works and incorporated into a newly created public realm for St Francis Abbey.

Plate 40 The Sacristy today

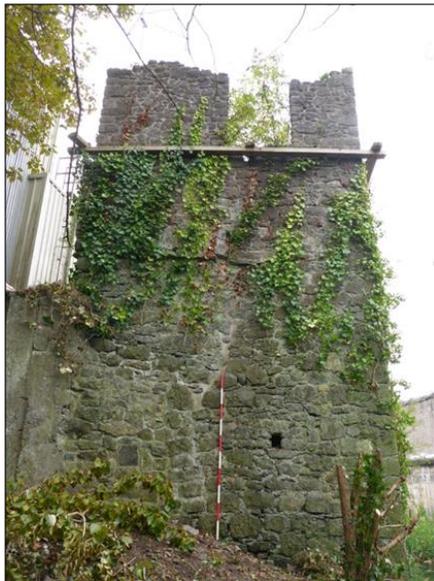
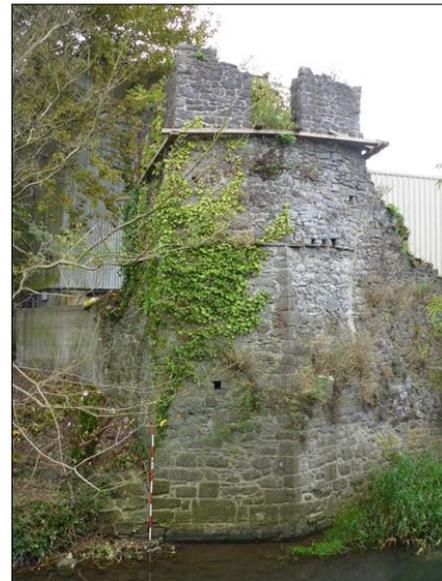
Plate 41 East elevation showing the repair work (2014) Plate 42 Northeast elevation

The inside of the three standing walls of the tower have many joist pockets and loose stones. The fourth wall facing to the wall walk is much degraded and has fallen exposing a large section of hanging unsupported masonry. This was propped but the timber has rotted and fallen.

The immediate proposals in the vicinity of Evan's Turret and adjoining City wall include a full digital survey of the remains, vibration monitoring and the installation of temporary works (wooden props) to replace those that have rotted away since 2000 (Appendix F ref LE drgs 101 & 102)

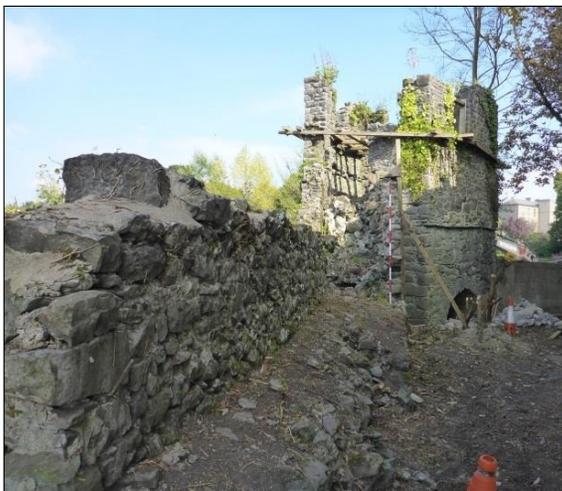
The river side wall walk is relatively intact, however at the landside of the wall walk there are many loose stones; fallen sections of mortared wall and severely leaning sections of wall. Previous stone steps up to the tower have fallen and the stones that formed the steps appear to have been removed - probably many years ago. There were no remedial works carried out to this wall in recent years except timber temporary propping.

Plates 43 Evan's Tower and wall walk landside

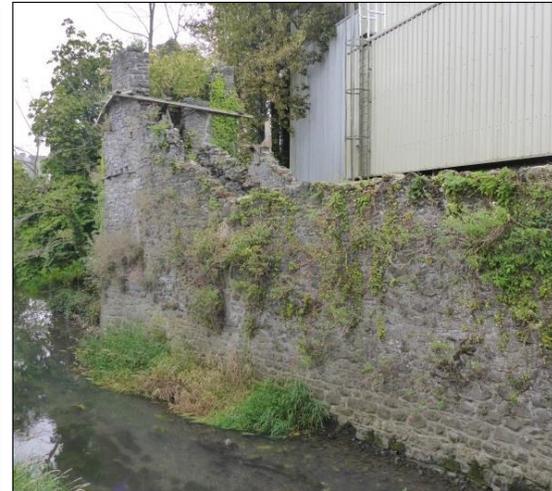
Plates 44 Evan's Tower and wall walk riverside elevation

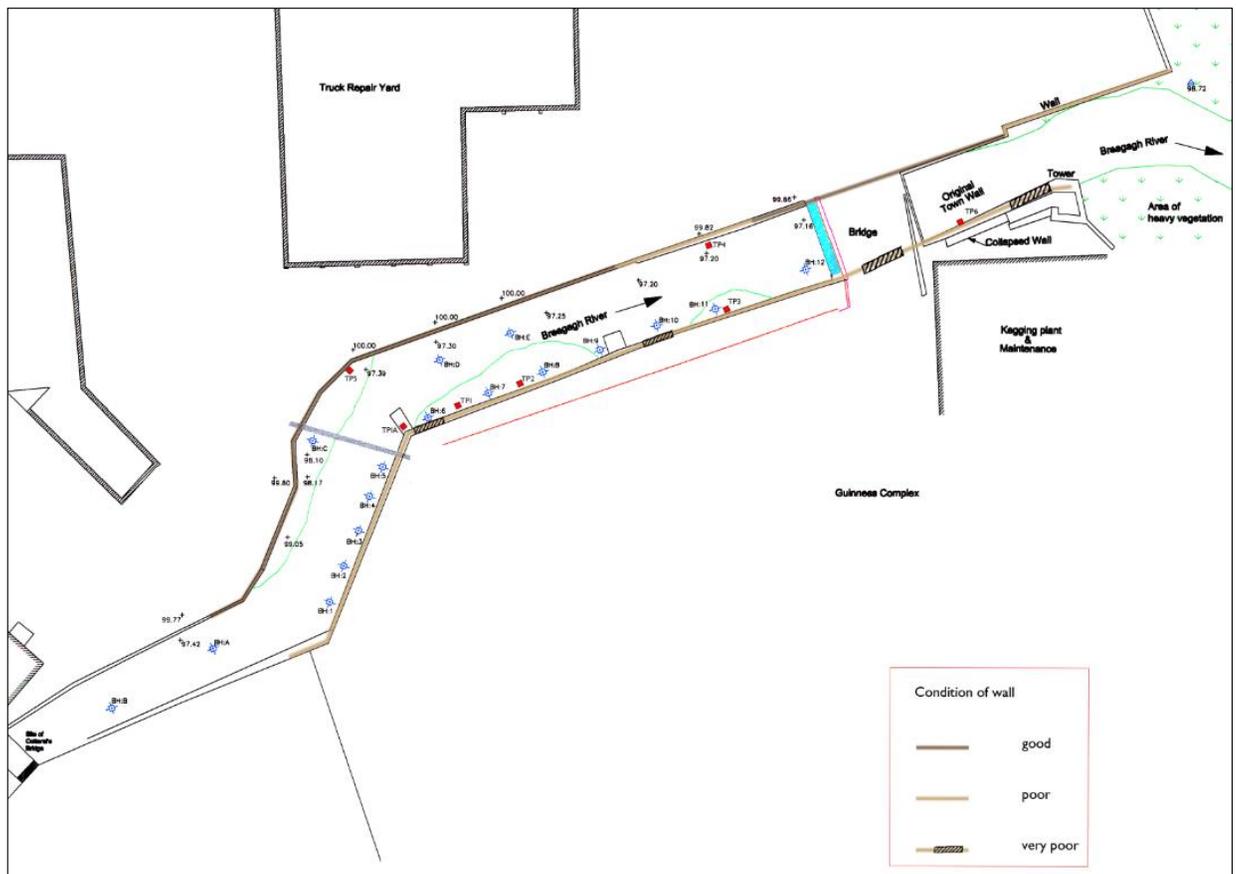
Figure 28 Plan showing Condition of City Wall September 1999, courtesy of Margaret Gowen & Co Ltd

Appendix F contains the original digital survey drawings undertaken by Margaret Gowen & Co Ltd in 1999 showing the extent of the original City Wall and the modern reconstruction and rebuilt wall. The survey also details areas of repaired masonry and features such as relieving arches, outflow pipes and blocked opes within the wall. While the masonry is in a reasonable condition and repointed with lime mortar in 2001 and 2004, notes and drawings from that time show the condition of the wall which can generally be taken as the current condition. There is one breach in this section of wall, effectively separating Evan's Tower and wall walk from the main section of City Wall. This breach forms a bridge which was constructed c.1974 and this was used to access the northern banks of the River Breagh by the brewery site. The original City Wall runs underneath this bridge and was repaired and repointed with lime mortar in 2001.

As part of the Masterplan works vegetation regrowth should be removed and a visual inspection of the existing conservation works take place. As part of a long term strategy a maintenance programme could be implemented (Plates 71-74) which would involve an inspection and clearance of vegetation at regular intervals to be determined by a conservation professional.

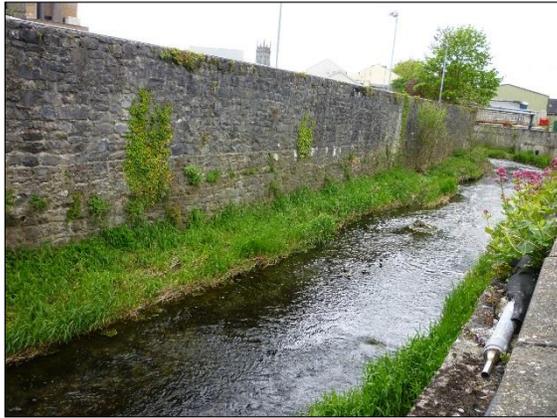
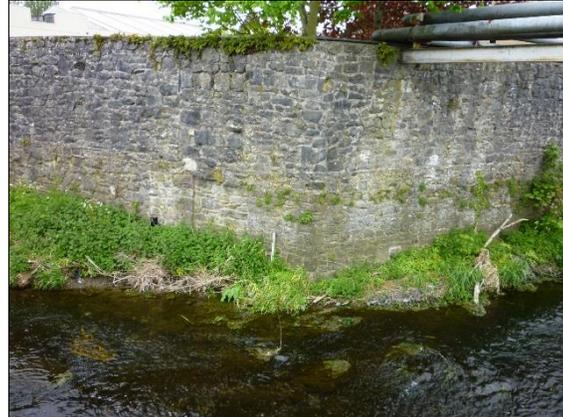
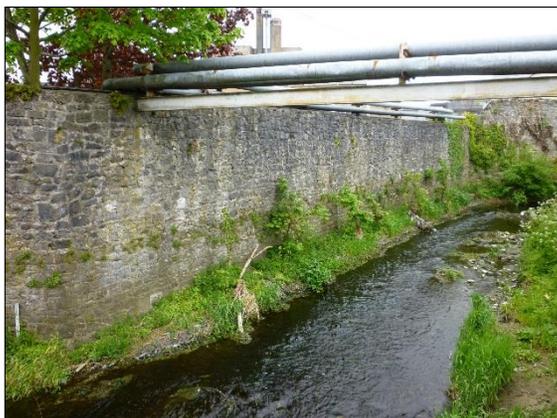
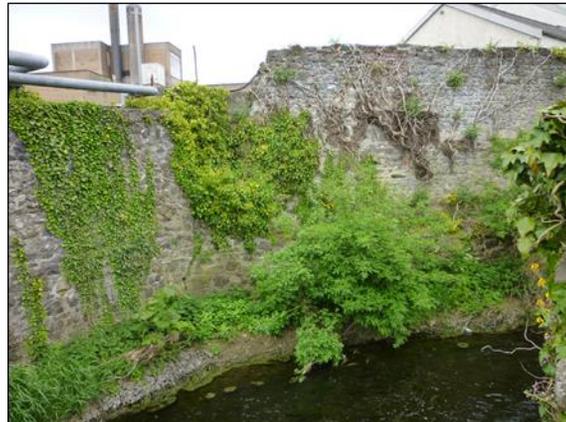
The wall is in a stable condition and relatively free from vegetation along its upper courses while vegetation has grown back at the lower levels partially obscuring the original City Wall (Plates 45-48 and 71-74).

Plates 47-48 Show the present day condition (2015) of the area that was subject to survey 1999-2001

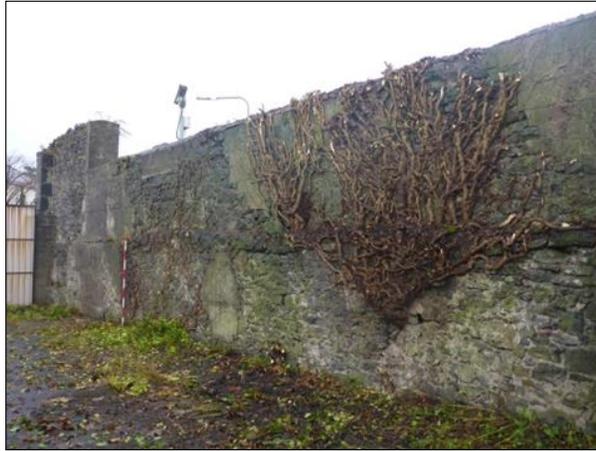
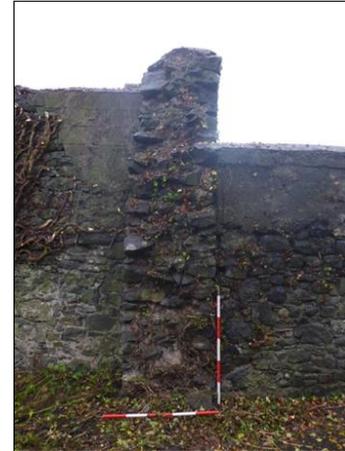
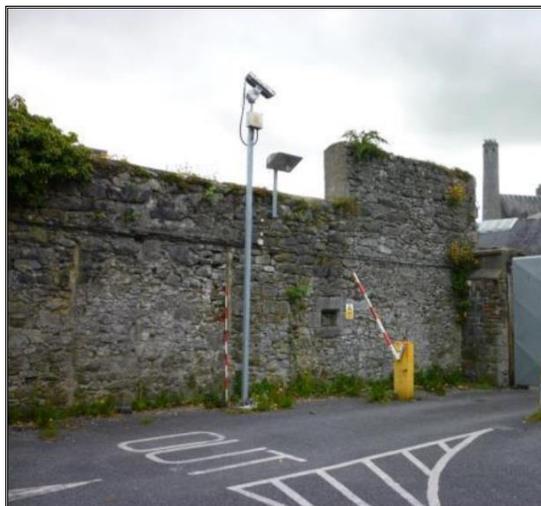
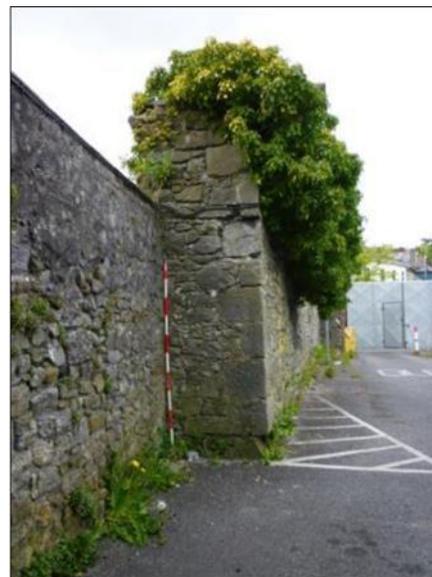
- The Bull Inn wall and associated adjoining upstanding masonry walls are in a ruinous condition. This is typical of walls that no longer have the roofs with which they were once protected nor the use for which they were originally constructed.

Plates 49-52: A collection of photographs showing the Bull Inn wall from the southwest face and southwest return after the removal of vegetation and the northeast wall with the chamfered stone ope and southeastern corner.

- The wall needs careful repair consisting of removal of vegetation including the roots of the plants, local reinsertion of stones, general repointing and a new weathering detail to the wall top to prevent water ingress into the core fabric.

- All works to walls of historic fabric should be carried out in materials to match the original such as soft flexible lime based mortars and sands to match the river deposit sands and gravels. All replacement stones should be if possible retrieved from local fallen random rubble and any new dressed stones such as lintels and quoins clearly marked (albeit in a desecrate location) with the date of insertion.

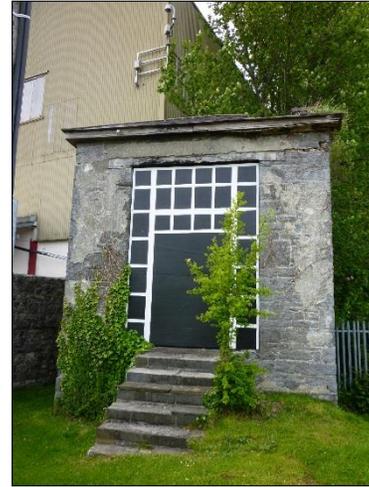
Plate 54 Sentry Box Tea House

The more northern Tea House is in close to its original form but in a very ruinous state. Timber elements such as the first floor have rotted away and the roof is in an extremely precarious condition. The Tea-House backs onto the Smithwick's brewery modern masonry boundary wall of the brewery. The roof and ceiling including the fine moulded ceiling decoration are in danger of complete collapse. There has been significant loss of fabric already. The degradation of the timber lintels and bonding timbers puts the wall tops and other local sections of the four external walls in jeopardy.

- Stabilising and reinstatement of the roof
 - Rescuing as much as possible of the ceiling ornamentation to inform repair works.
 - Replacement of rotted lintels and bonding timbers throughout the building
- Such works will leave the building weather tight and stable but not necessarily attempt to re-create lost details.

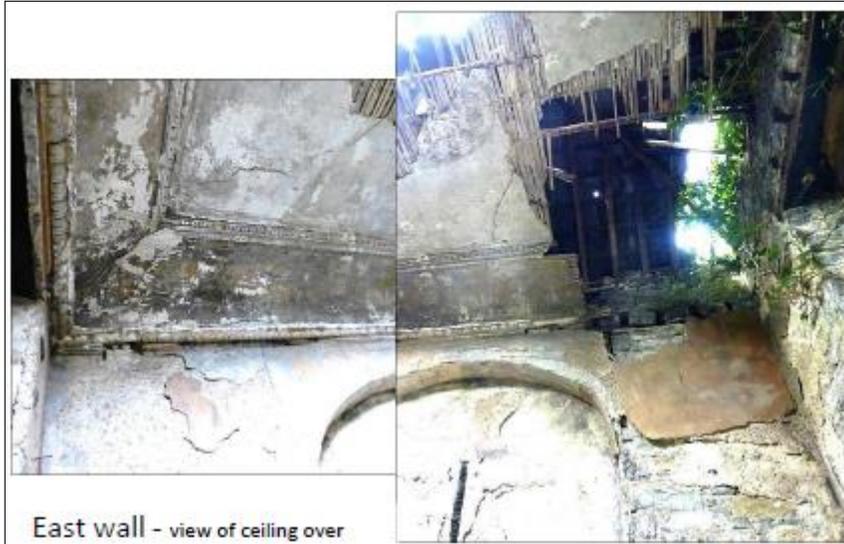
East wall - view of ceiling over

Note Condition of Ceiling and roof over

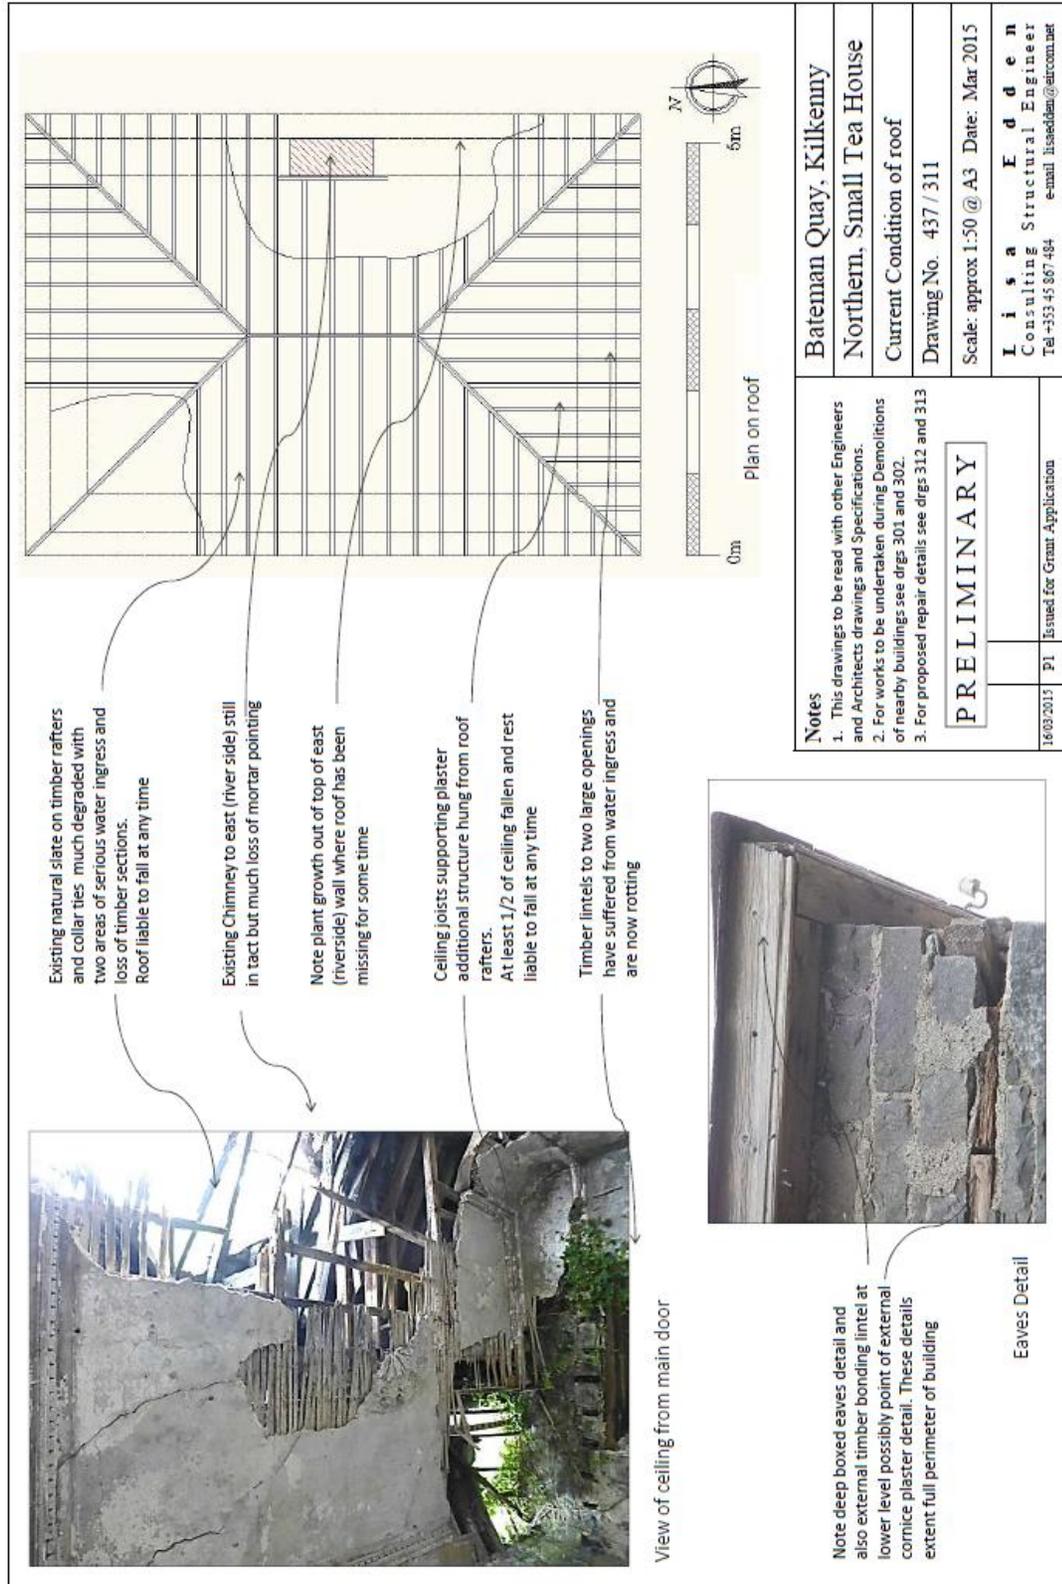
Figure 31 Tea House Roof Condition
