SITE SUITABILITY REPORT

**Graigueswood,
Freshford,
Co. Kilkenny**

Kilkenny County Council

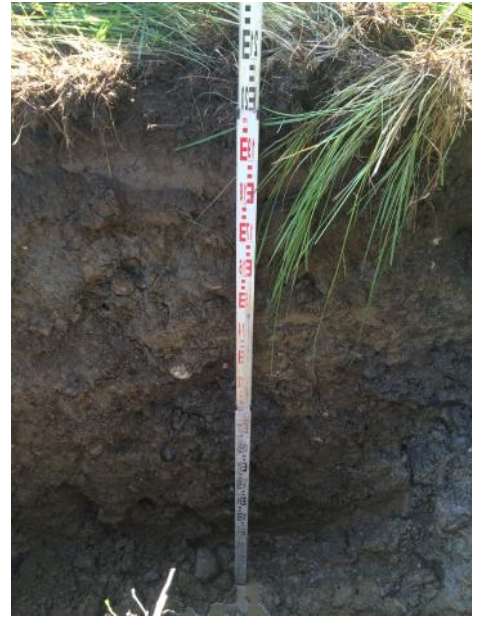
Trial Hole Depth (2.1m)

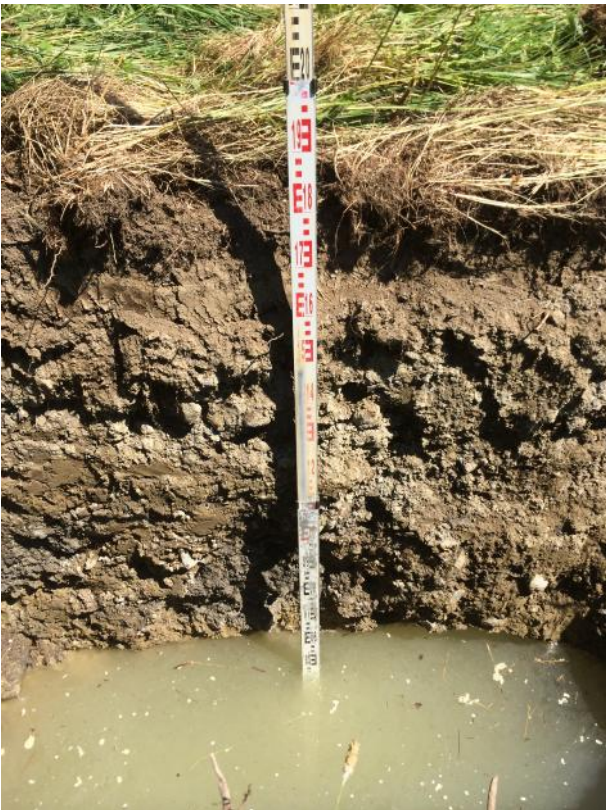
Trial Hole after 48 hours

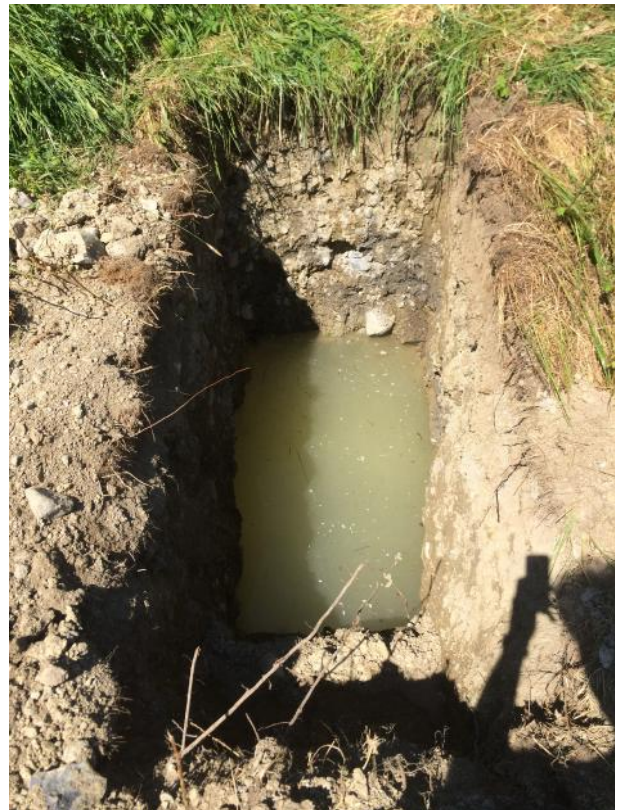
Trial Hole after 48 hours

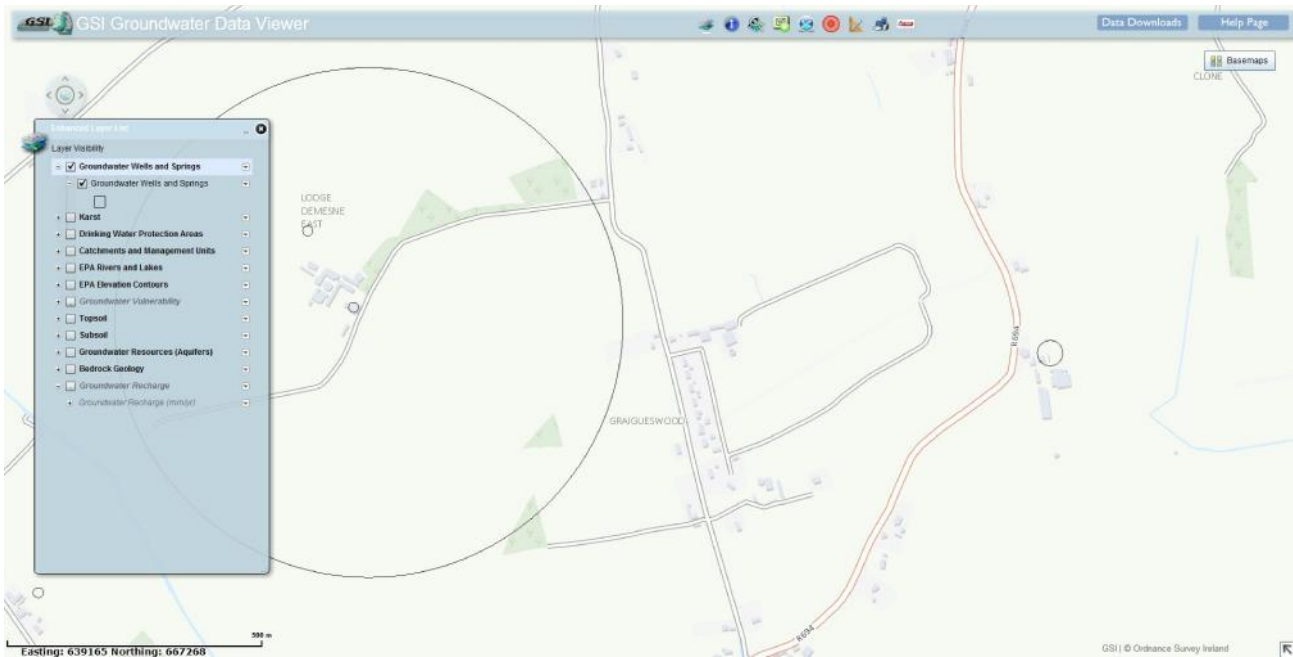
Appendix Fig. 1 Groundwater Well Data

There is no wells recorded in the immediate vicinity of the proposed site.

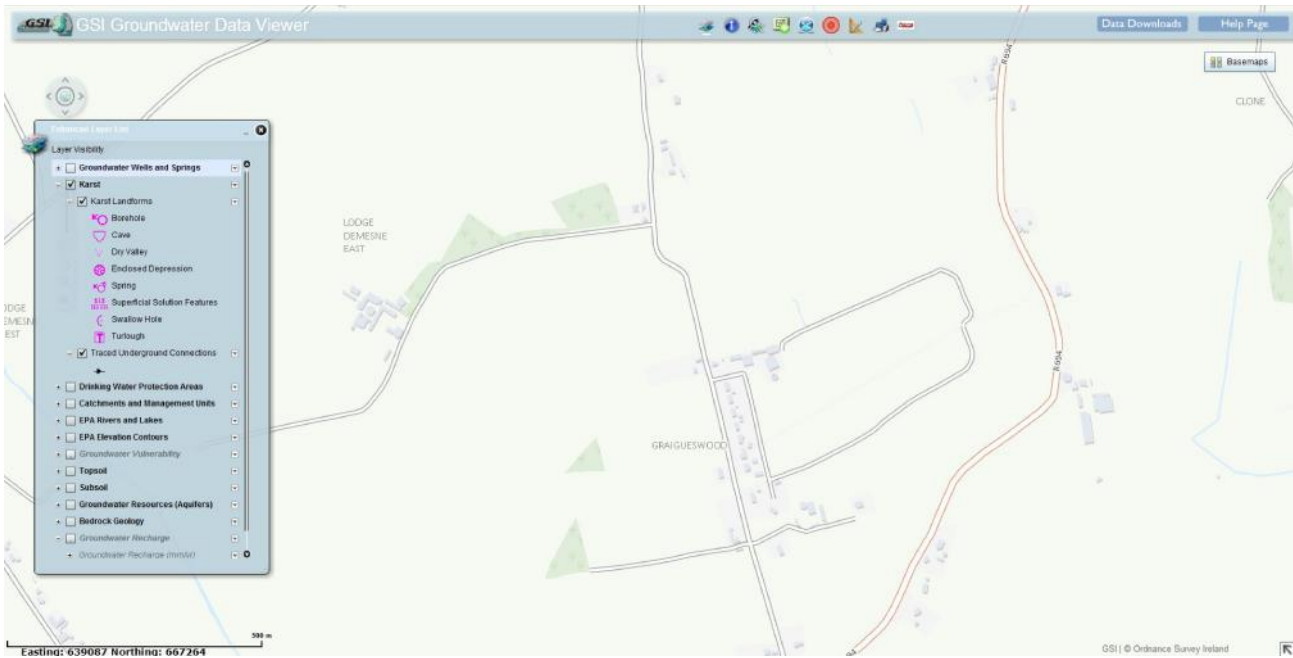
Appendix Fig. 2 Karst Features

There are no karst features in the immediate vicinity of the proposed site.

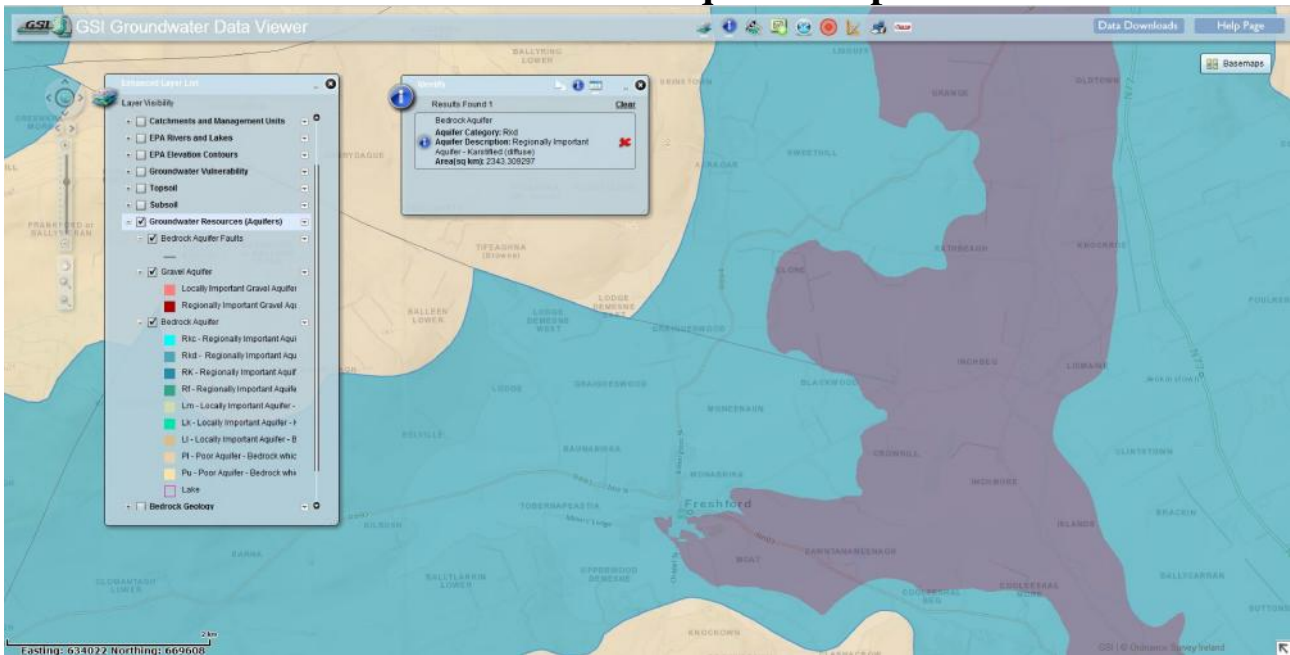
Appendix Fig. 3 Bedrock – Aquifer Map

The Bedrock-Aquifer Map classifies the location of the percolation test as *Rkd*– *Regionally Important Aquifer – Karstified (diffuse)*

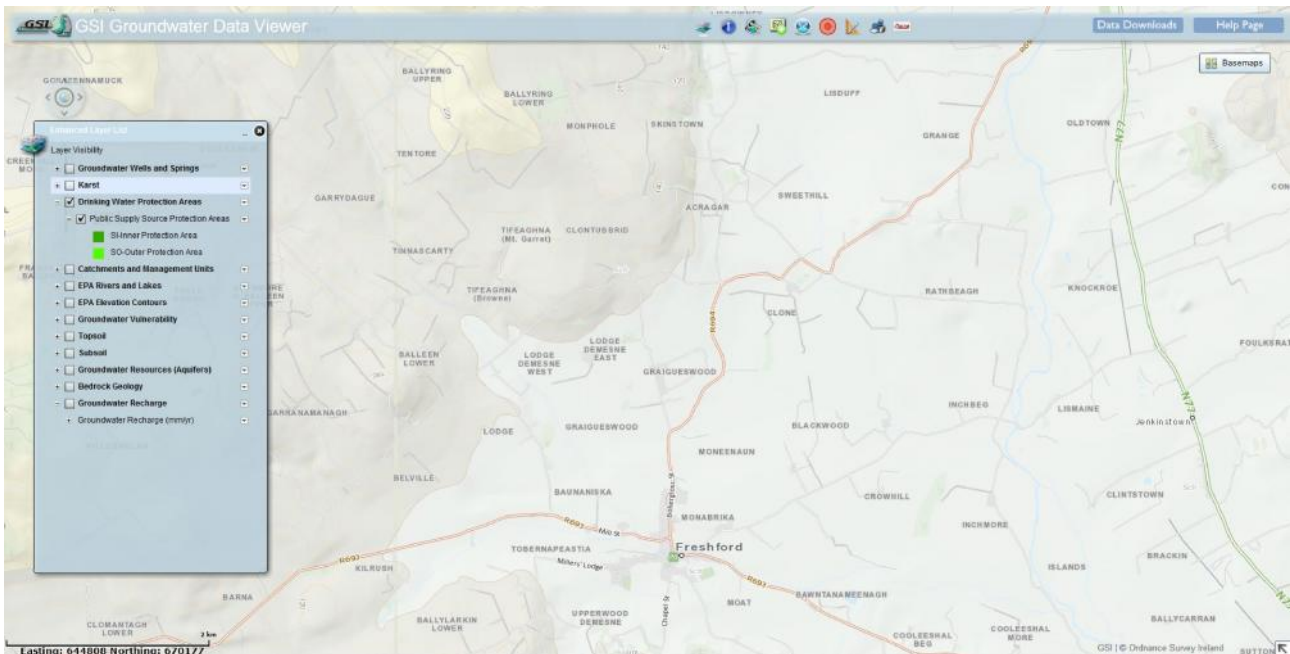
Appendix Fig. 4 Source Protection Zones

Not applicable.

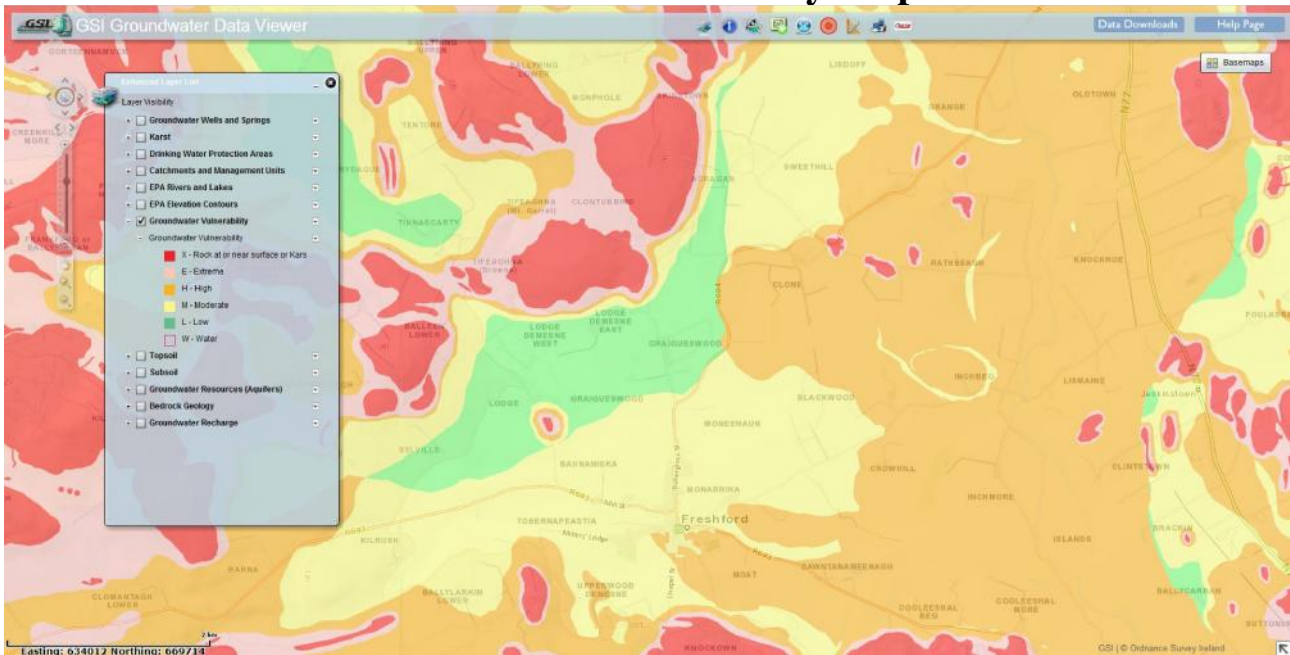
Appendix Fig. 5 Interim Vulnerability Map

The Interim Vulnerability Map classifies the location of the percolation test as having a vulnerability of: *L-Low*

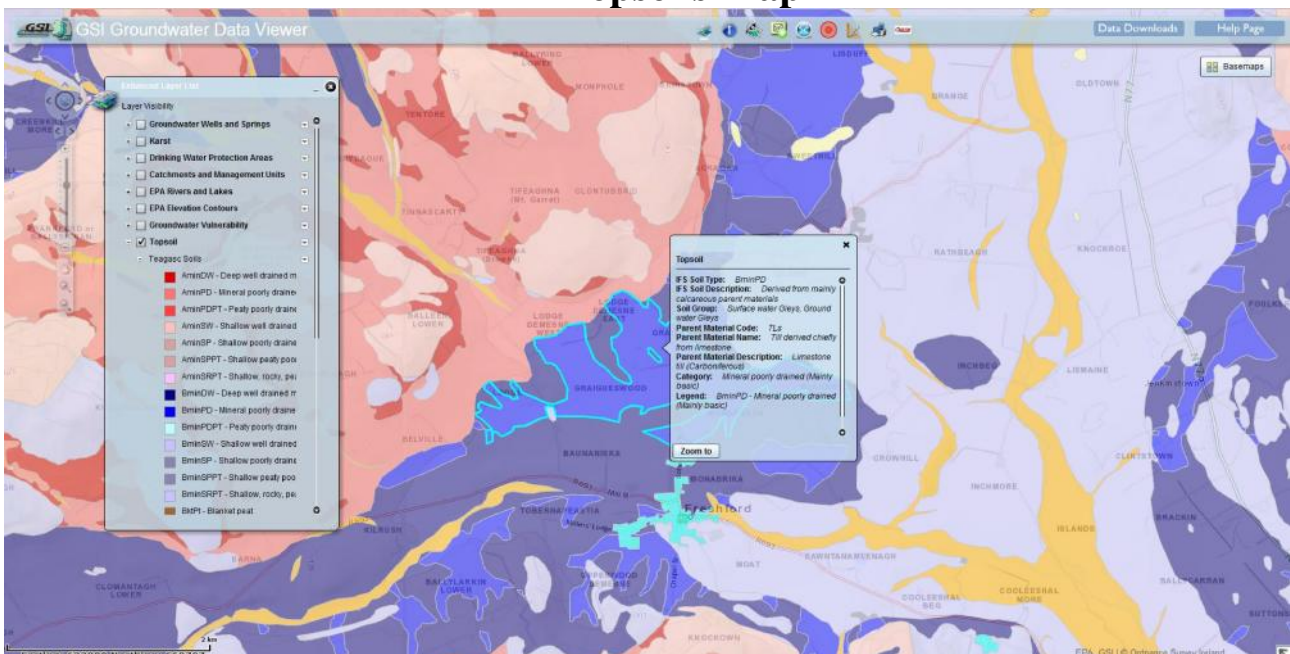
Appendix Fig. 6 Topsoils Map

The Topsoil Map gives a soil classification at the location of the percolation test as: **BminPD – Mineral poorly drained (Mainly basic)**

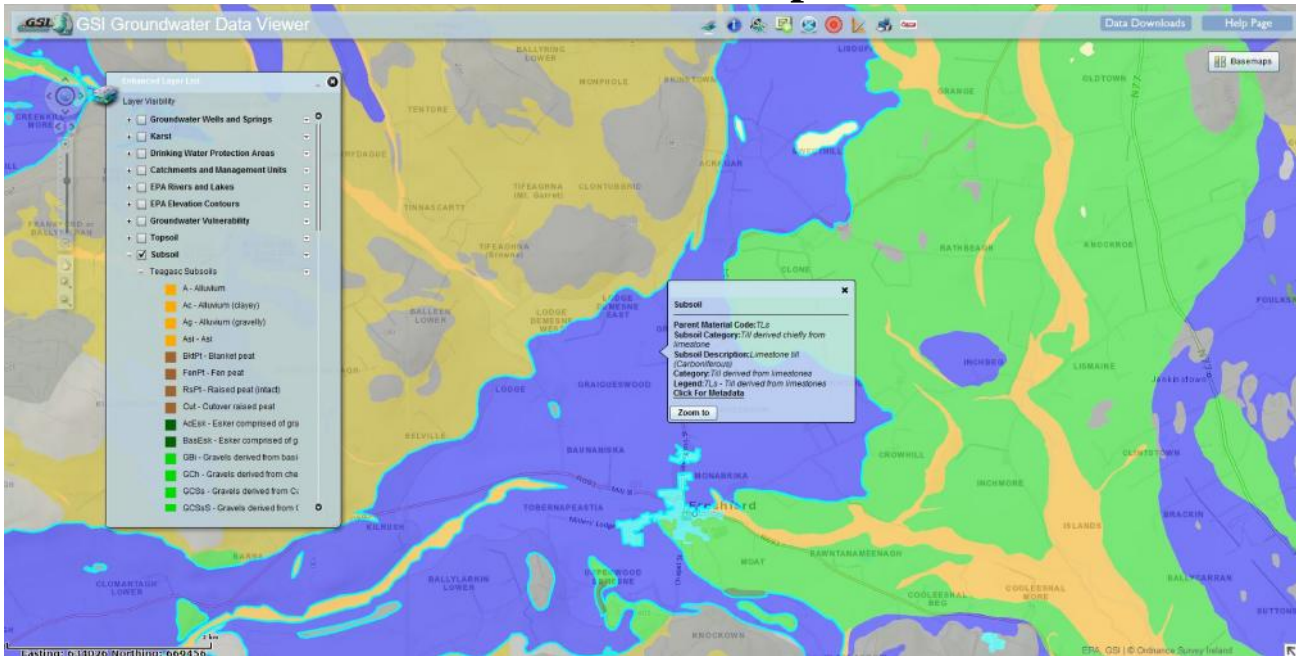
Appendix Fig. 7 Subsoils Map

The Subsoil Map gives a soil classification at the location of the percolation test as: TLs – Till derived chiefly from limestone

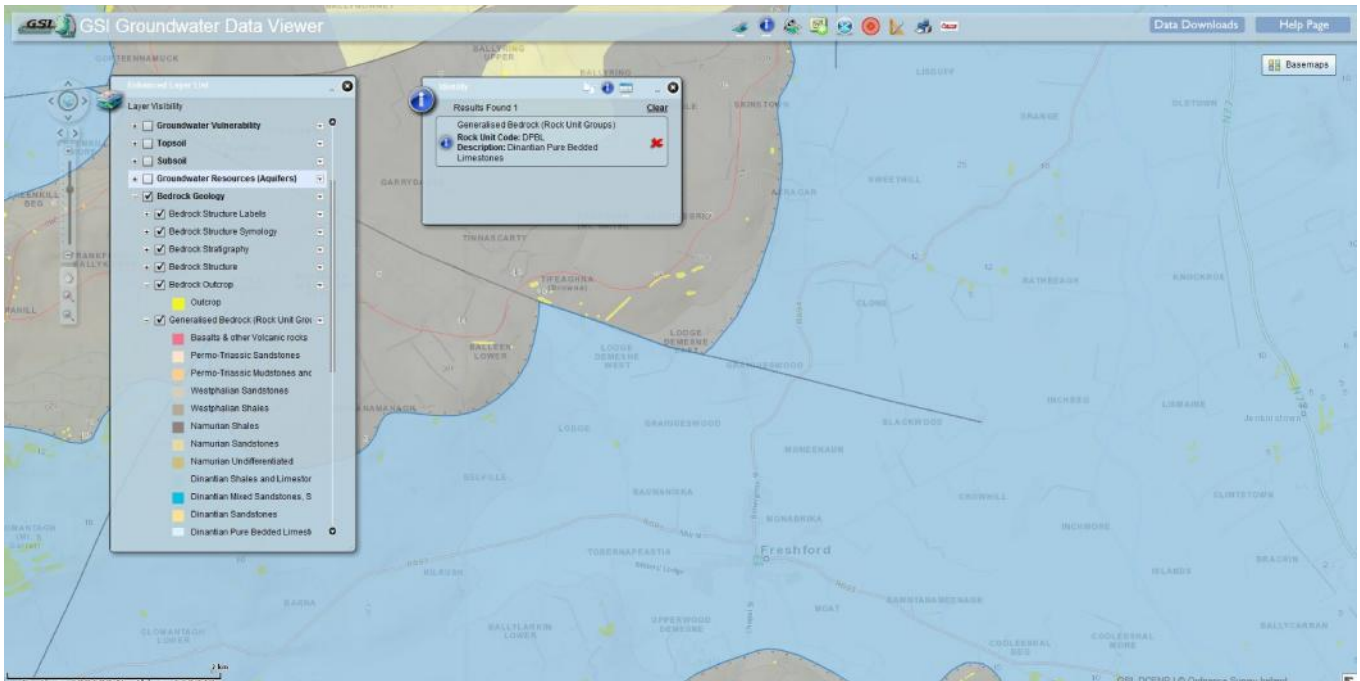
Appendix Fig. 8 Generalised Bedrock MAP

The Generalised bedrock map indicates the occurrence of DPBL – Dinantian Pure Bedded Limestones
