**BALLYHALE TO KNOCKTOPHER FOOTPATH PROJECT**

**FOR ROADPLAN CE & KILKENNY COUNTY COUNCIL**

**BUILT HERITAGE ASSESSMENT**

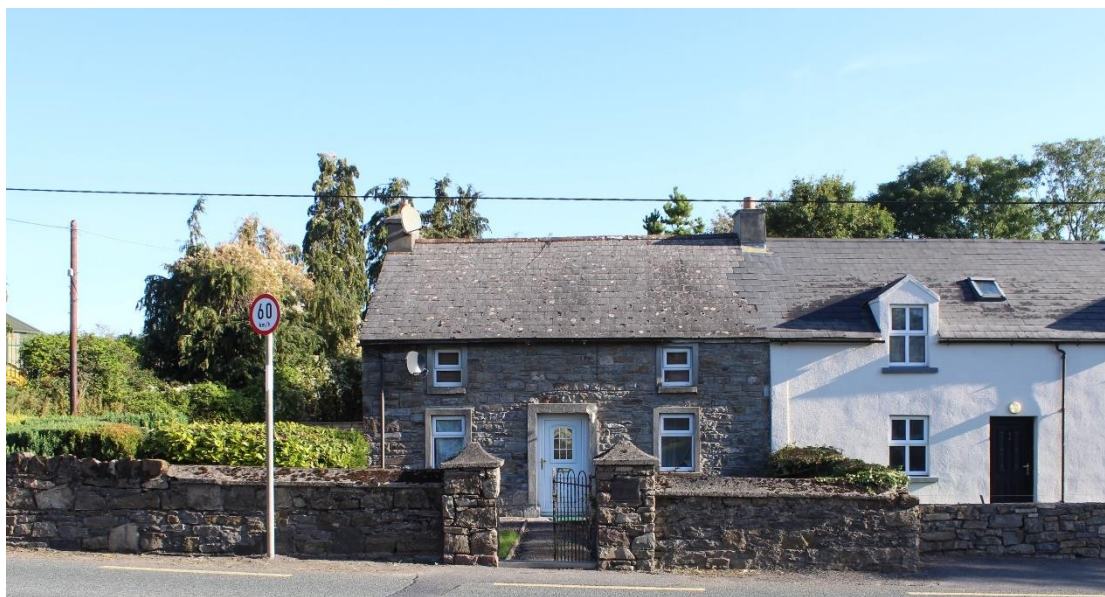
Figure 7: Front elevation of nineteenth century house and boundary wall

This section of stone wall is situated on the north-eastern side of the R713 road at the northern end of the project area, just south of the Glanbia Ltd premises. It forms the front boundary wall of an early nineteenth century house and adjoining yard.

This is a modest stone wall that begets architectural significance as the front boundary wall and part of the curtilage of an early nineteenth century house. The unassuming aesthetic of rubble stone piers and plain wrought-iron gate are congruent with scale and composition of the house and complement its roadside setting.

A detailed written and photographic survey should be undertaken prior to the commencement of works.

The exact position of the footpath is not set out and if the landtake requirement of the footpath allows the gate and piers should be retained and the wall set back in a gradual tapered manner as indicated by the green line in figure 23. It should follow a curving alignment similar to the existing. This recommendation would minimise the impact of the proposed changes on the setting of the nineteenth century house.

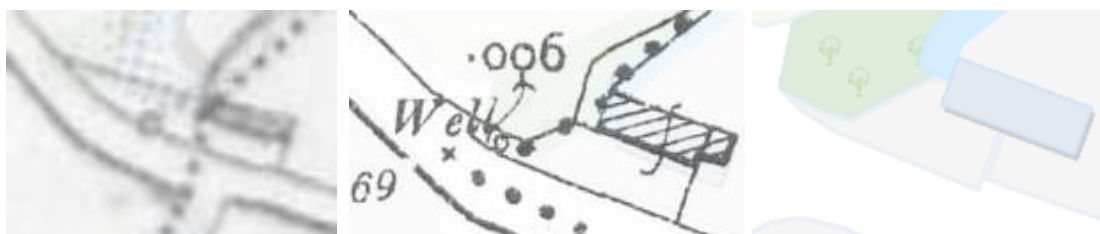
Figure 8: Extract of ordnance survey maps of nineteenth century house – 1839, 1900 and current day (from left to right)

The historic ordnance survey maps appear to show the same alignment of the property boundary (and therefore wall) to present day. Map evidence and construction suggests that the wall is an early-mid nineteenth century wall.

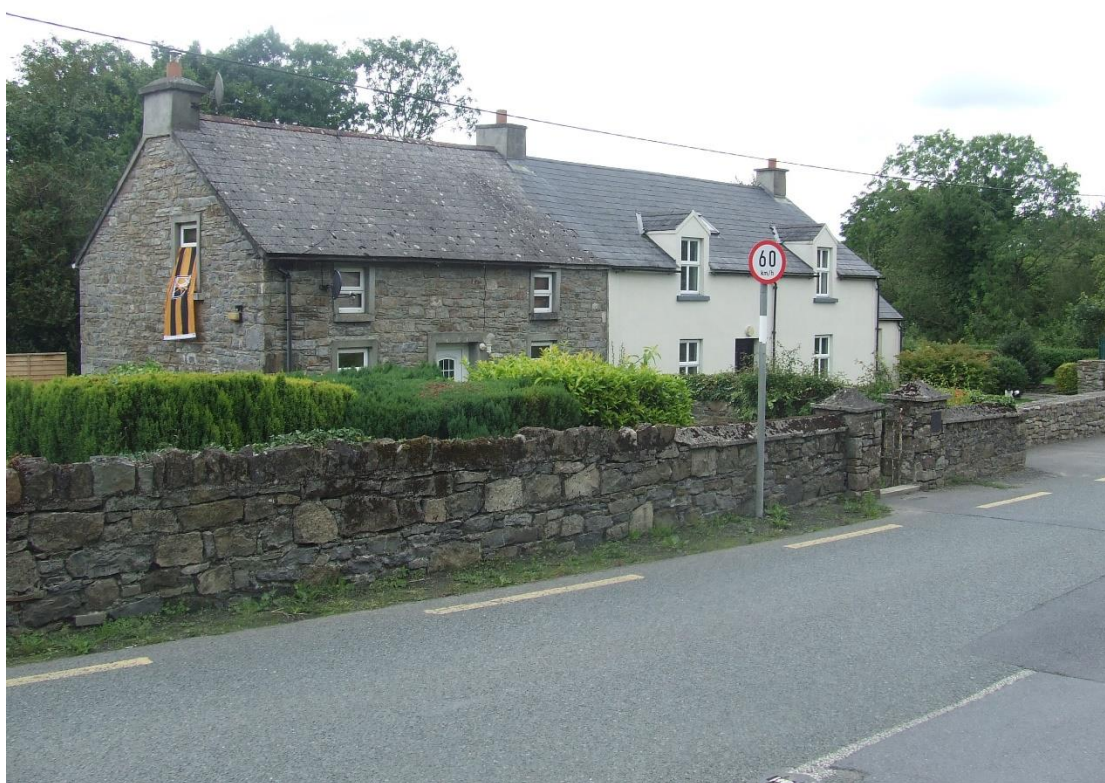
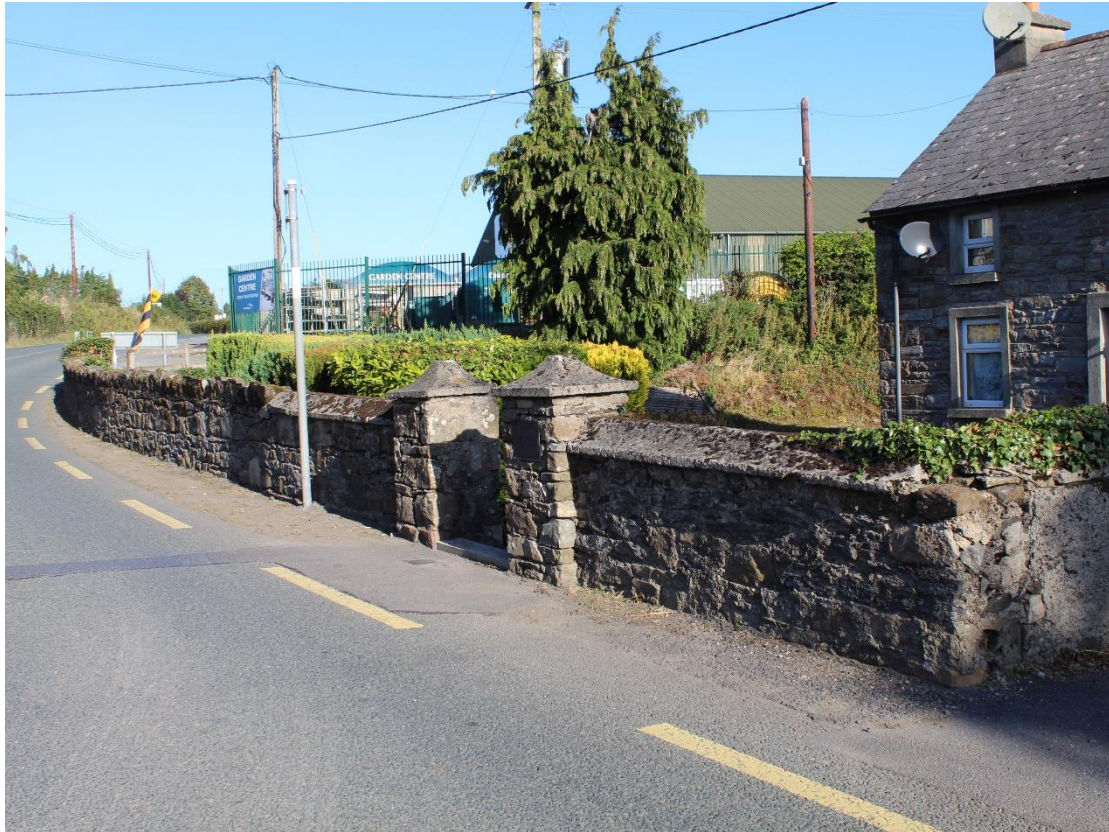
It is constructed of rubble limestone with lime-based mortar and later cement-based mortar. It has upstanding stone coping and later concrete coping on either side of the entrance gate. The

ground level of the yard is below that of the road and consequently acts as a retaining wall. It is approximately 1m above road level and 1.5m above yard level.

Figure 9: View of house and wall from west

Figure 10: View of house and wall from east

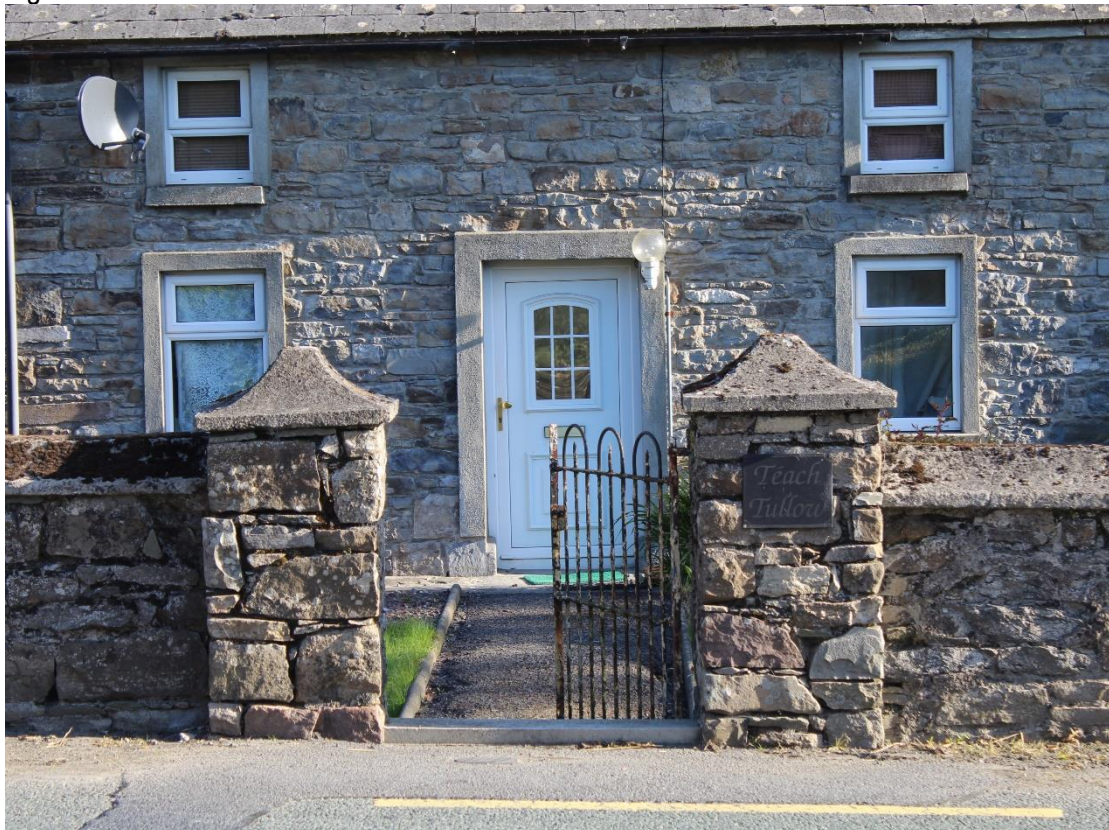
The pedestrian entrance gateway is directly aligned with the entrance door. It has square plan gate piers and later concrete pier caps. The stonework is more dressed and squared than the adjoining boundary wall. It has a simple wrought-iron and modern raised concrete threshold.

Figure 11: Gate piers and gate

If the landtake requirement necessitate the demolition of the gate and piers, they should be reconstructed using the existing material by an expert traditional stonemason in a manner matching the existing piers and reusing the historic gate.

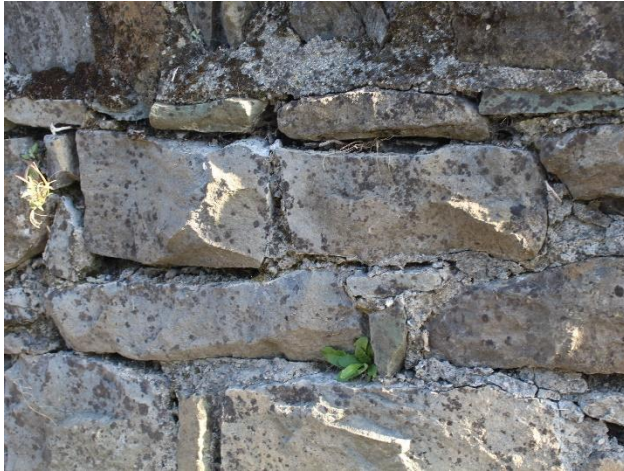
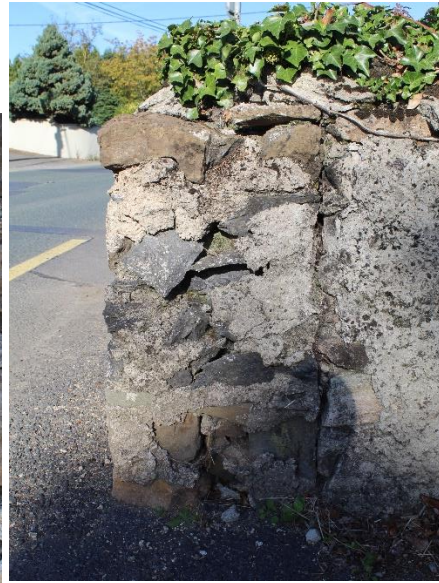
Figure 12: Detail of rubble stone and mortar construction and Figure 13: Cross section of wall

The wall should be reconstructed using the existing material by an expert traditional stonemason in a manner matching the existing wall. A plaque should be affixed to the wall indicating that the wall was reconstructed in the twenty-first century as part of a road improvement scheme.

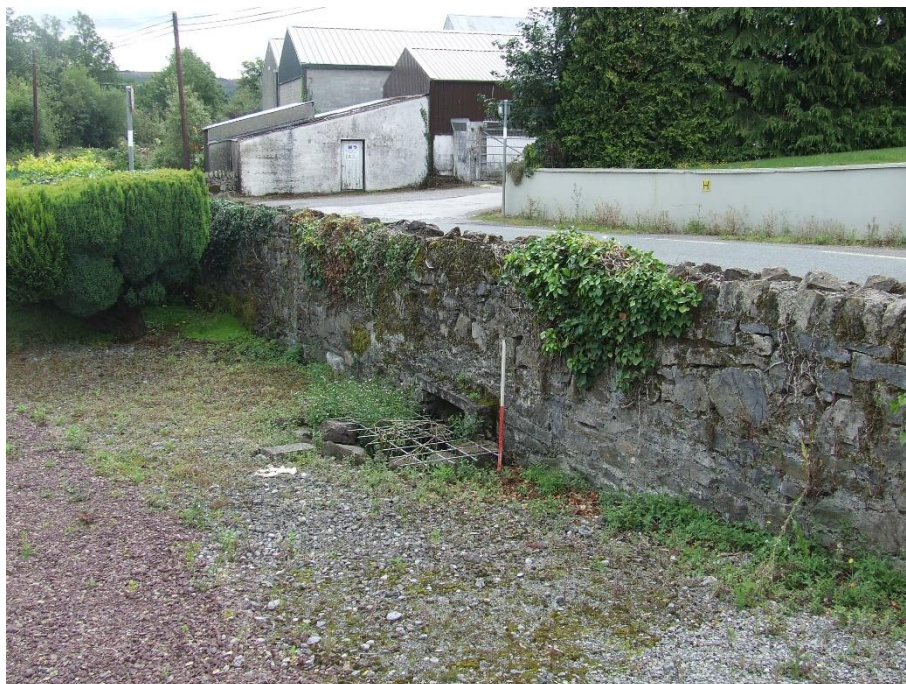
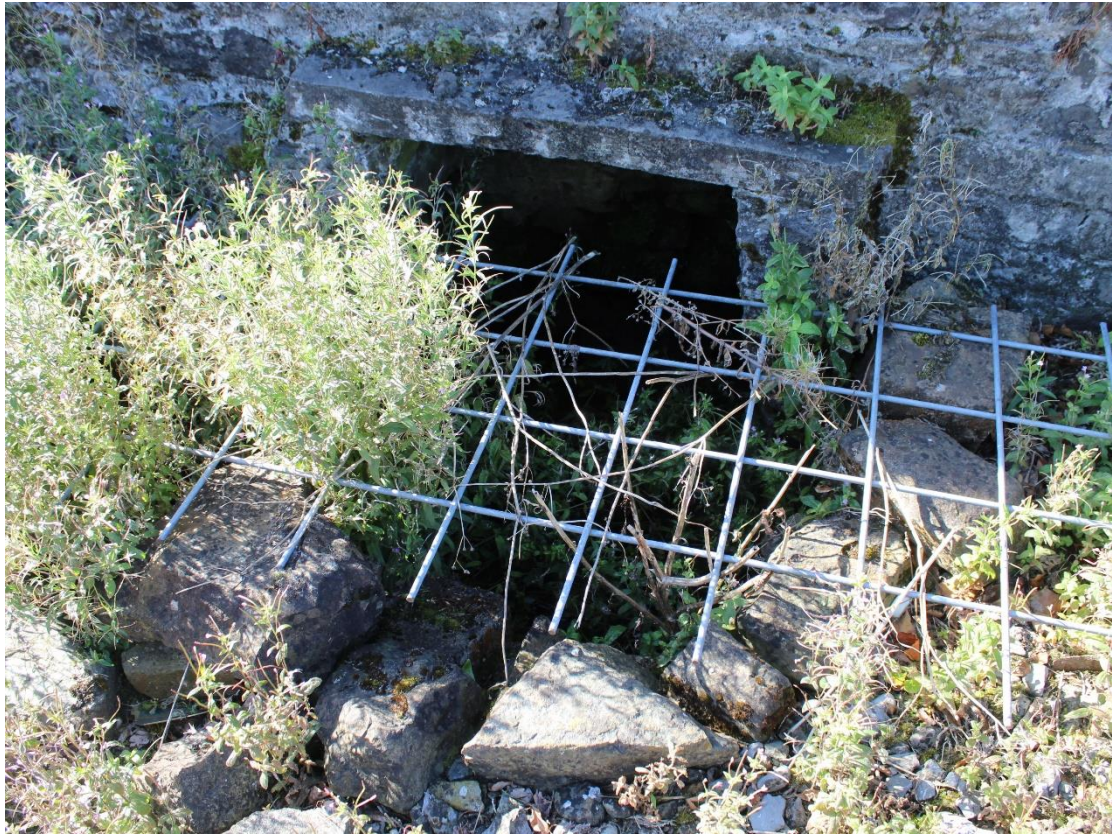
Figure 14: Well adjoining roadside

The well is located on private property and consequently was not closely inspected. A well is located on the site from before the mid-nineteenth century. The well comprises of a square-arched opening in the lower part of the retaining wall beneath the roadway formed by a limestone lintel and an adjoining circular opening in the ground surrounded by rubble stones.

Figure 15: View of well

The proposed scheme traverses directly over or very close to the well and consequently the well would be covered, potentially damaged and no longer visible along the roadside. This is detrimental to the historic roadside character. The proposed works are considered to have a moderate level of impact.

A detailed written and photographic survey should be undertaken prior to the commencement of works. The well requires careful protection during the demolition and reconstruction of the adjoining wall.

It is recommended that the well should be retained in-situ and the footpath bridged over the well if the construction scheme allows. A transparent viewing platform along the footpath showing the well would allow the well to continue as an important historic roadside landmark and contribute to its appreciation.

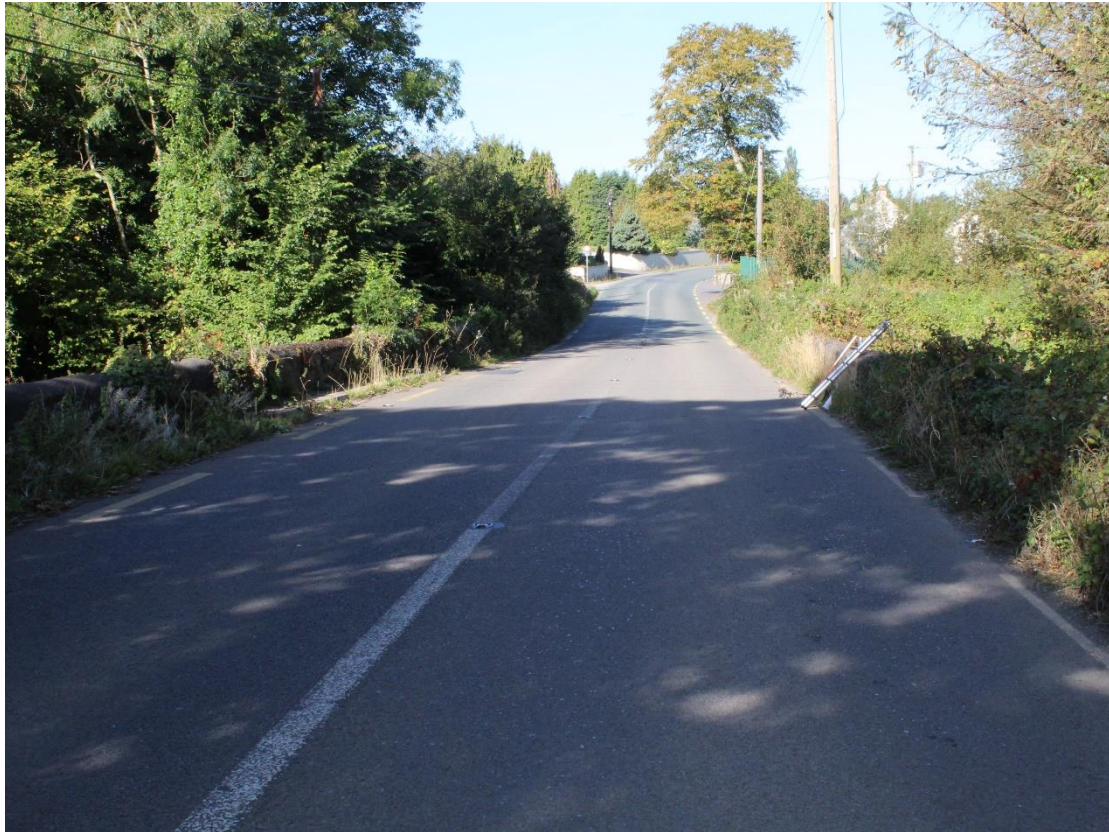
Double segmental-arched bridge constructed of random coursed limestone rubble likely in the late eighteenth or early nineteenth century. The main river flow is through the eastern arch while the western arch was likely historically a tailrace for the adjacent "Old Flour Mill" on the first edition ordnance survey map (1839) and "corn mill" on the later edition ordnance survey map (1900)

Figure 16: View westwards of bridge along road

The proposed footpath will alter the visual bucolic aesthetic form of the bridge. This has already been altered by the existing footpath on the southside. The proposed footpath is intended on the northern side of the bridge which appears to have been widened in the twentieth century. It is therefore unlikely that the footpath should impact on the historic bridge fabric. The proposed works are considered to have a moderate level of impact.

A detailed written, photographic and measured survey should be undertaken prior to the commencement of work.

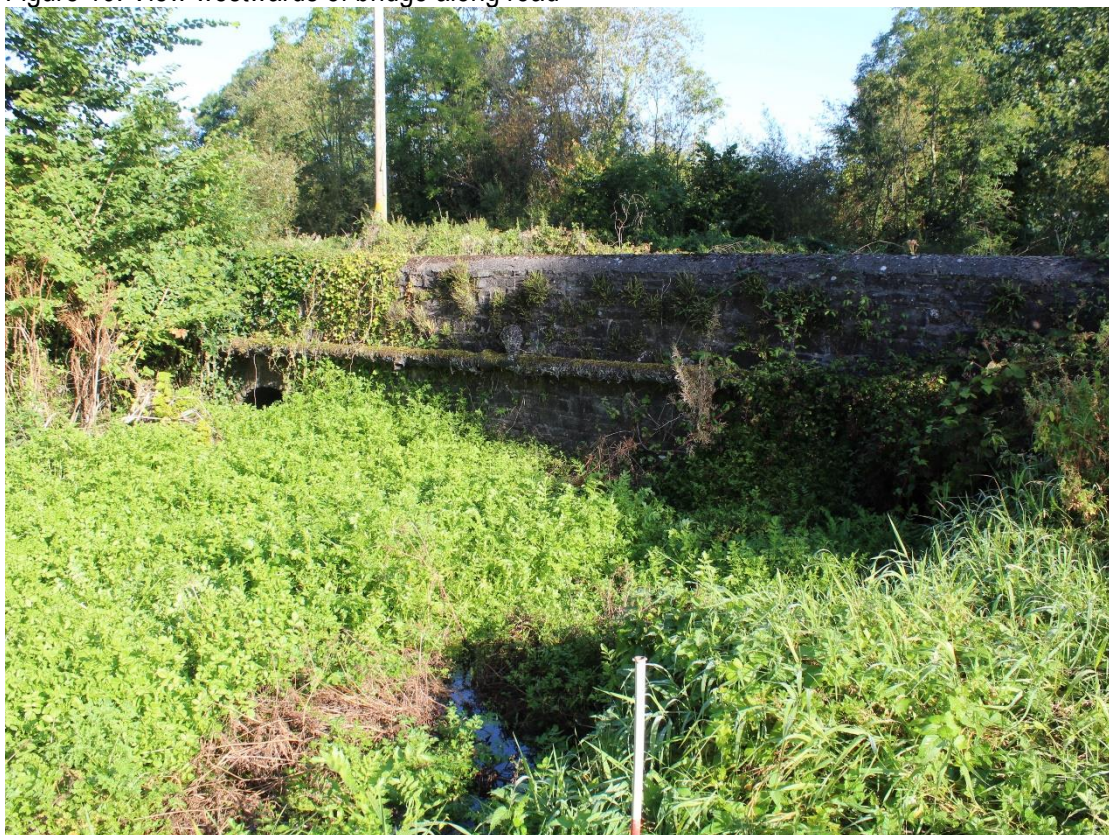
The spandrel walls and abutments of the bridge are largely concealed on the southern side due to dense vegetation growth. Rubble stone voussoirs are evident to the western arch. The parapet on the south-western side is limestone rubble with rendered half-barrel coping.

Figure 17: Southern elevation of bridge

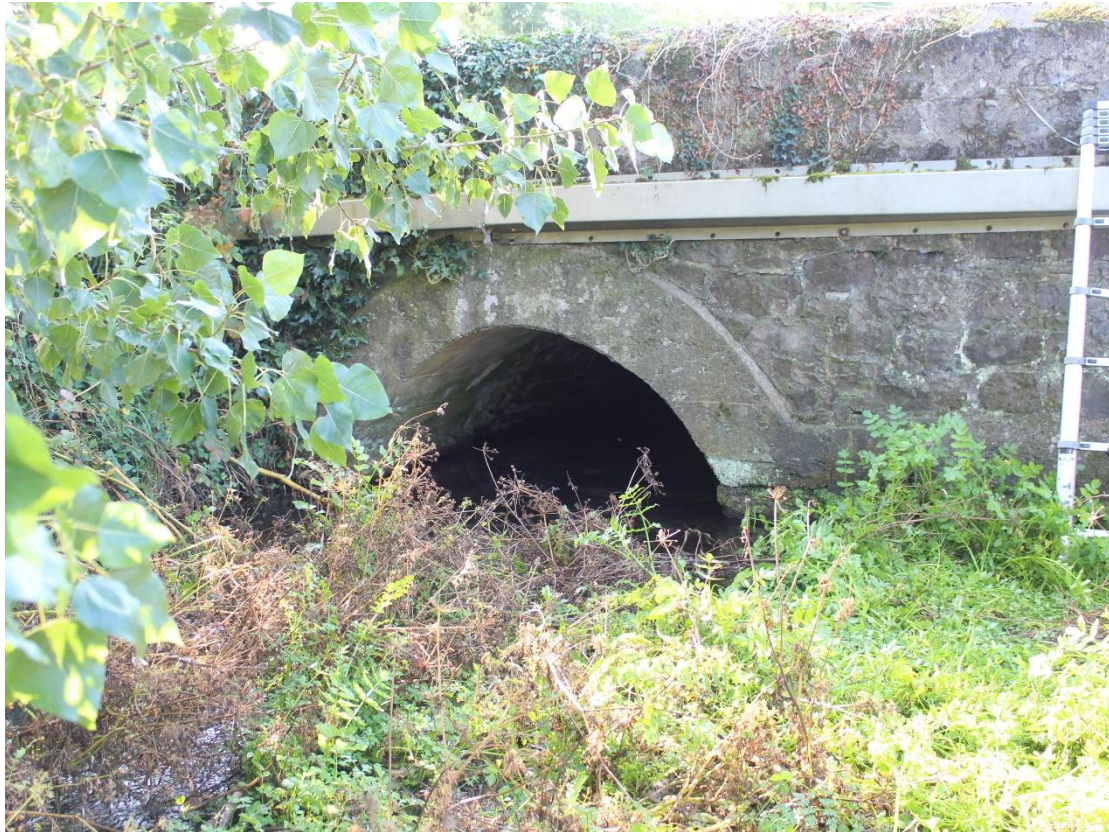
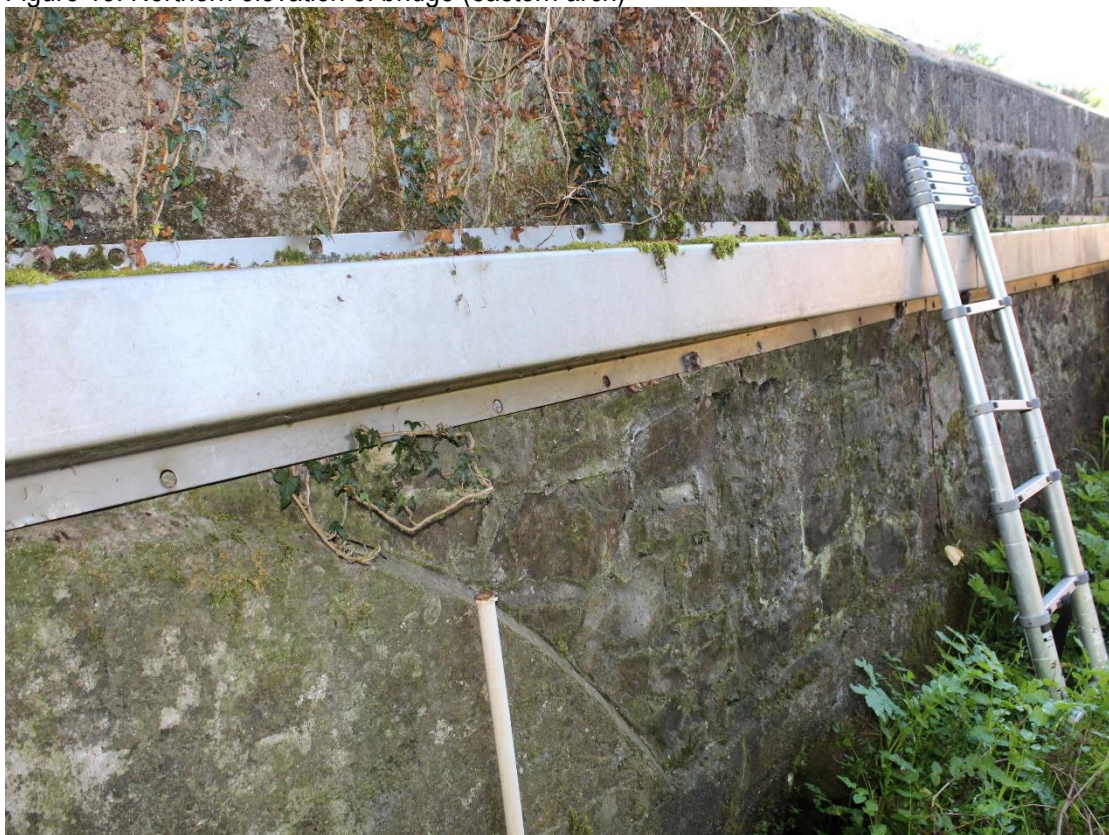
Vegetation is less dense on the northern side. It has rubble limestone spandrel walls. The two arch rings are concrete. It appears that the bridge was widened on its northern side during the twentieth century. This is suggested by the barrel of both bridge arches which change in profile and building material (rubble stone vs concrete). The parapet on the north side has been rebuilt in the later twentieth century in modern concrete blocks.

Figure 18: Northern elevation of bridge (eastern arch)

Figure 19: Stonework along northern elevation

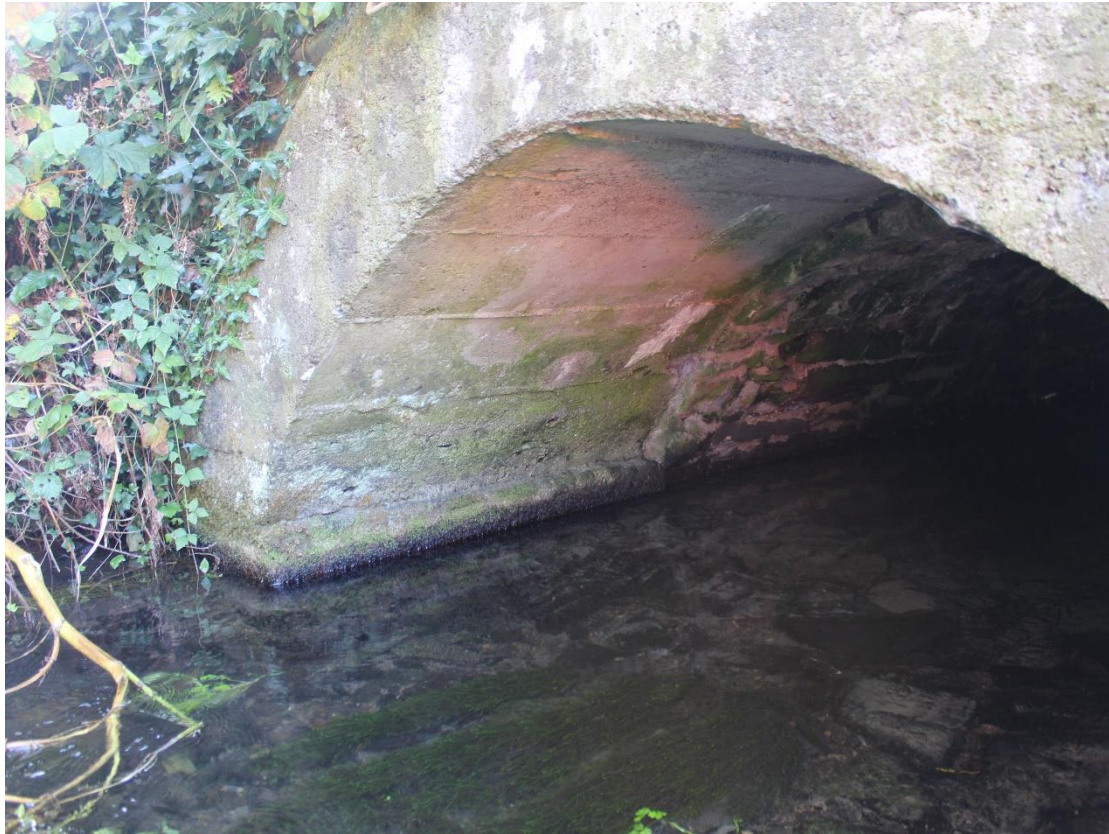
Figure 20: Barrel arch of bridge showing the changing building materials and profile

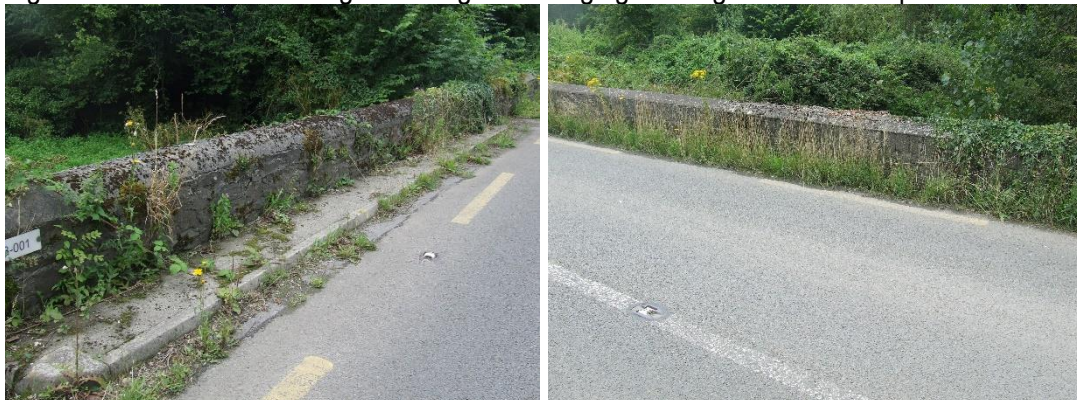
Figure 21: South parapet wall and Figure 22: rebuilt northern parapet wall
