Knocktopher to Ballyhale Footpath Scheme

ROAD SAFETY AUDIT STAGE 1

December 2019

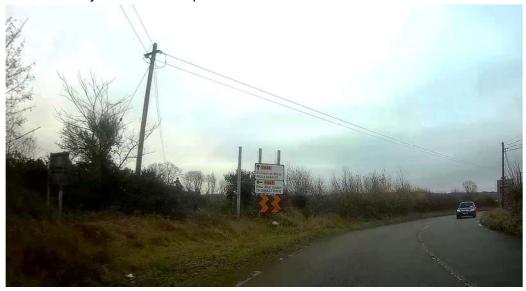
2.4 Problem

The existing chevron signs at chainage 545 are misleading to drivers and are not necessary in a 60 km/h speed limit zone.

Recommendation

Remove chevron signs and erect the existing advance direction signs on new poles

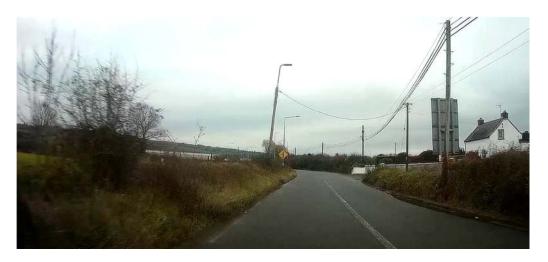
2.5 **Problem**

The existing public lighting column at chainage 694 appears to be leaning towards the road and may be at risk of falling putting pedestrians and drivers at risk of injury.

Recommendation

Replace this lighting column with a new column.

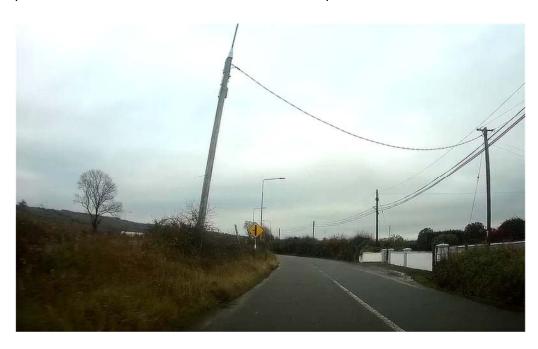
2.6 **Problem**

There is a junction warning sign at approximately chainage 710. It is not clear whether this sign will be in the footpath, where it may be an obstruction to pedestrians, or be moved to the back of the footpath.

Recommendation

Move the sign to the back of the footpath if necessary.
