DESIGN STATEMENT

Archaeological Assessment: The Mayfair Ballroom, Horse Barrack Lane, Kilkenny

Cóilín Ó Drisceoil MA MIAI, Kilkenny Archaeology

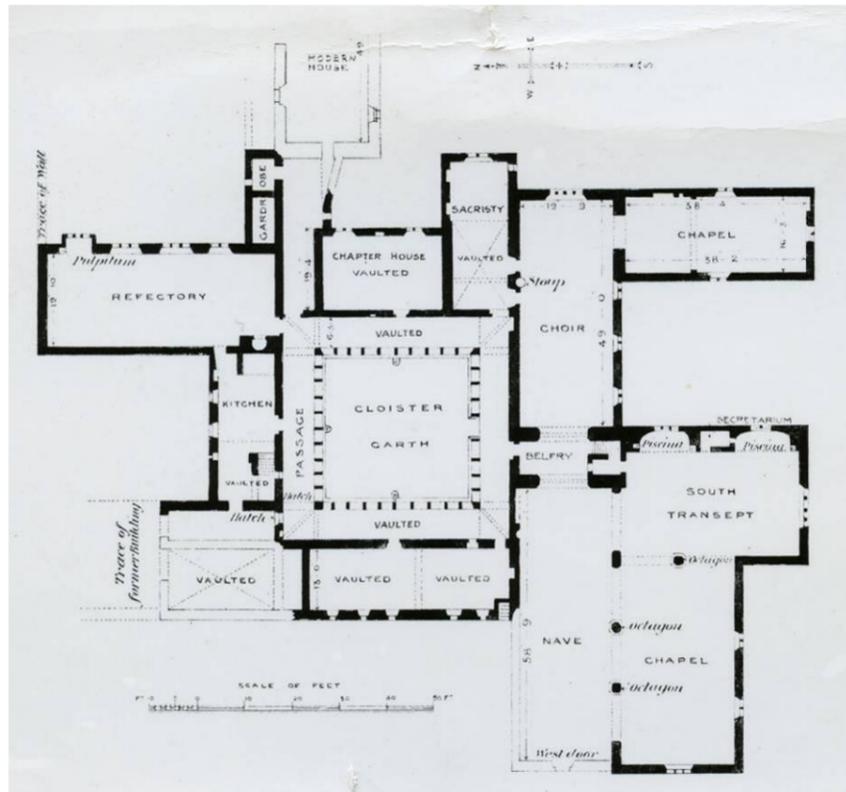
review 1975) and photographs (see below) indicate that an extremely large north transept with an aisle, in reality another church, was found to extend 22m north of the nave (also excavated) and chancel, which still stands. The transept is known to have contained an early 17th century graveslab (Manning 2007), indicating it was used for burial beyond the reformation.

Figure 5: Sketch plan of St. Francis' Abbey (Old Kilkenny Review 1975)

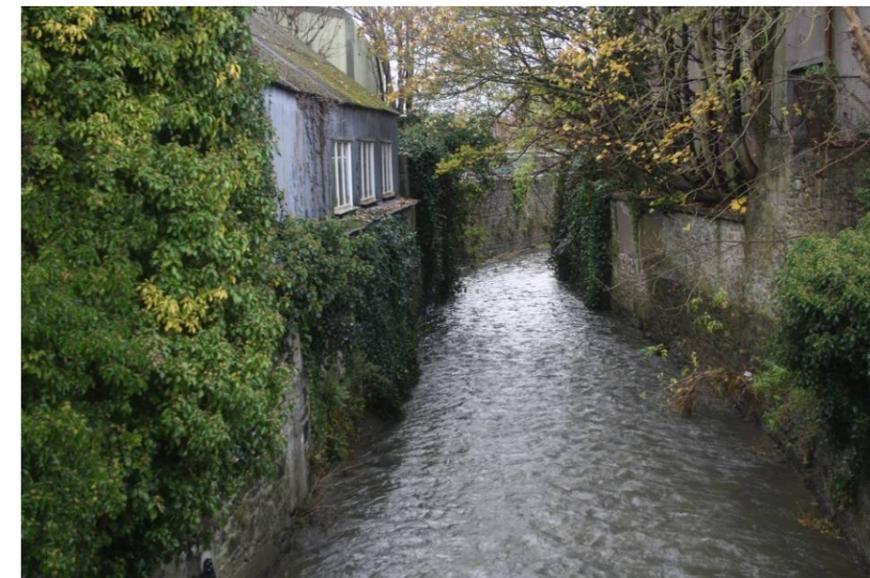
A 120m long stretch of riverside wall, which stands to a height of up to 5.5m in places, extends west from the Irishtown gate, breaks across the former millrace and turns south at the junction with the Dominican 'Black Abbey' precinct.

Figure 8: The Town Wall from Watergate Bridge

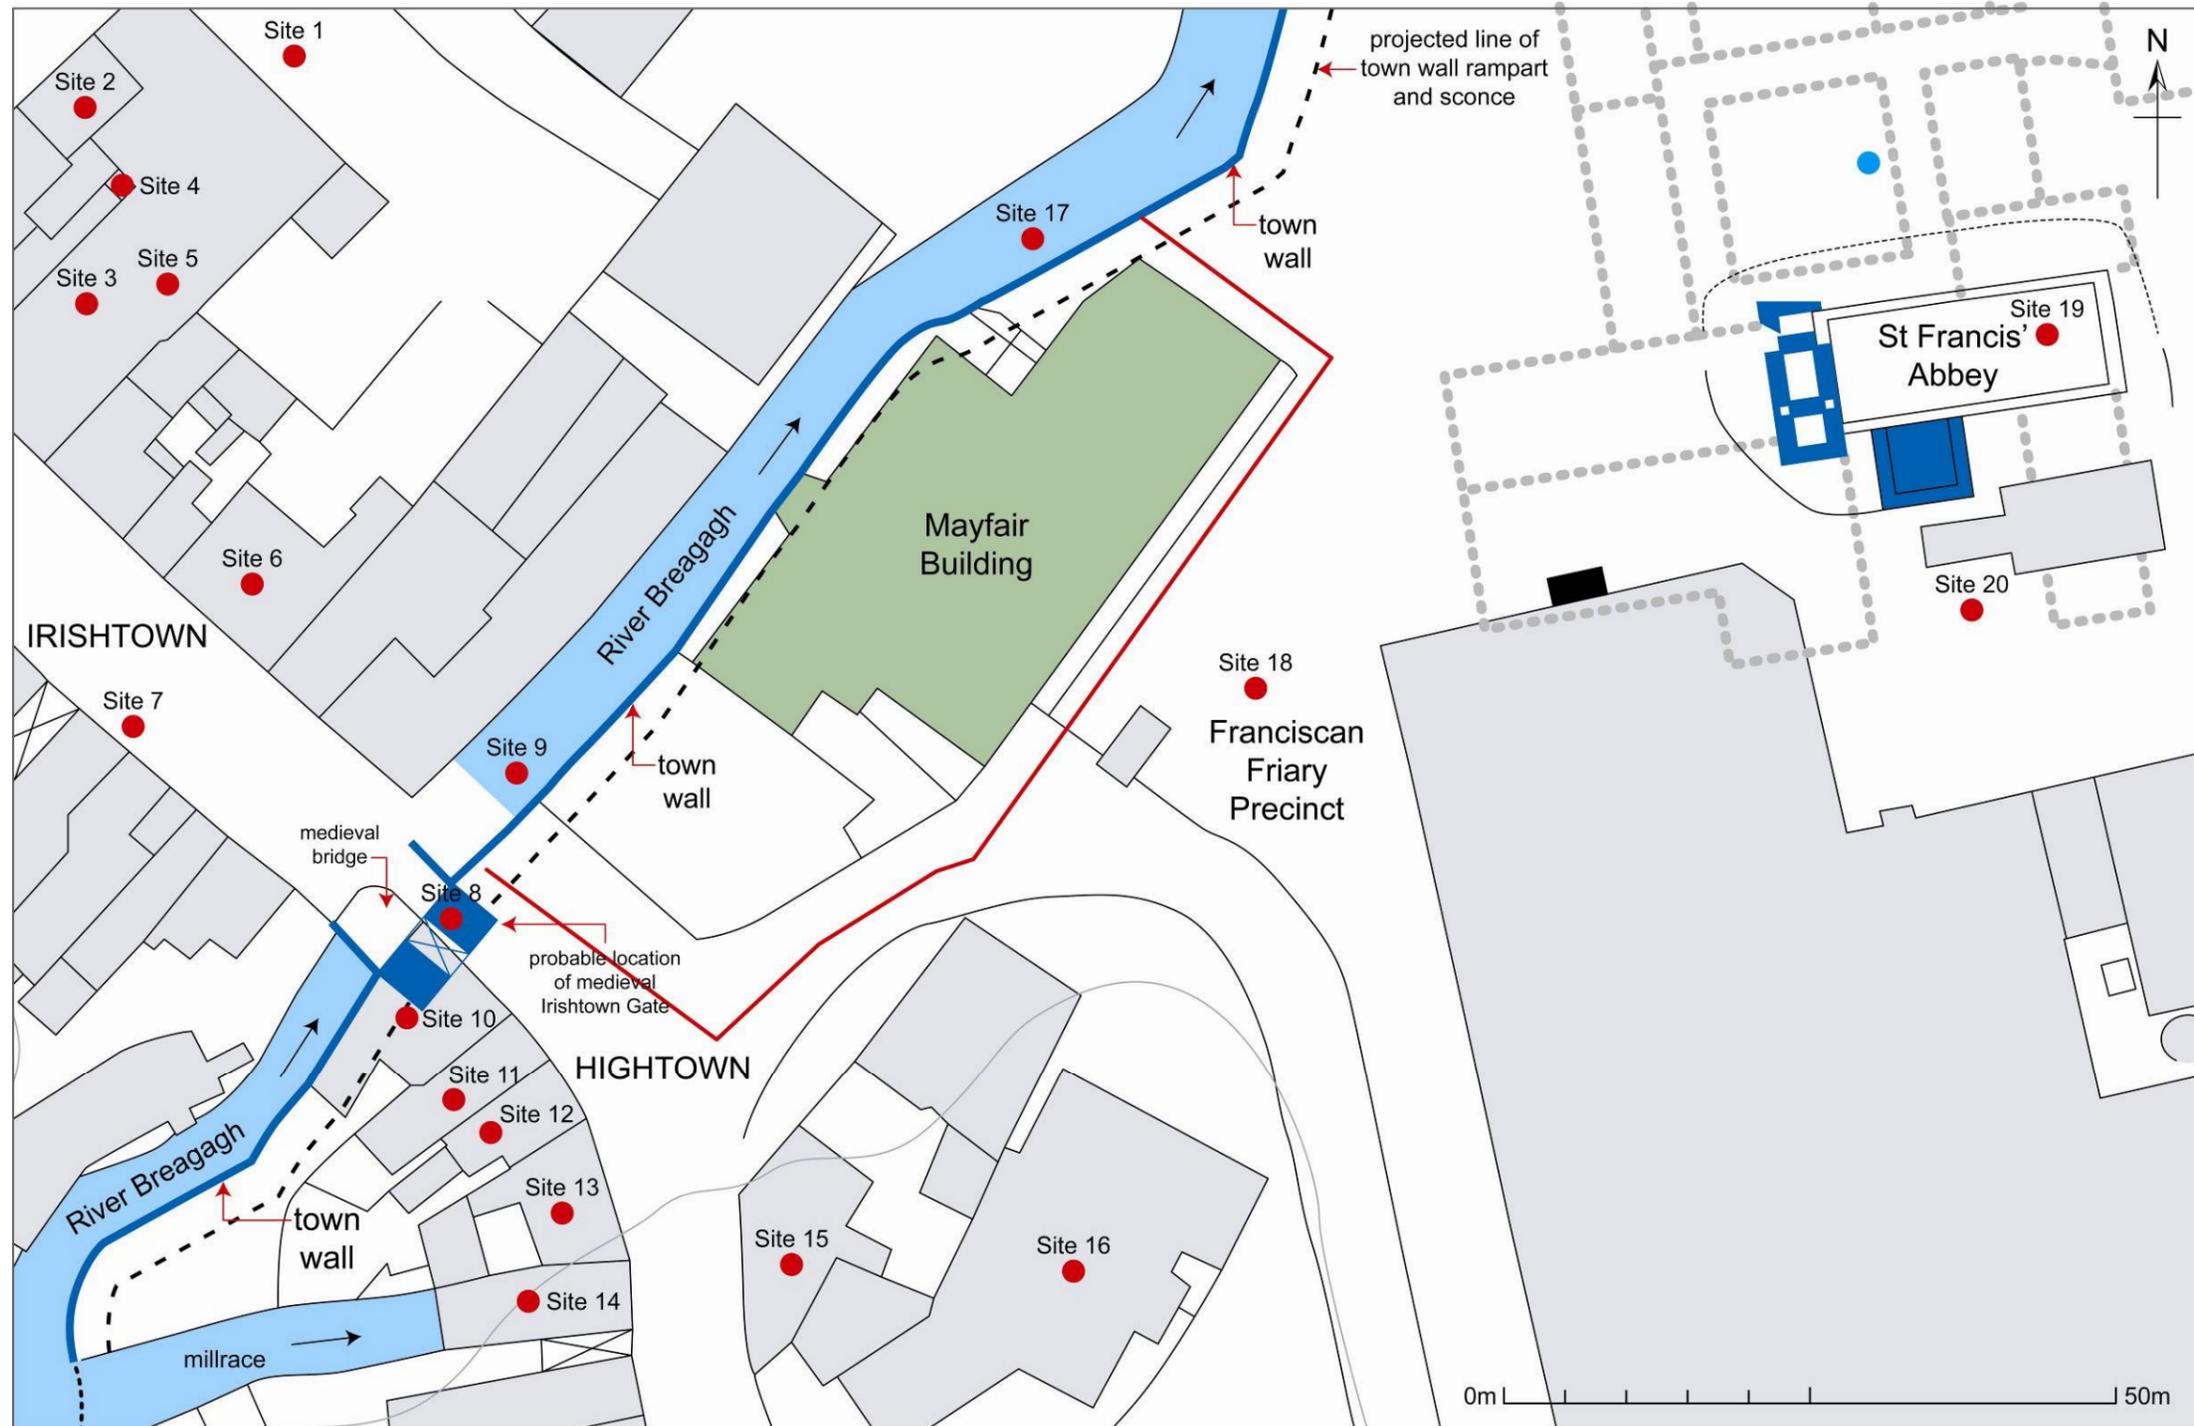
Figure 10: Archaeological sites in the immediate environs of the proposed area of development (numbers refer to Table 1)

The following provides brief descriptions of the each of the archaeological sites that fall inside and within the immediate environs of the proposed development area (Figure 10).

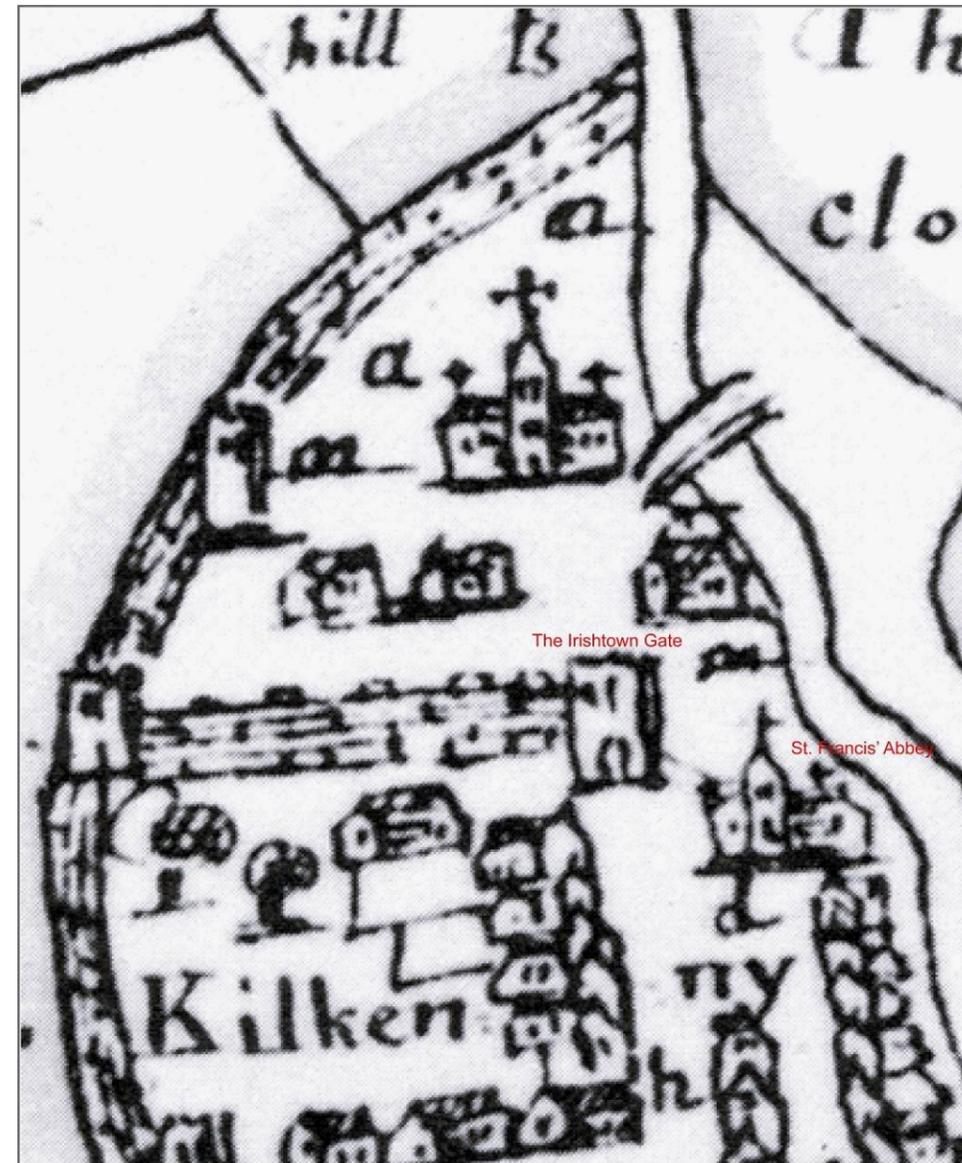
Figure 11: The Irishtown gate and St. Francis' marked on the 1655 Down Survey map of Kilkenny shows both the Irishtown Gate and the church of St. Francis' Abbey.

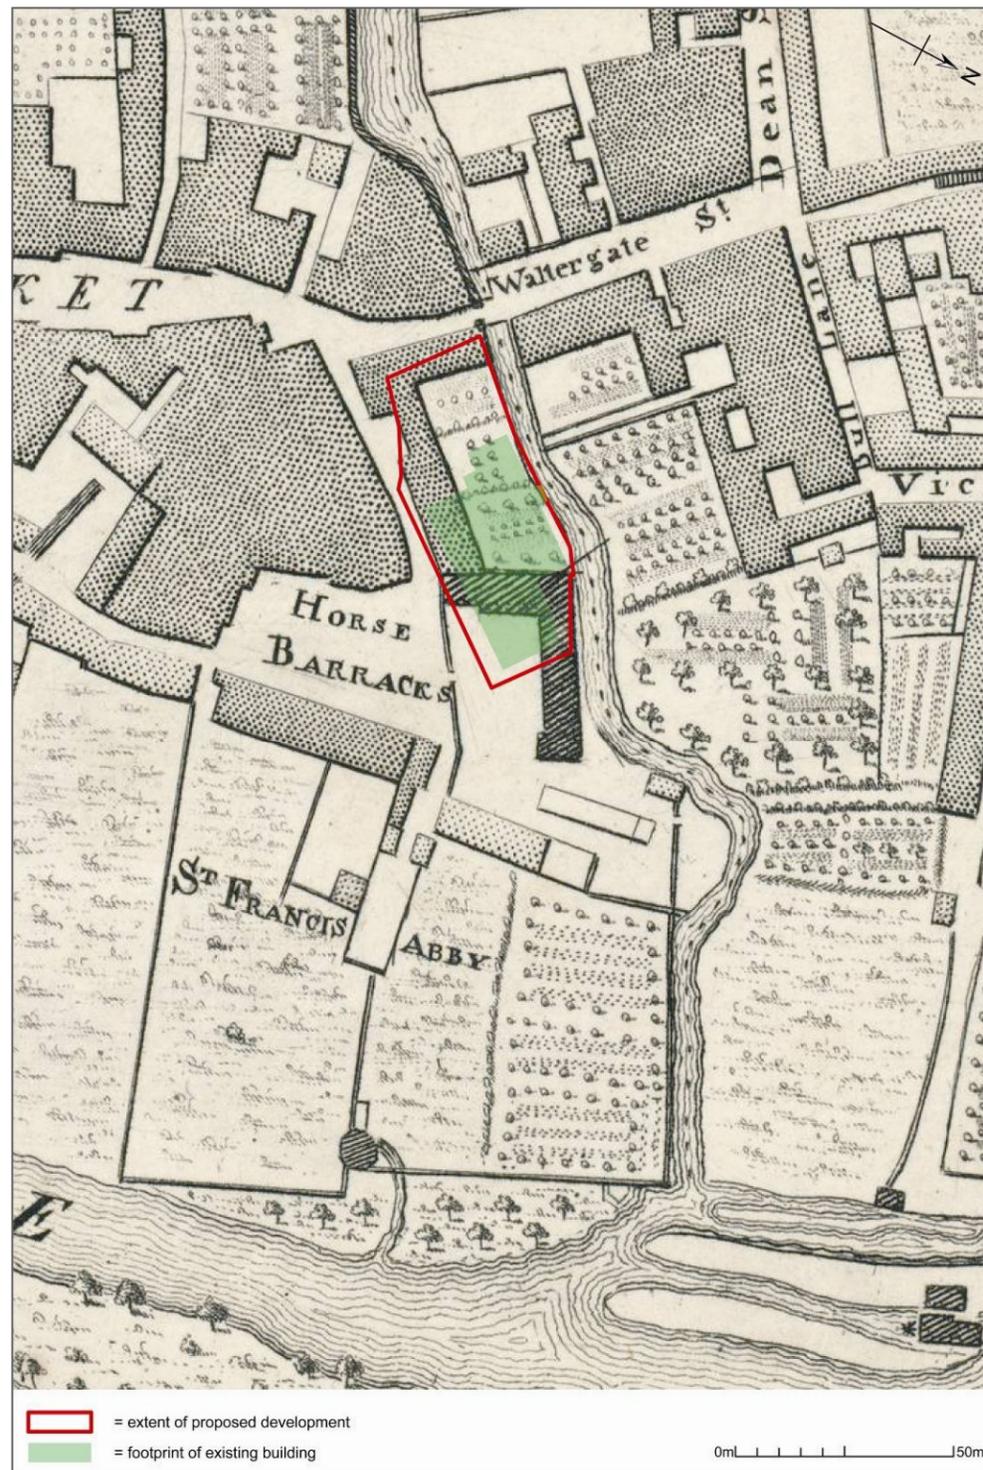
Figure 12: Area of proposed development on Rocque's 1758 Map of Kilkenny

John Rocque's 1758 map of Kilkenny shows the Horse Barracks as a large L-shaped building in an enclosing yard. Buildings front onto Horse Barrack Lane and Watergate Street, with a series of gardens between the buildings and the Town Wall. Evan's Tower is not shown.

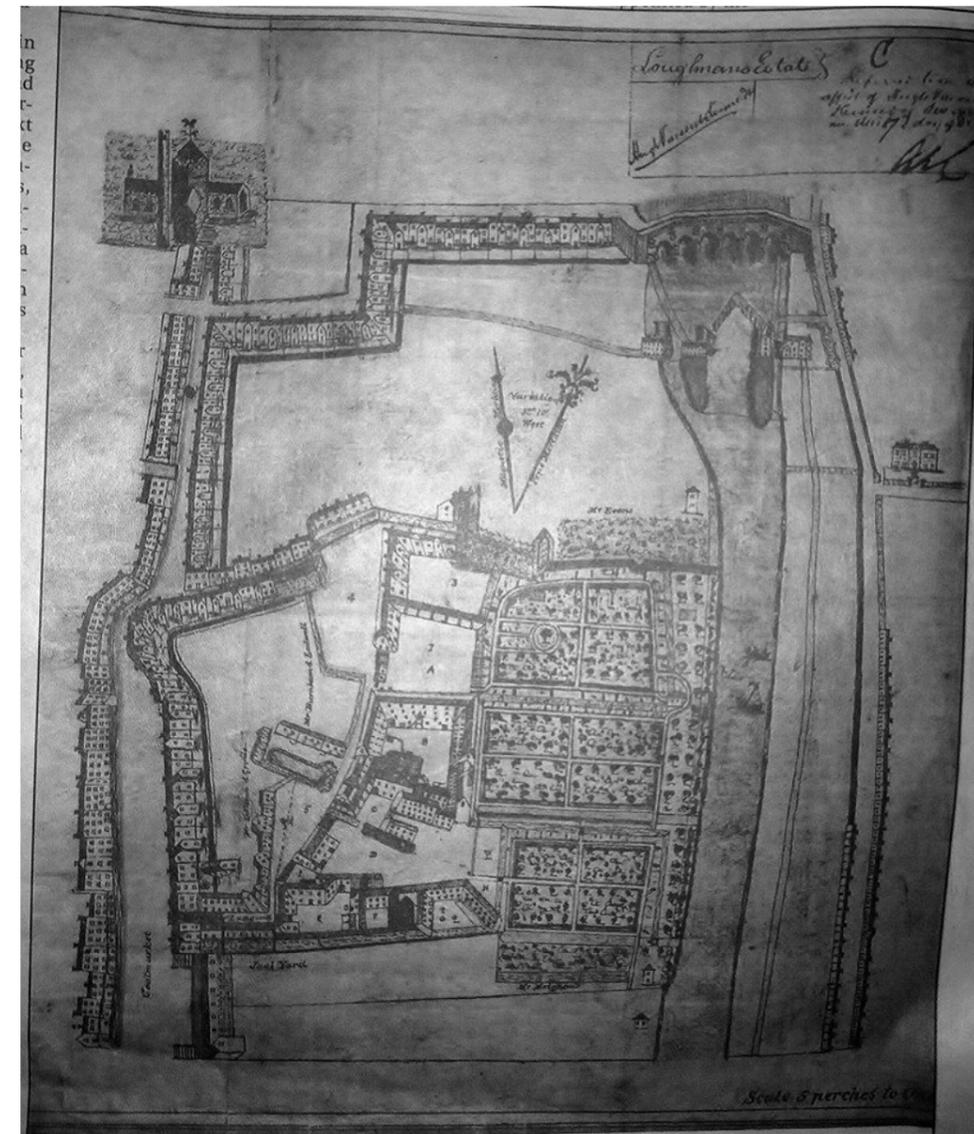
Figure 13: Loughman's Estate Map c.1750

Whilst Loughman's estate map is very schematic, the Town Wall and St. Francis' Abbey are both shown.

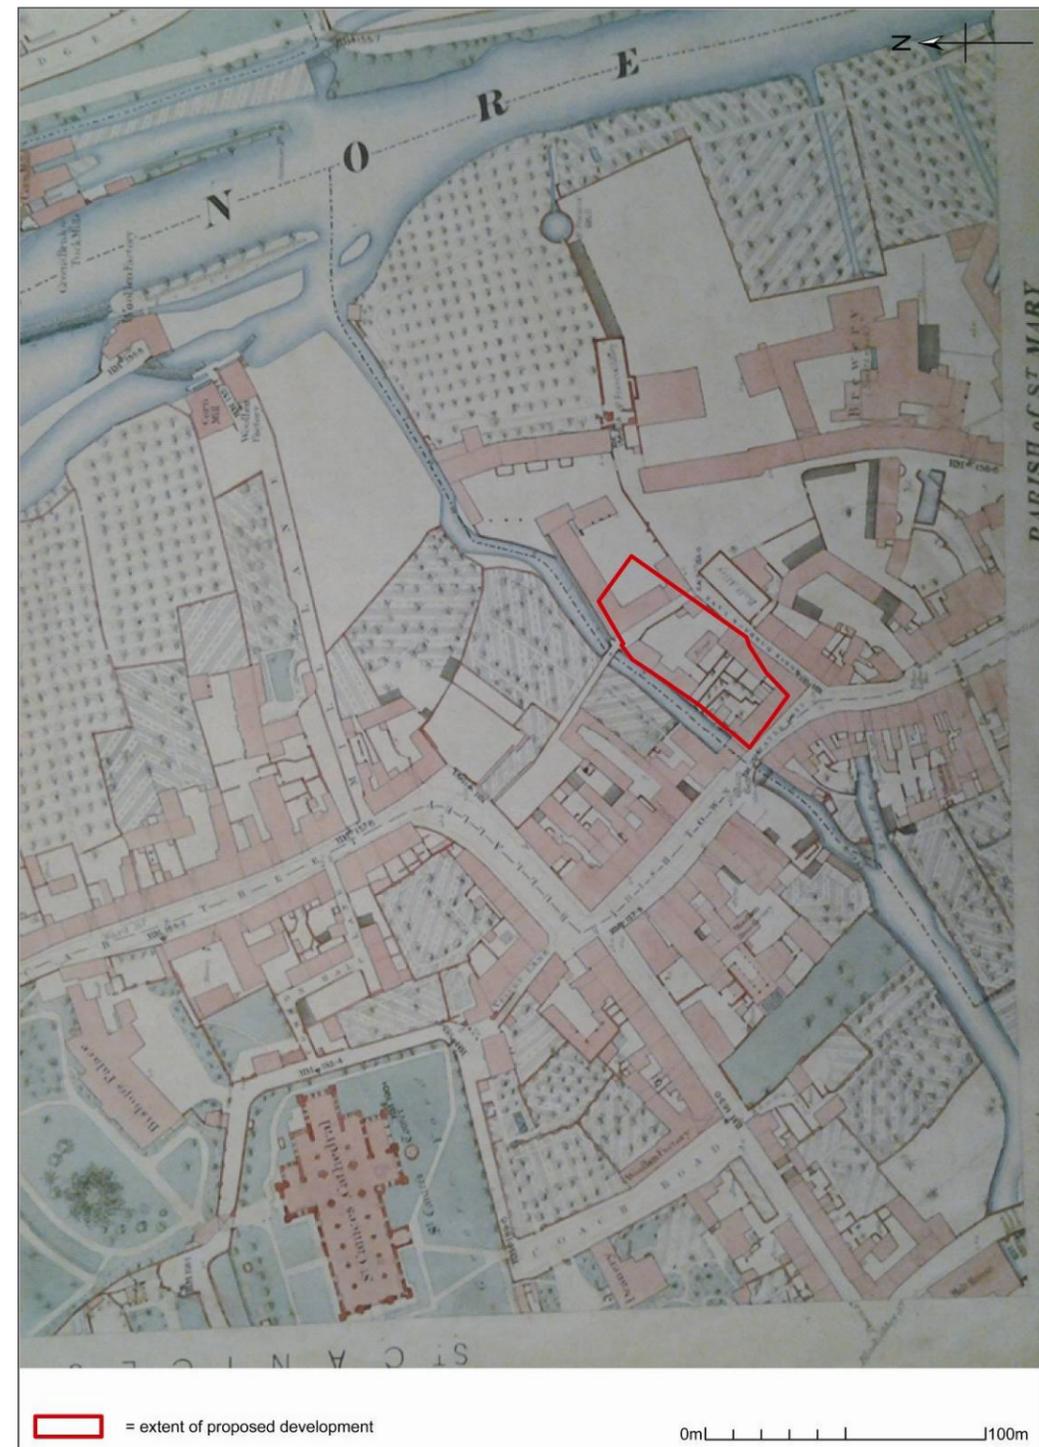
Figure 15: Area of proposed development marked on the 1870 OS map

The 1870 OS map shows a number of out buildings and enclosed yards between the buildings fronting onto Watergate Street and Horse Barrack Lane. The building to the north of the Abbey has been extended to the north. A bridge crossing the Breaghagh links lanes on each bank. Another building is shown traversing the Breaghagh just downstream of the Watergate Bridge.

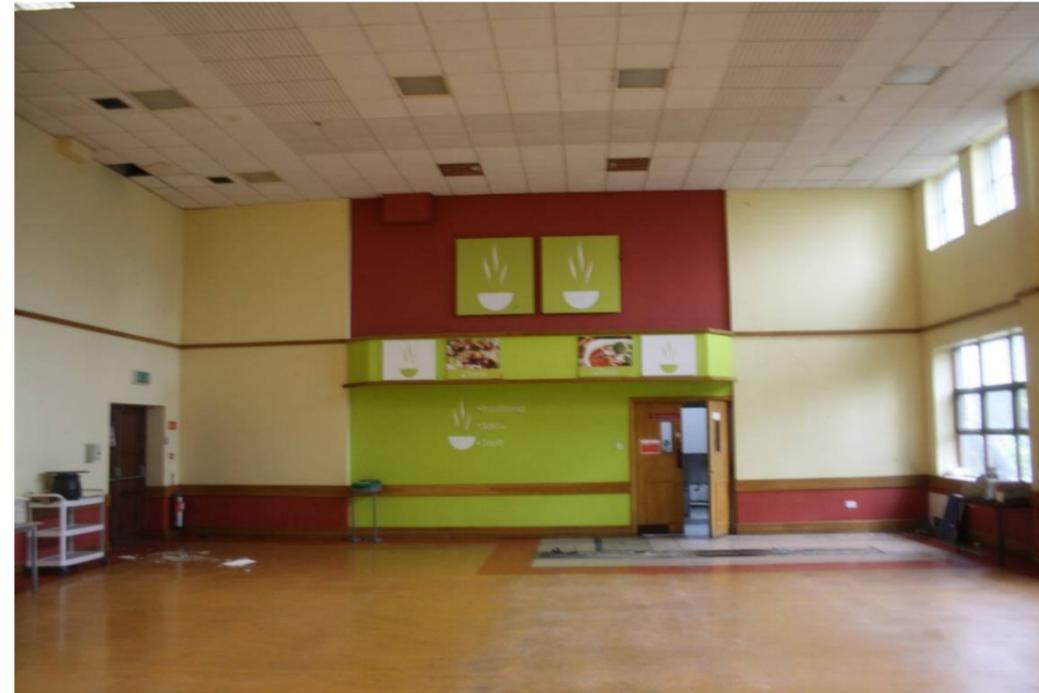
The building was originally constructed as a ballroom, which opened in 1943. The ballroom itself occupies the northwest side of the building. It is a large, high-ceilinged room with large windows facing onto the Breaghagh river. The southeast side of the building is two stories high, including a balcony looking out onto the ballroom. The original building is built of mass concrete walls, the roof is of corrugated sheeting. A two storey concrete block built extension at the rear of the building and a lean-to kitchen extension at the front were both added after the ballroom closed in 1973. A covered walkway along the southeast side of the building supports two offices which extend from the southeast side of the first floor. A yard enclosed by a high concrete block wall separates the building from the car park to the northwest. A yard at the northeast of the building contains concrete steps that lead to a first floor entrance to the office extension. A concrete block built boiler house at the northeast corner of the ballroom truncates the Town Wall. The Mayfair building has until recently housed offices and a staff canteen for the Diageo Brewery. The original ballroom was divided to create the staff canteen and the men's locker room. A suspended ceiling over the locker room houses several first floor offices. There is a 1m - 1.6m wide ledge between the northwest wall of the Mayfair building and the surviving Town Wall to the northwest. This ledge is very overgrown and currently inaccessible.

Figure 20: The Mayfair Ballroom.

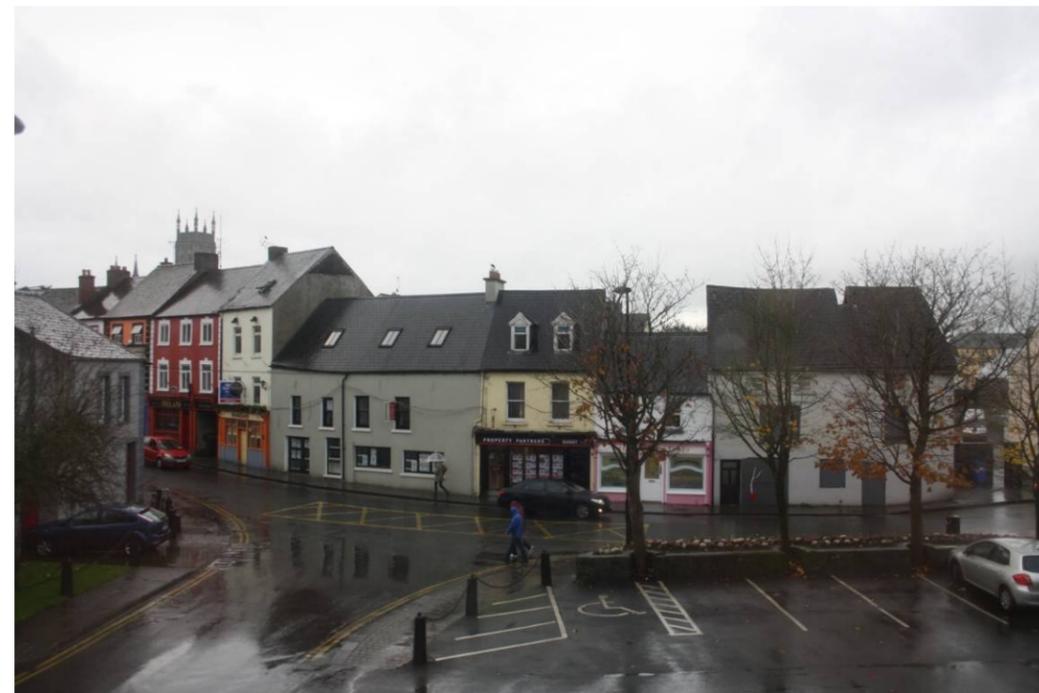
A small car park at the southwest end of the site is separated from Watergate Street by a raised planting bed surrounded by a modern low stone wall. The car park is paved with tarmac.

Figure 21: The car park and Watergate Street

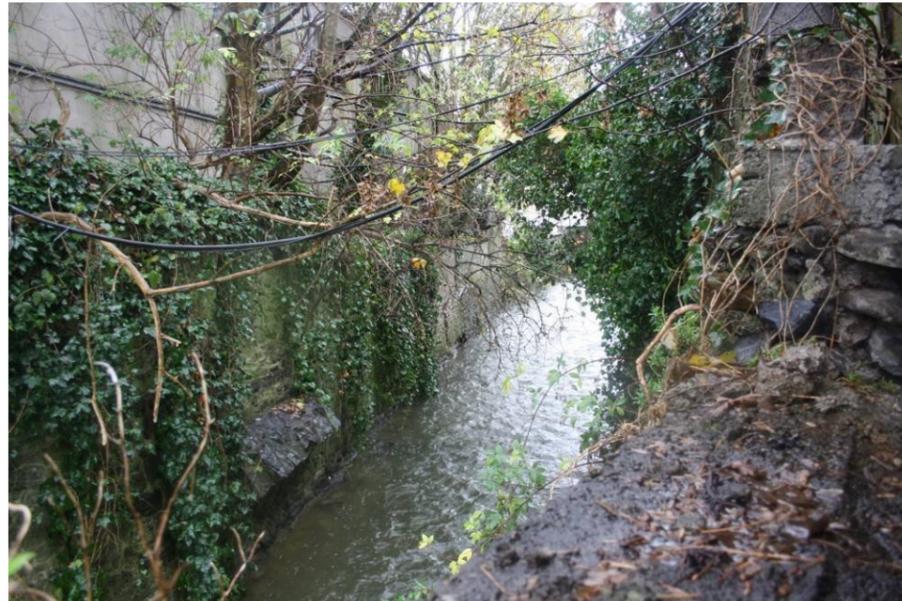
Two opes, probable arrow-loops, were noted in this stretch of wall. Ope 1 was 1.10m wide. The sides of the ope may taper inwards. A red brick arch at the head of the ope is a later rebuild. Ope 2 was less accessible. It was c.1m wide with a red brick arch at the head which like in Ope 1, seems to be a rebuild. The spring stones of a truncated arch were also noted, the remains of the bridge marked on the 1870 OS map.

Figure 22: Truncated arch in the Town Wall, from northeast

A comprehensive buildings archaeology assessment of the Town Wall within the development area, to include drawn and photographic recording, should be undertaken. This will inform the scope, extent and specifications for a conservation engineering appraisal of the monument.

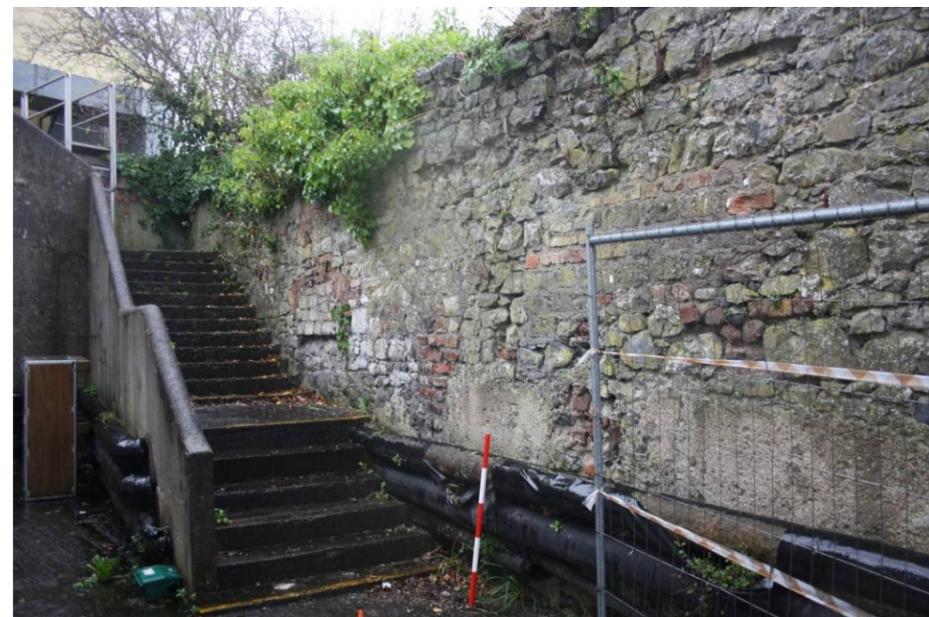
Figure 23: Blocked arrow loops in Town Wall adjoining Mayfair building
