ARCHAEOLOGICAL IMPACT ASSESSMENT: PROPOSED RESTRUCTURING AND RENOVATION OF THE THOLSEL (RMP KK019-026061), HIGH STREET/ST MARY'S LANE, KILKENNY

Client: Kilkenny County Council, John Street, Kilkenny
Archaeological Excavation Licence: 18E0413
Detection Device Reference: 18R140
Report Author: C  il  n    Drisceoil MA MIAI

05/12/2018

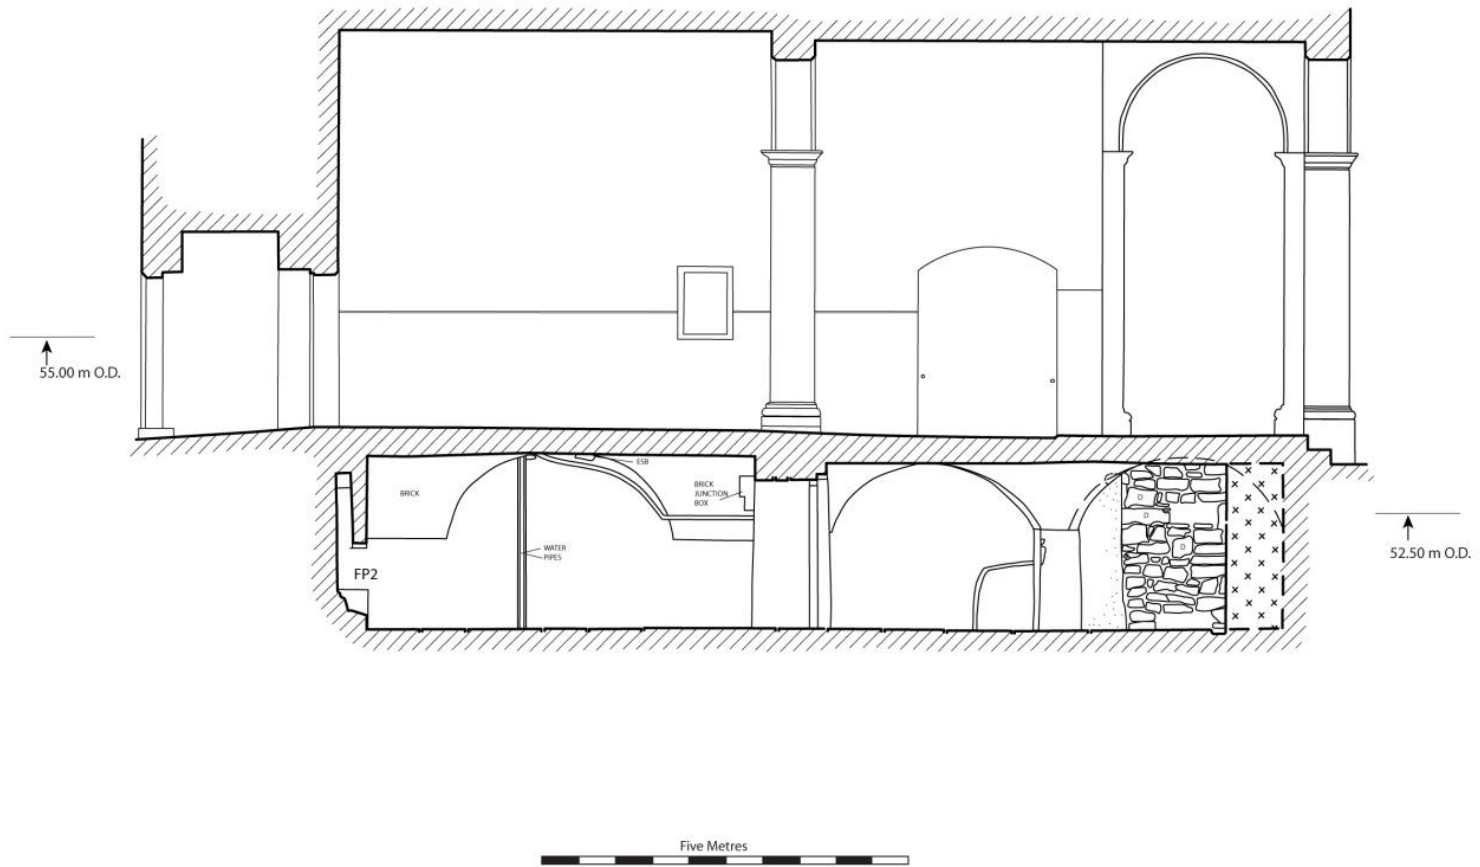
Figure 4: North-facing elevation the Tholsel basement and ground floor (by Phelim Manning/ Patrick Neary for Kilkenny County Council)

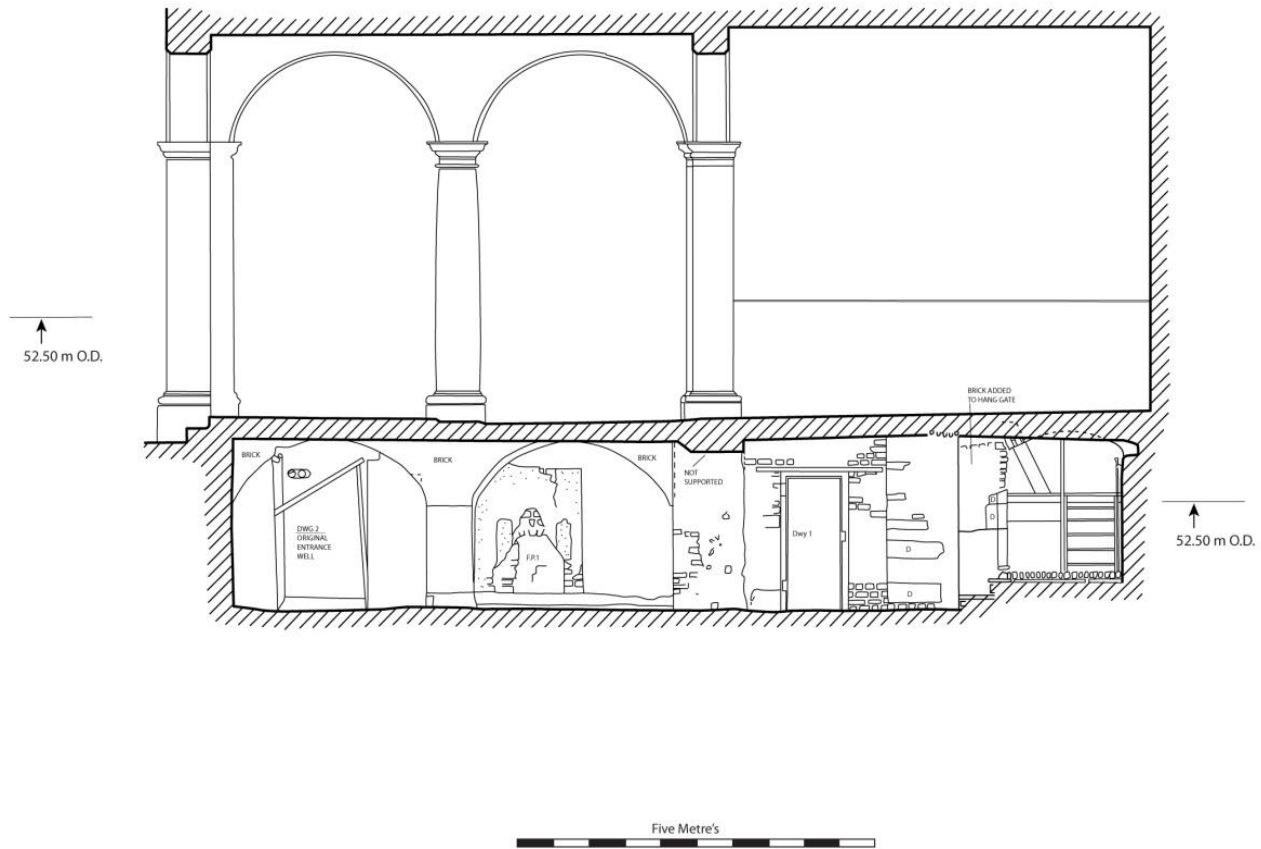
Figure 5: South facing elevation basement and ground floor the Tholsel (by Phelim Manning/ Patrick Neary for Kilkenny County Council)

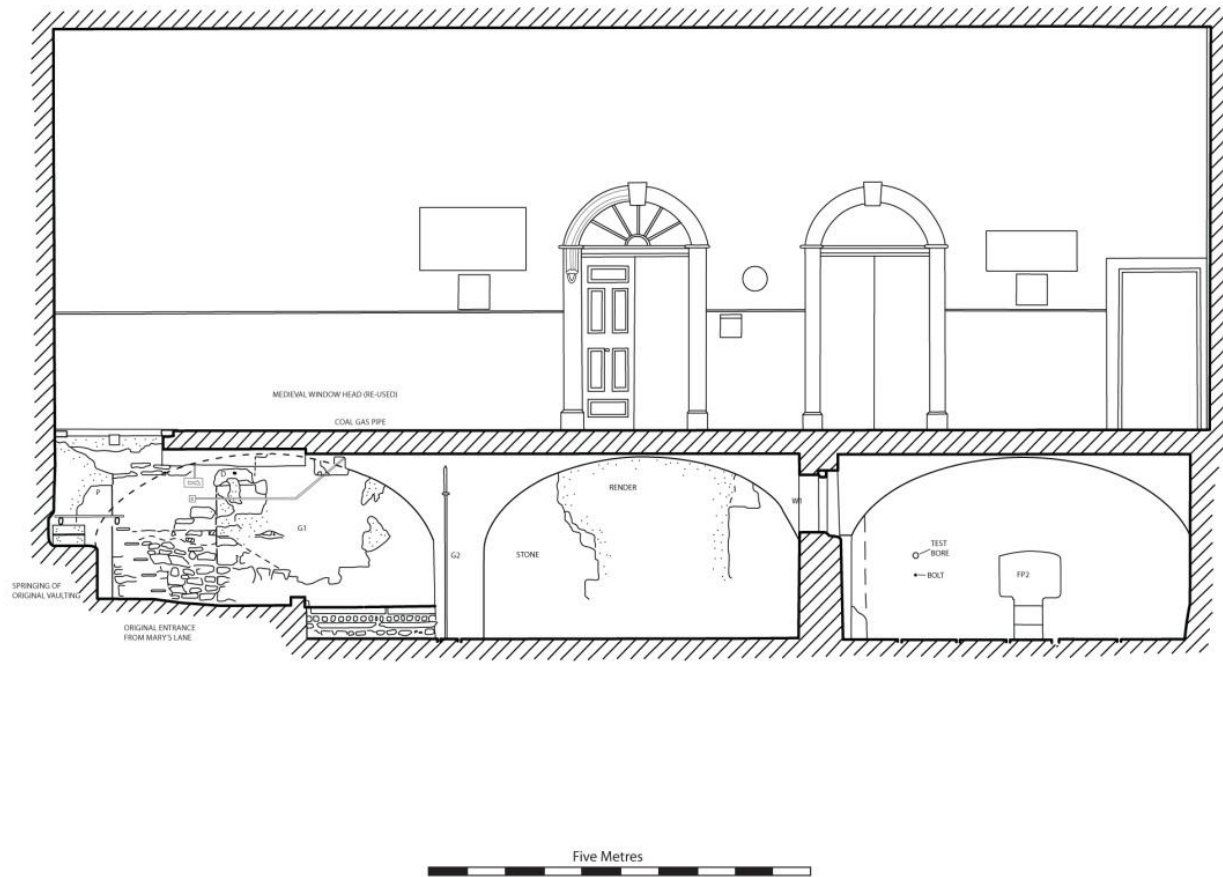
Figure 6: West facing elevation the Tholsel basement and ground floor (by Phelim Manning/Patrick Neary for Kilkenny County Council)

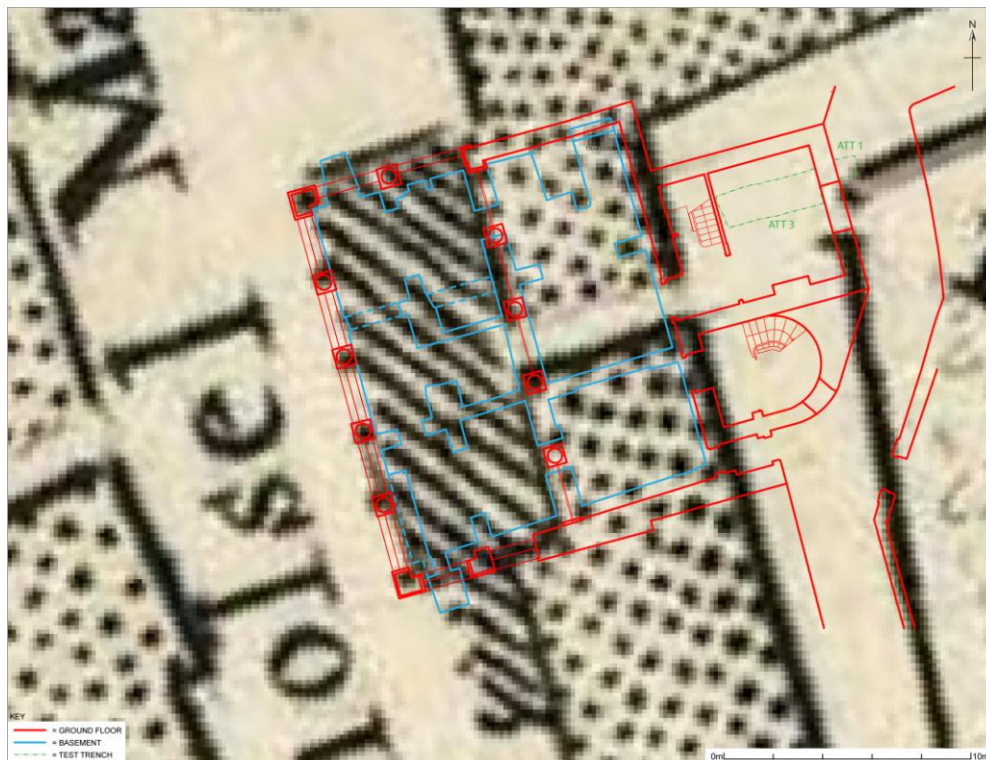
Figure 15: Current ground and basement plans overlain on John Rocque's 1758 'Survey of Kilkenny' (Trinity College Dublin). Note the close correlation between the two.

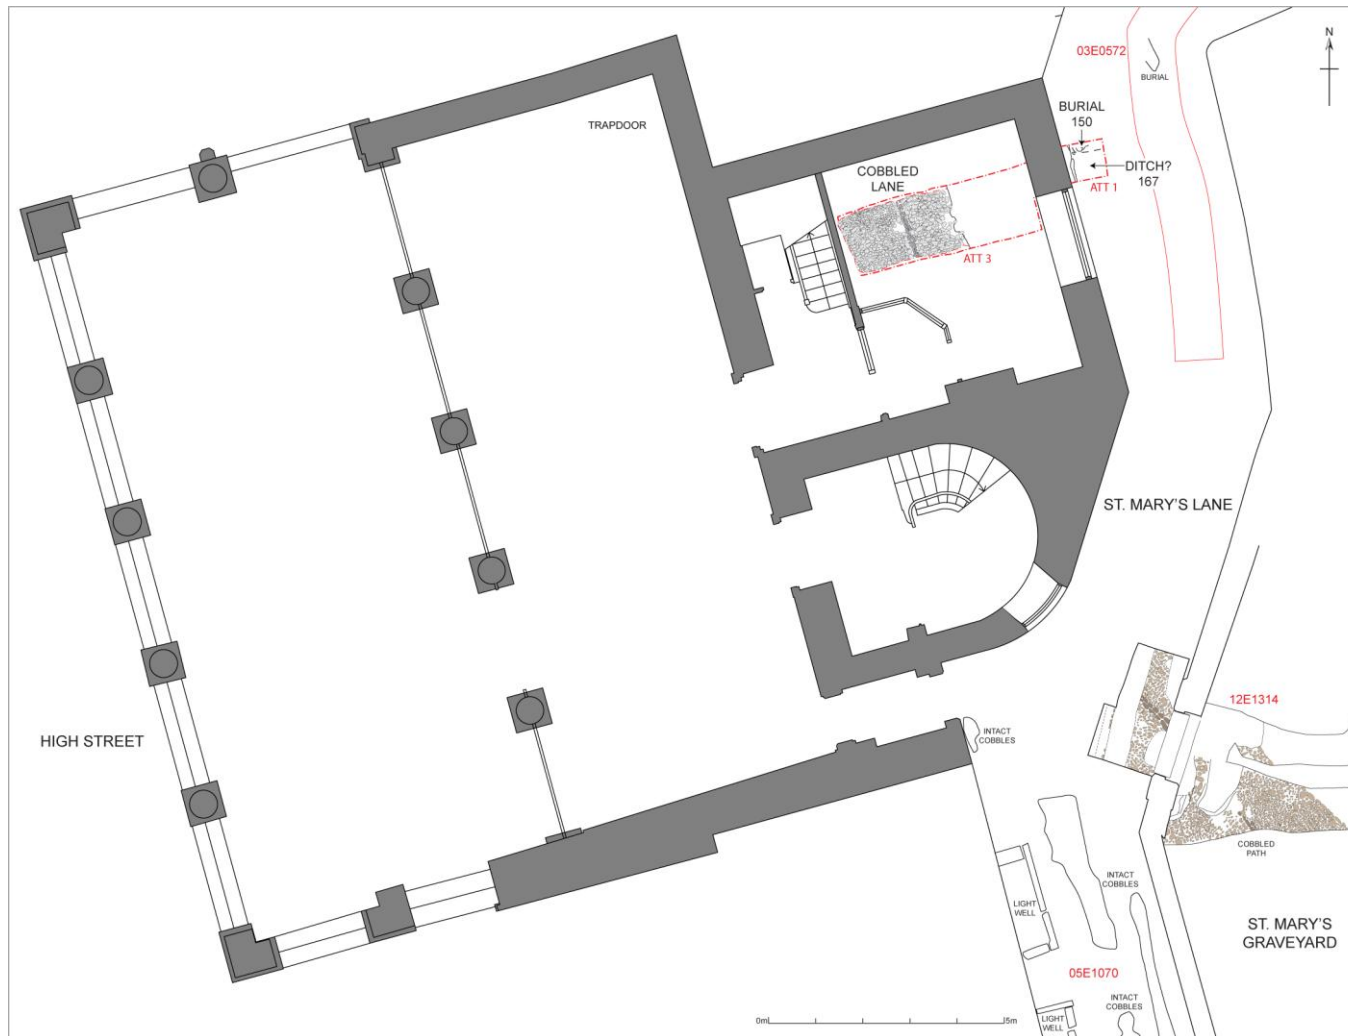
Figure 36: Location ATT1 and ATT3, ground floor level the Tholsel

ATT 1 was opened against the east face of the rear (east) wall of the Tholsel in St. Mary's Lane (Figures 36, 37). The trench was 0.90m (E-W) x 0.80m (N-S) and 1.10m deep. The trench was opened primarily to investigate the form of the foundation of the east wall for engineering inspection, but also to ascertain the level of the glacial subsoil.

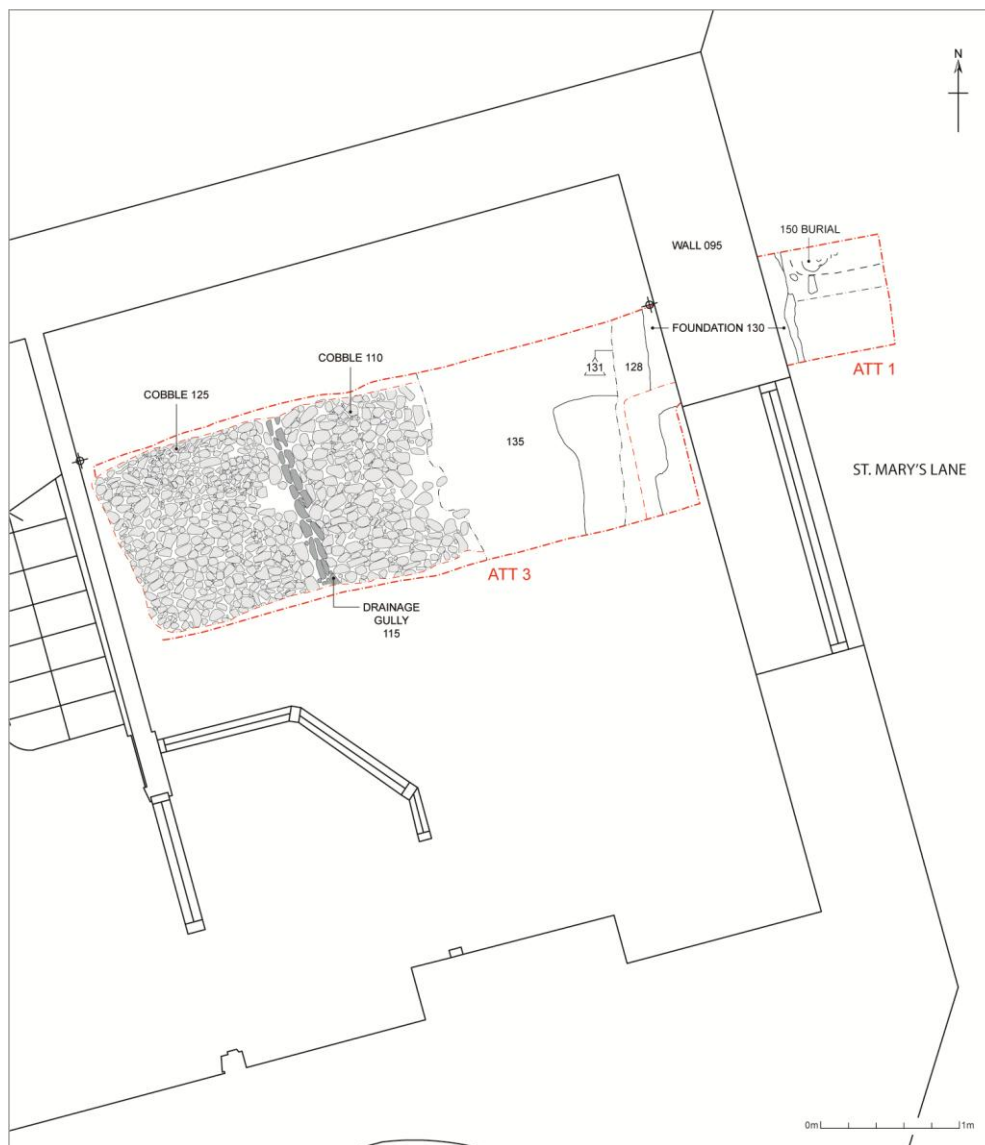
Figure 38: Plan of ATT 1 in St Mary's Lane and ATT 3 in the receipts office, showing the location of the burial 150 and the cobbled lane 110/125

ATT 3 was opened in the receipts office, on the ground floor of the former stairwell, built *c.* 1760 on the east side of the Tholsel (Figures 38, 39). The trench was aligned east-west and measured 4.26m x 1.5 x 1.75m deep. No human skeletal remains were found and it would appear therefore that the possible ditch **167** (see above) acted to define the western extent of the medieval graveyard of St Mary's. The cobbled surface of the early-mid 18th century St Mary's Lane, which is marked on Rocque's map (Figure 13), was found overlaying a series of post-medieval make-up deposits. At the same time as the construction trench for the foundation for the east wall of the *c.* 1760 stairwell was excavated, the eastern portion of the east side of the cobbled lane was robbed. Following construction of the stairwell the interior floor level was raised by the importation of several deposits of construction waste. A pad foundation, possibly for the original staircase, was found resting on the raised floor level. A possible red brick floor surface was also found.

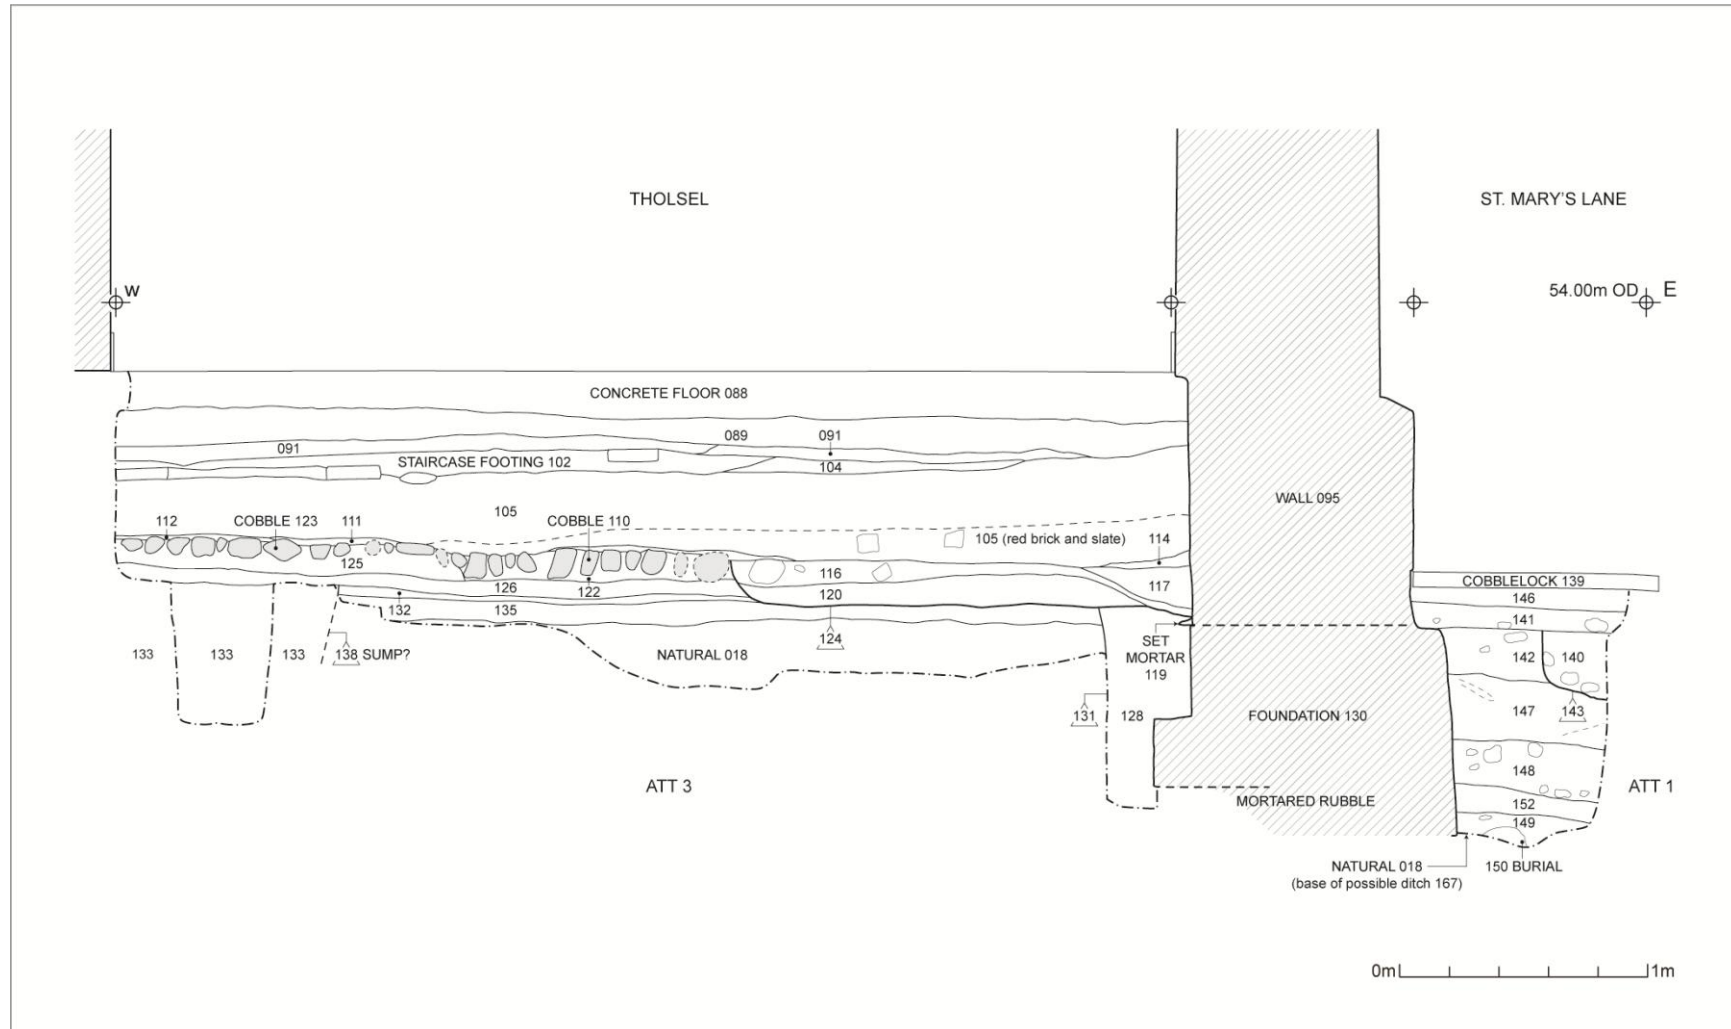
Figure 39: South facing section of ATT 1 and ATT 3, showing the east wall of the former stairwell, the medieval deposits in St Mary's Lane and the early to mid eighteenth century cobbled lane sureface below the current receipts office.

The natural glacial gravel **018** was a firm mid-grey sand with occasional to frequent well sorted rounded cobbles, was uncovered at 1.10m below the current lane surface (51.85m OD) (Figure 39).

The east side of the construction trench **131** for the foundations **130** of the east wall of the c. 1760 former stairwell had truncated the deposits **147**, **148** and **152**, the grave **151** and the natural gravel **018** at the base of the possible ditch **167** (Figure 39). At 0.84m

A trench **143** was dug through **142** at the east side of ATT 1. The exposed cut was 0.33m (E-W) x 0.89m (N-S) and 0.19m deep (Figure 39). It extended beyond the excavation to the north, south and east. The trench was backfilled with **140**, a loose mid brownish grey gravelly silty clay with moderate small stones and fragments of slate and red brick. **143** was probably a modern service trench.

141 was a dumped deposit of light brown clay and small stones and gravel, with occasional oyster shells (Figure 39). The deposit was 0.1m thick and extended beyond the excavation to the north, south and east. It sealed the foundation **130** and abutted the

The sump **138** cut through the construction layer **132** and the make up deposit **135** into the natural gravels **018** (Figure 39). The exposed cut was 1.2m (N-S) x 0.6m (E-W). It extended beyond the excavation to the north and west. It was excavated to a depth of 0.58m and extended below the base of excavation. The pit was backfilled with **133**, a very loose deposit of small to medium sized cobbles in a matrix of dark brownish grey silty clay. The cobbles became more frequent in the lower part of the cut, with a greater proportion of large cobbles towards the base. The sump was sealed by the make up deposit **126**.

The deposit **126** sealed the make up deposit **135**, the construction layer **132** and the sump **138** (Figure 39). It was a thin deposit of firm mid-greyish brown silty clay with *c.* 30% small to medium rounded and angular stones and *c.* 10% sand and gravel, with moderate flecks of lime mortar, occasional chunks of lime mortar, and fragments of red brick, animal bone and slate. The top of the deposit was hard and compact. **126** was 2.6m (E-W) x 1.4m (N-S) and 0.12m thick. It extended beyond the excavation to the north, south and west. It was truncated at the east end by **124**. This deposit represents either the ground level immediately pre-dating the mid eighteenth century cobbled surface **123** and **110**, or perhaps a working surface for the laying of the cobbles.

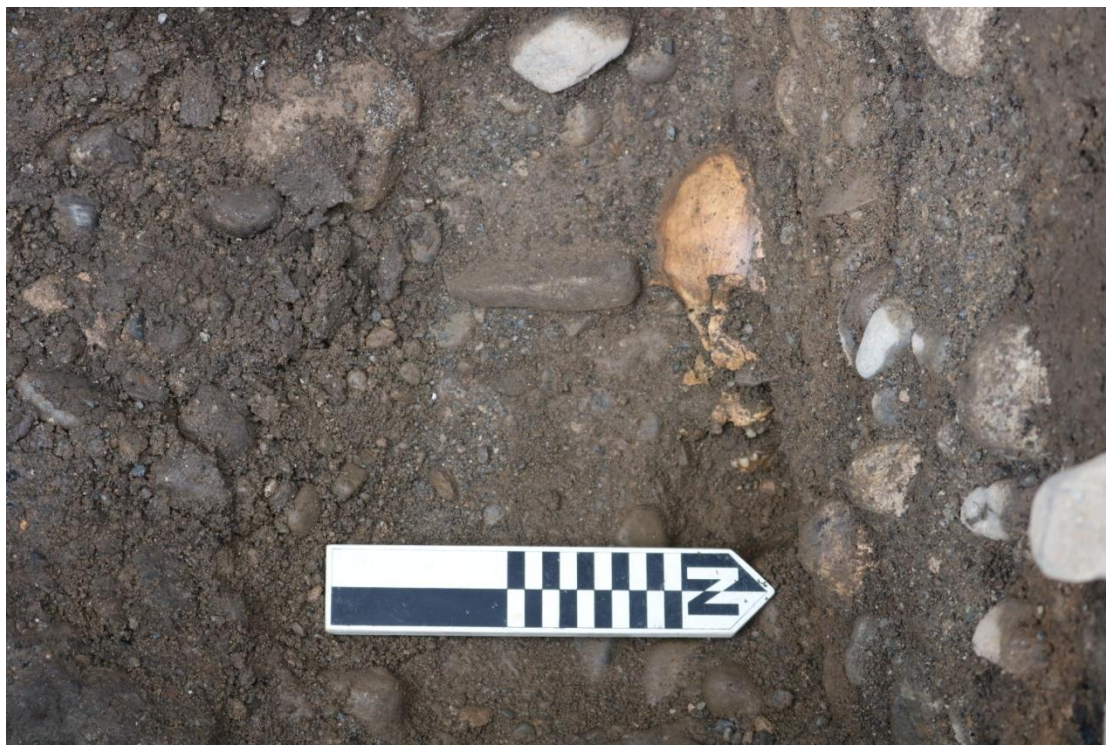
Figure 40: The cranium, mandible and upper spine of human skeleton 150, the medieval burial uncovered at the base of ATT 1. The burial was aligned east west. The skull rested on its right side. The burial remains in situ.

At the base of the possible ditch **167** a human skeleton **150** was identified. Its grave **151** cut into the glacial subsoil **018** at the base of the possible ditch (Figures 39, 40, 41). The west end of the grave, just to the west of the skeleton, was truncated by the construction trench **144** for the plinth foundations of the east wall of the c. 1760 former stairwell. The grave was only partially exposed but was found to contain the articulated skeleton **150** of an adult (Figure 40). The burial **150** was just minimally exposed in order to confirm that it represented an articulated skeleton. The front of the cranium and the mandible and two upper vertebrae were found to be articulated. The backfill **149** of the grave was a

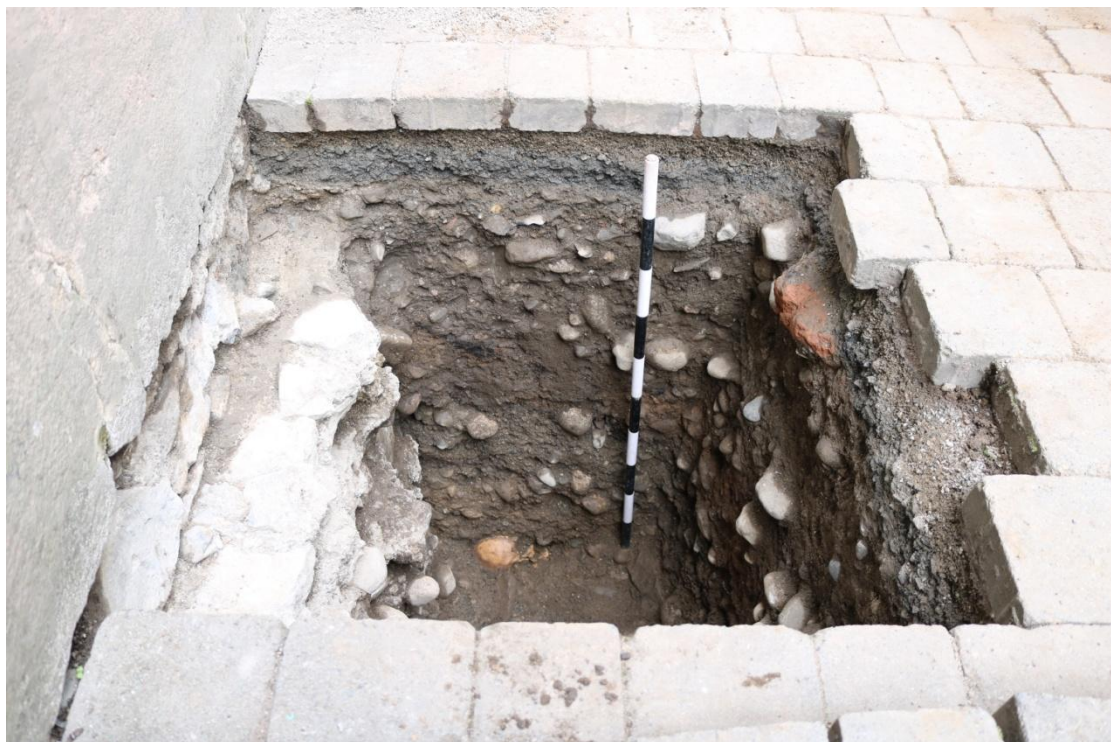
Figure 41: ATT 1 from the south. Showing the burial 150 below a series of possible ditch-fills 152, 148, 147 and 142 cut by the construction trench 131. Also shows the wall foundation 130.

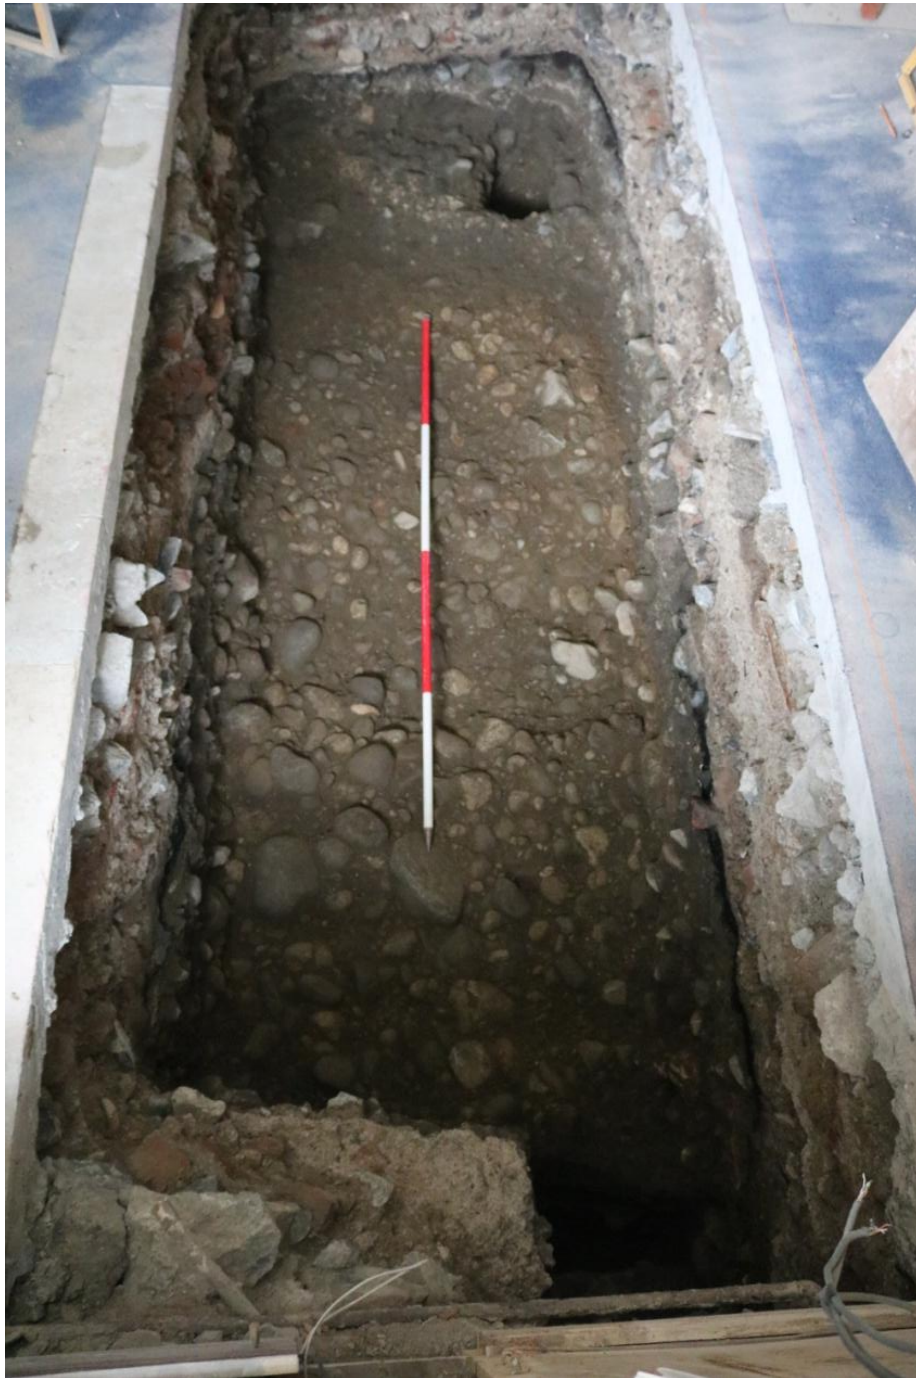
Figure 42: ATT3, natural sands and gravels 018, from the east.

The natural glacial gravel **018** was uncovered at 1m (52.72m OD) below the concrete floor surface (Figures 39, 42).

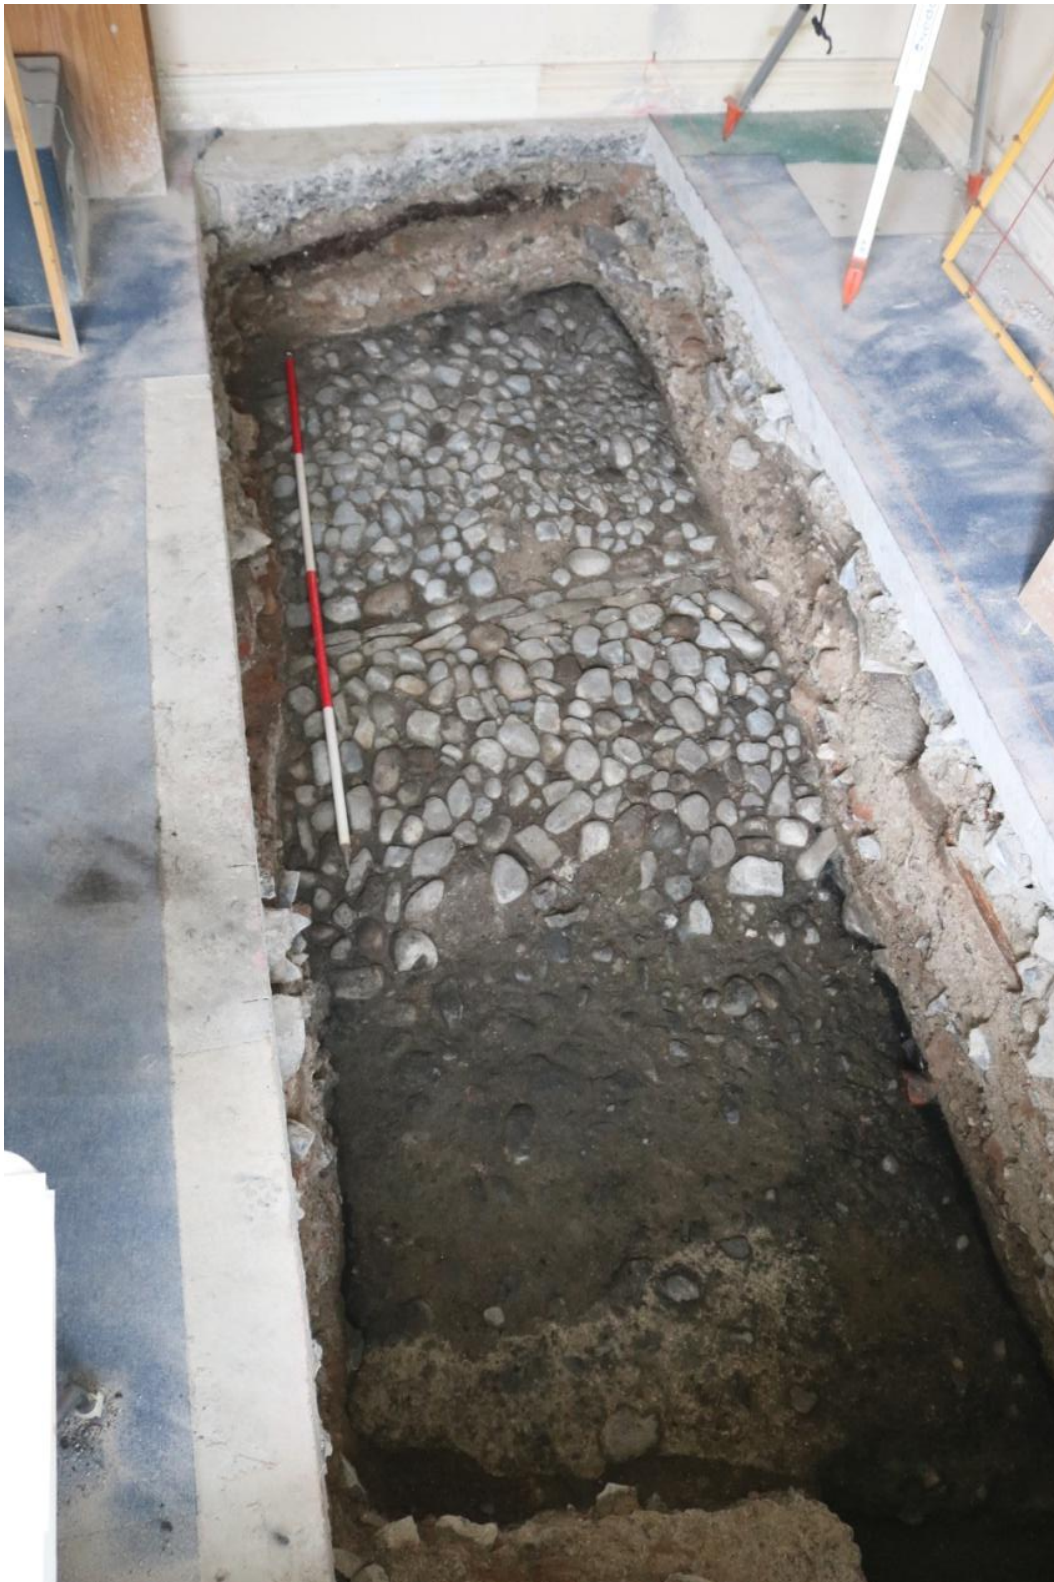
Figure 43: ATT3 cobbled lane 110/123, from the east

The cobble surface **123** was laid in a bedding **125** over **126**. It measured 1.57m (E-W) x 1.40m (N-S) (Figures 38, 39, 43, 44). It extended beyond the excavation to the north, south and west. The cobbles were set vertically in the bedding **125**, a loose deposit of light greyish brown sandy clay and mortar with occasional fragments of coal and red brick which produced six fragments of clay pipe stem (18E413:125:001-006) and GRE and Creamware pottery. The finds from the cobbles bedding suggests a post 1700 date for the cobbles. The bedding was up to 0.14m thick and extended vertically between the cobbles. Individual cobbles were up to 0.12m x 0.10m at the surface and up to 95mm deep. Occasional small angular stones were used as packing and the cobbles formed a very slightly cambered surface of densely packed stones. The east side of the surface was defined by a single row of larger cobbles (c. 0.2m x 0.1m) which were c. 60mm to 80mm lower than the main body of the surface and were probably an original edging.

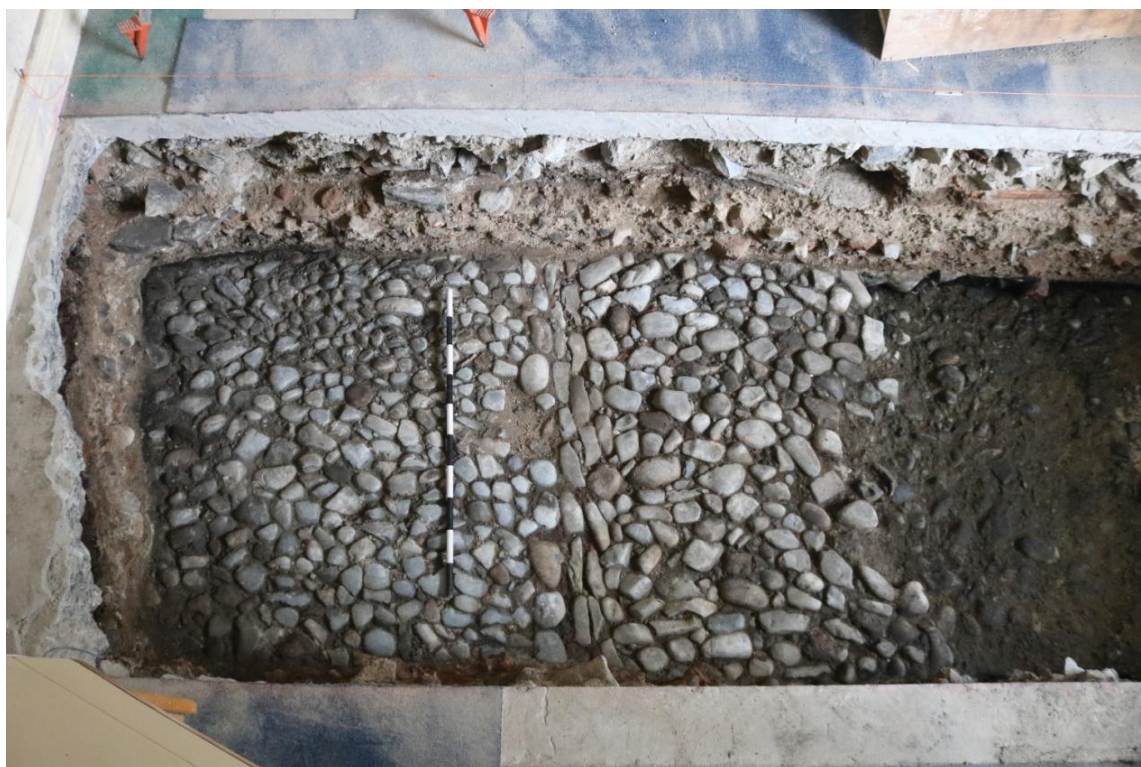
Figure 44: ATT3, cobbled lane 110, 123 with gully 115 running along the centre, from the south

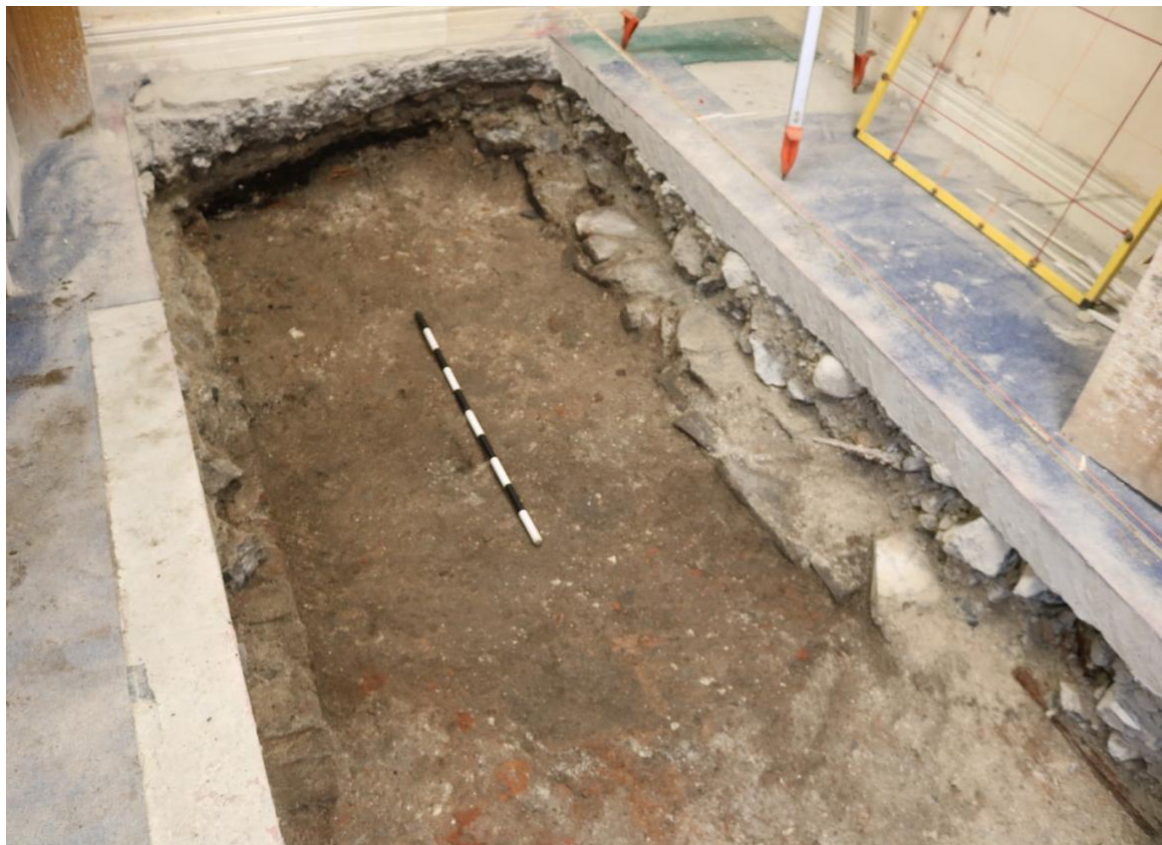
Figure 45: ATT3, possible staircase footing 102 running under the north extent of ATT 3, sitting on the make up deposits 104 and 105, from the southeast.

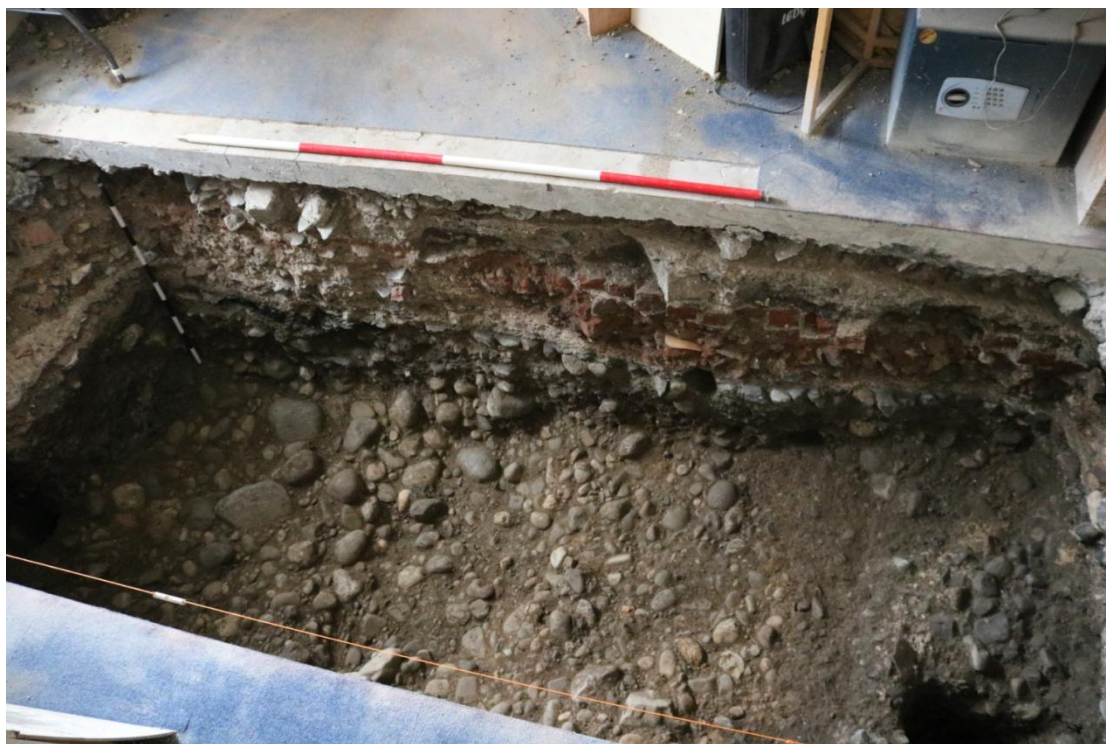
Figure 46: ATT 3, north-facing section, red brick possible floor surface 103, the cobbles 110 and 123 and the natural sands and gravels 018 at the base of the trench.

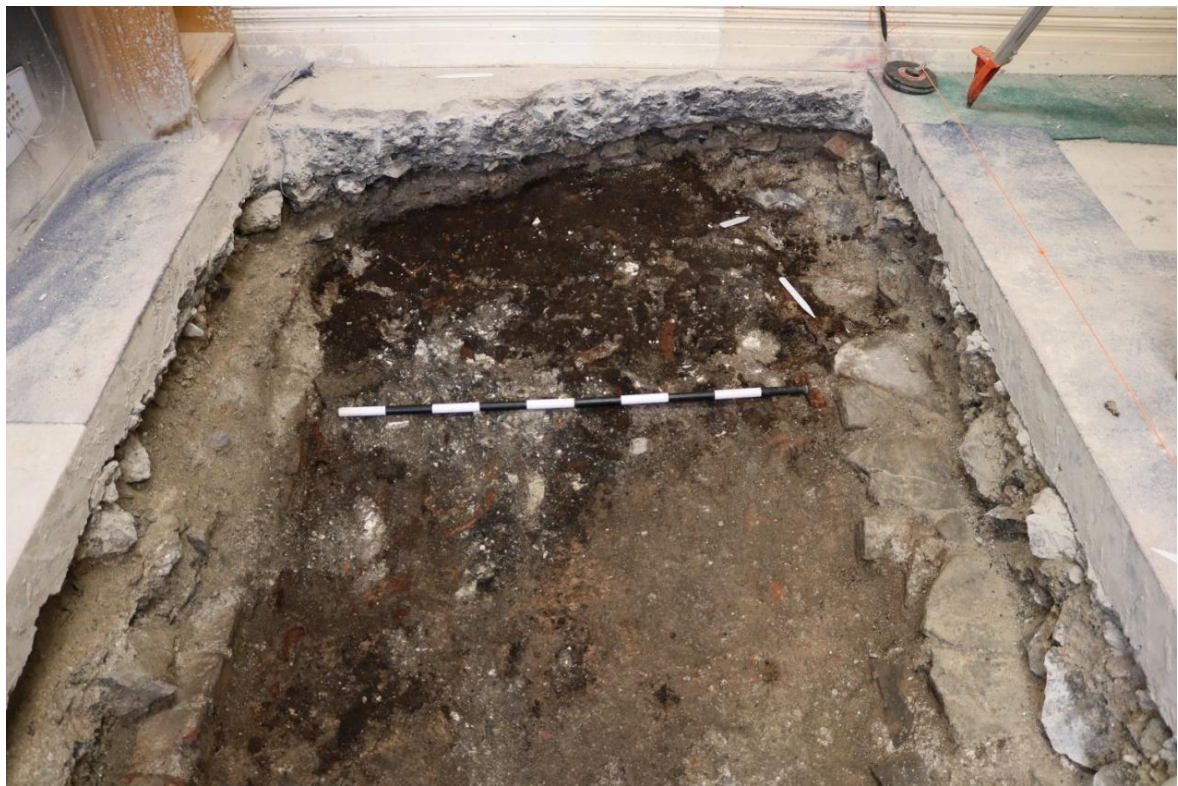
Figure 47: The remains of the mid 20th century fuel store 096, from the east

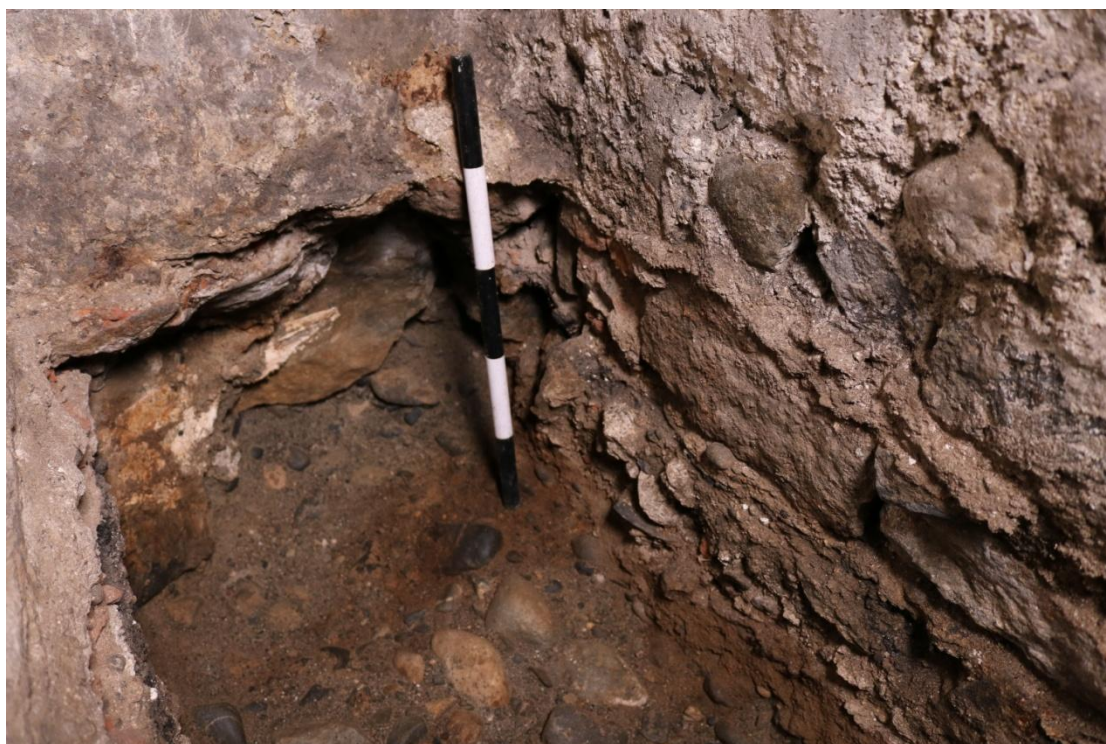
Figure 52: ATT6 truncation of north basement wall 081, the pier 080 abutting 081 and sitting directly on the floor 063, from the south.

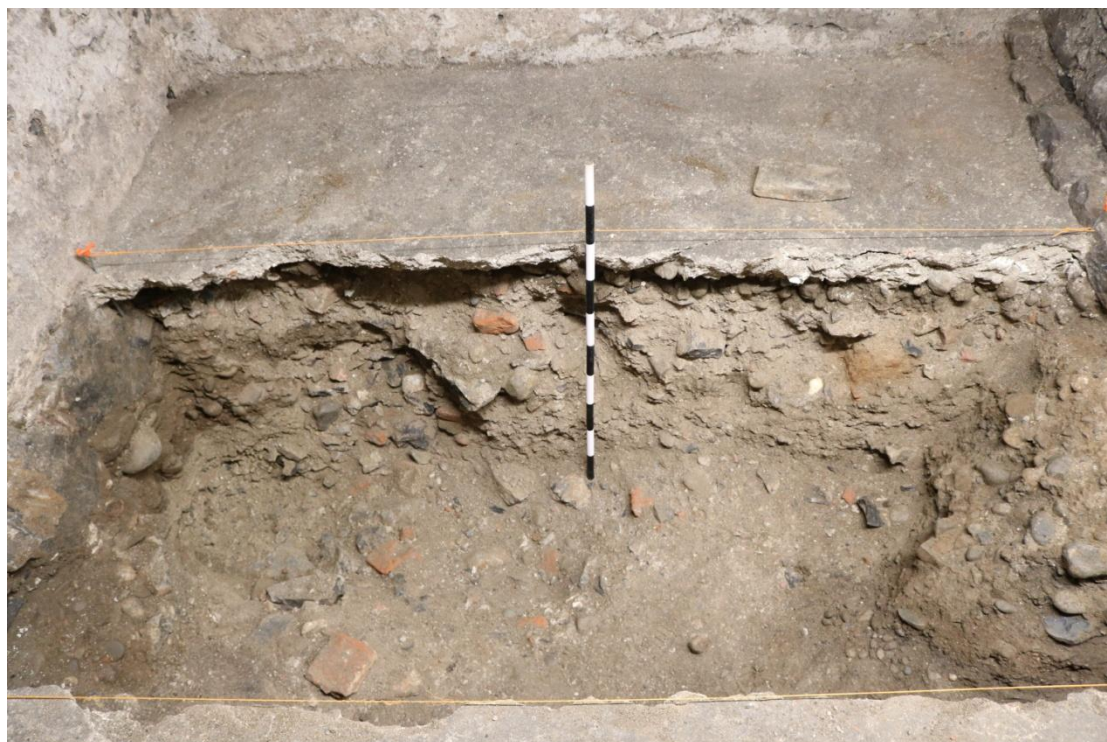
Figure 56: ATT7 north facing section, showing the partially emptied borrow pit 031 and the wall foundation 032.

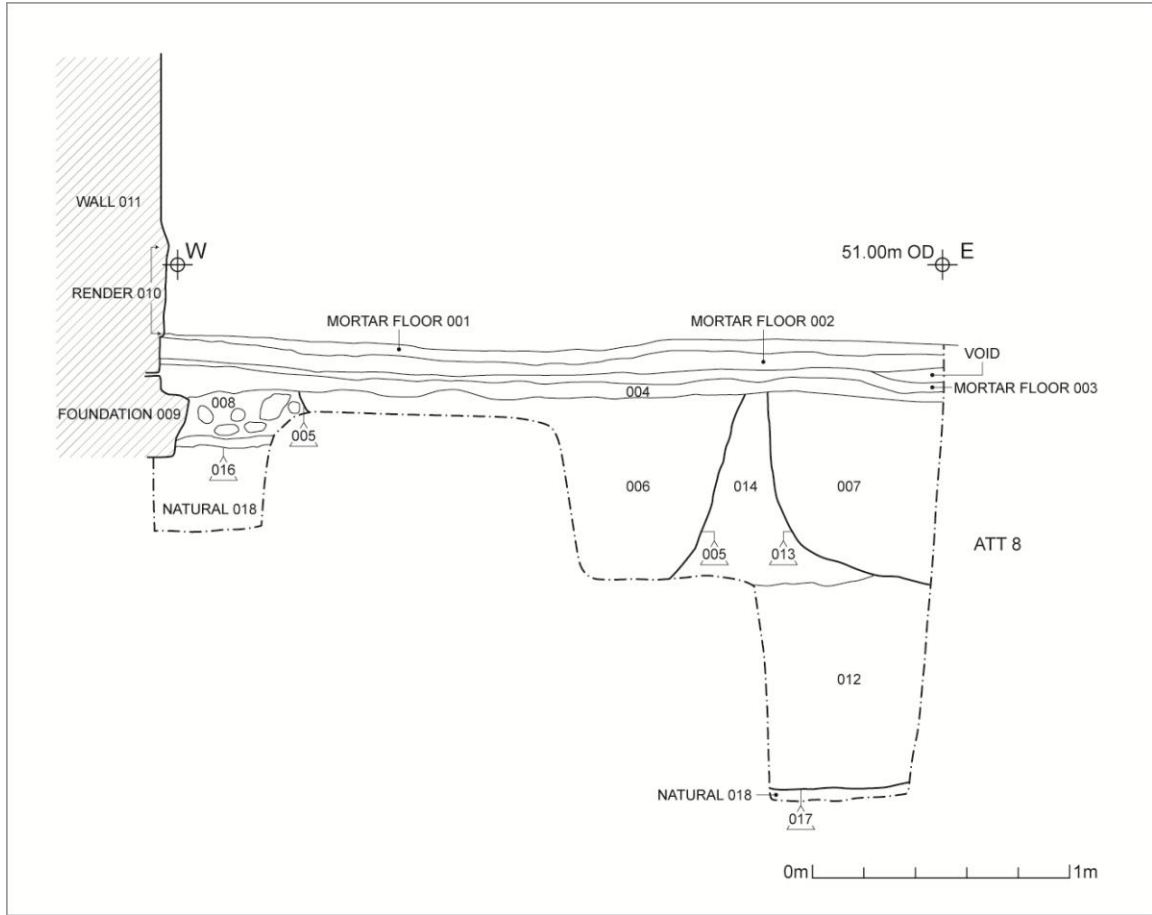
Figure 58: ATT8, south facing section, borrow pits and wall foundation

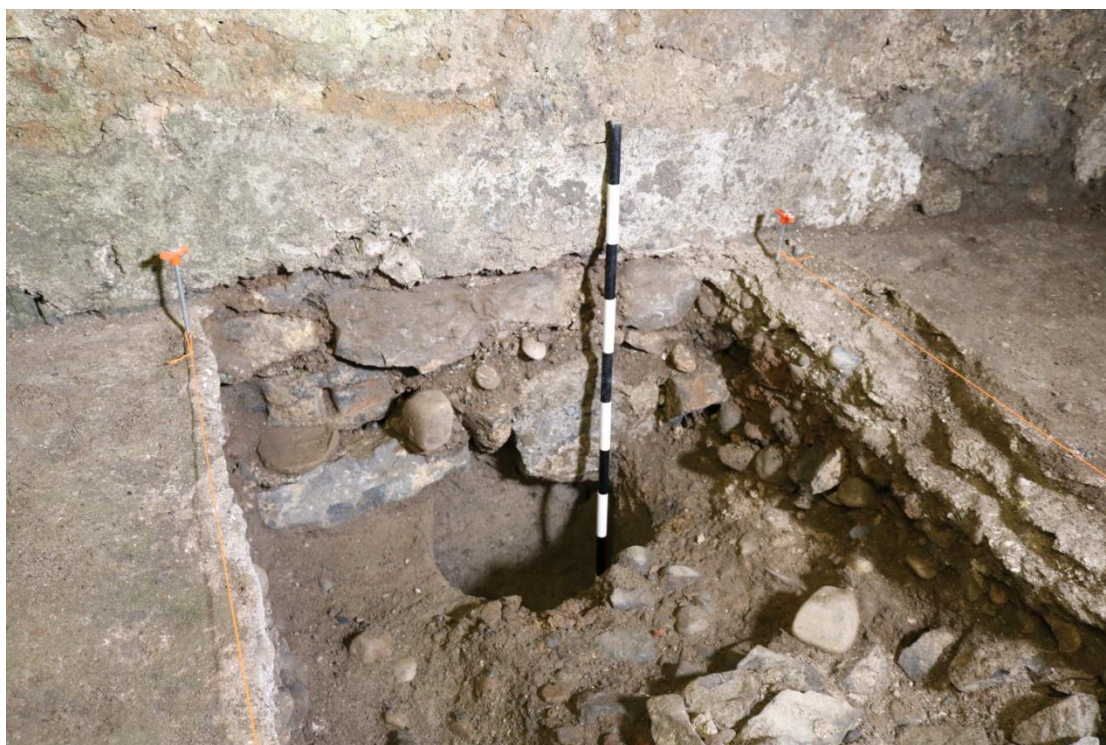
Figure 60: ATT8 sondage excavated at the foundation 009, showing the natural 018 beneath 009, from the southeast.
