ARCHAEOLOGICAL IMPACT ASSESSMENT: PROPOSED RESTRUCTURING AND RENOVATION OF THE THOLSEL (RMP KK019-026061), HIGH STREET/ST MARY'S LANE, KILKENNY

Client: Kilkenny County Council, John Street, Kilkenny
Archaeological Excavation Licence: 18E0413
Detection Device Reference: 18R140
Report Author: C  il  n    Drisceoil MA MIAI

05/12/2018

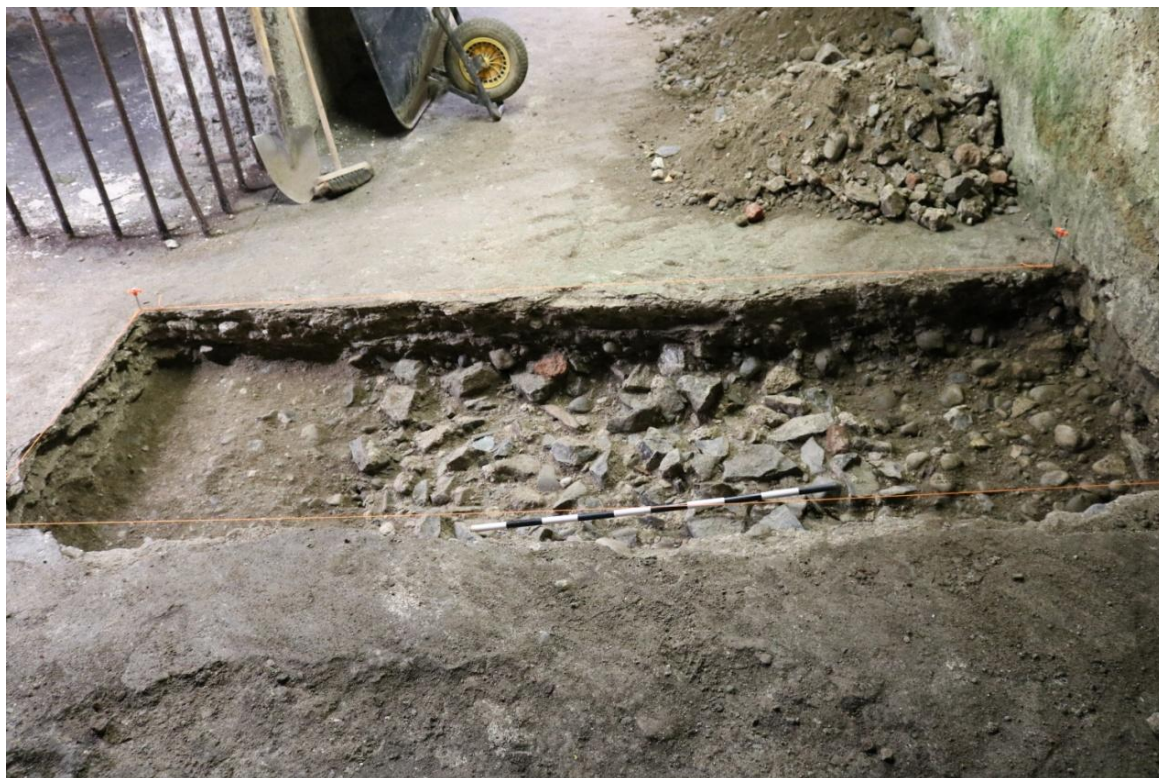
Figure 61: The backfilled borrow pits 005 and 013 in ATT 8, from the north.

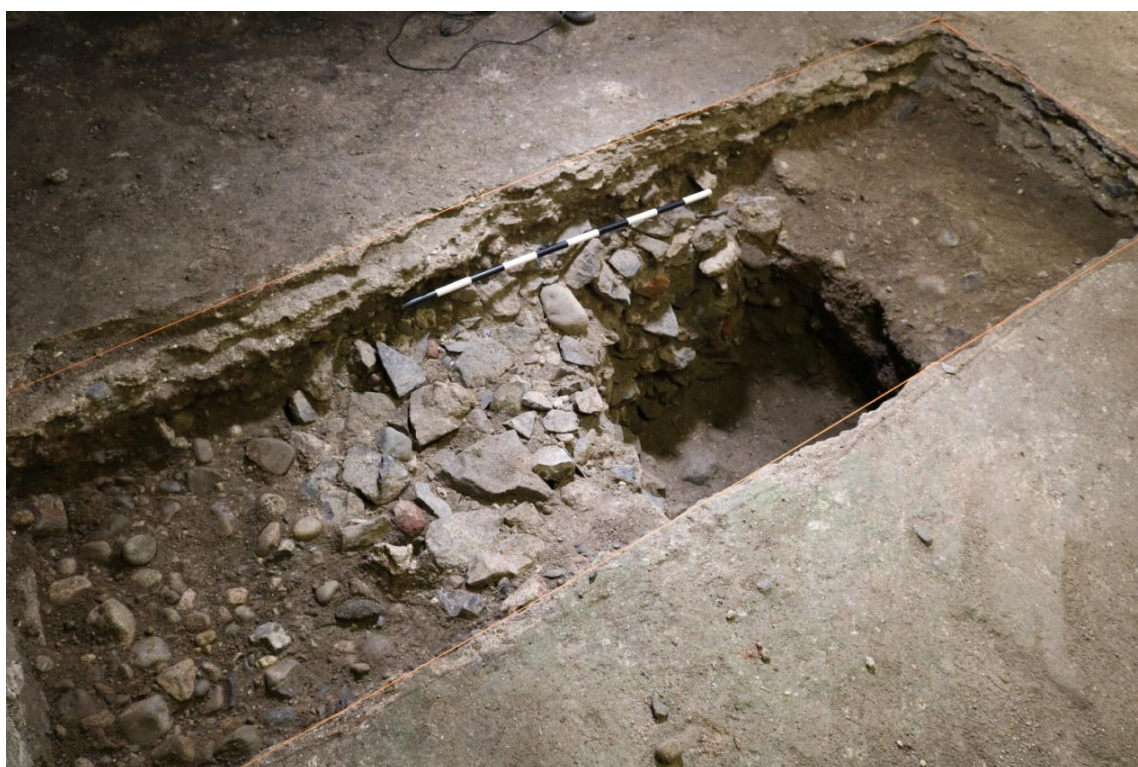
Figure 62: Partially excavated borrow pits 005 and 013, from the southwest.

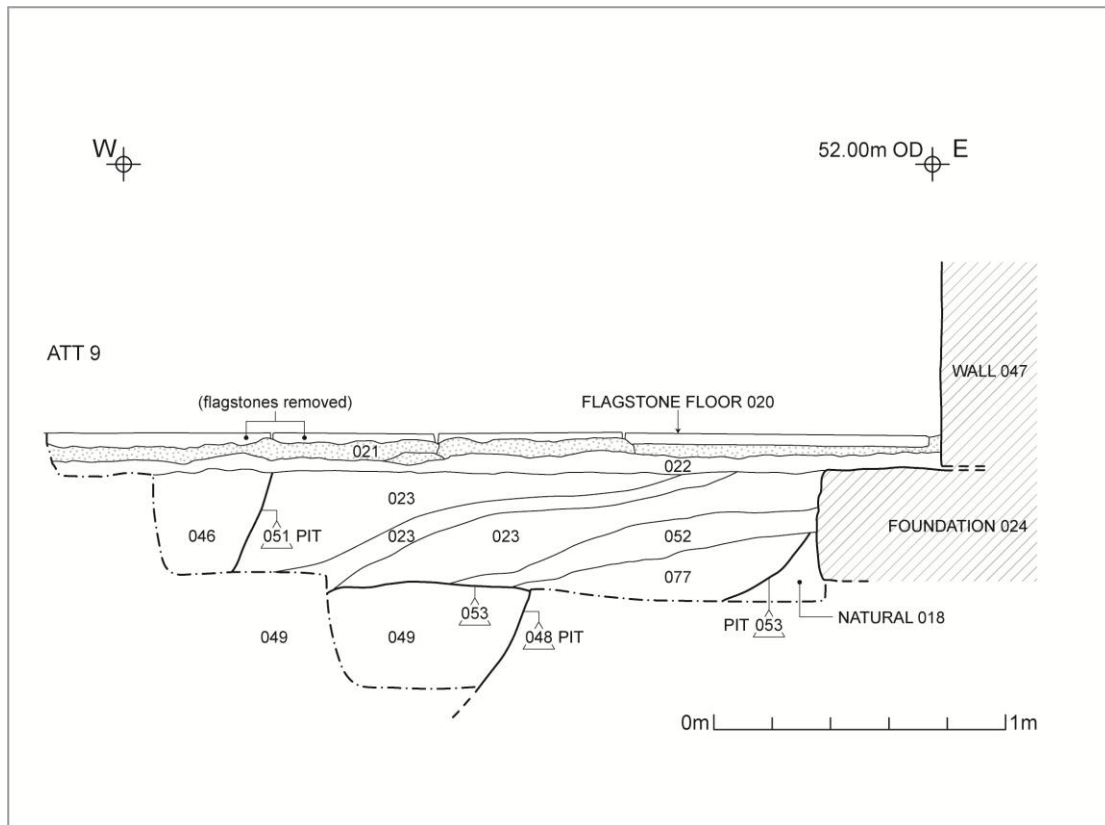
Figure 64: ATT9 south facing section, showing the medieval foundation 024, medieval borrow pits 048 and 053 and flagstone floor 020

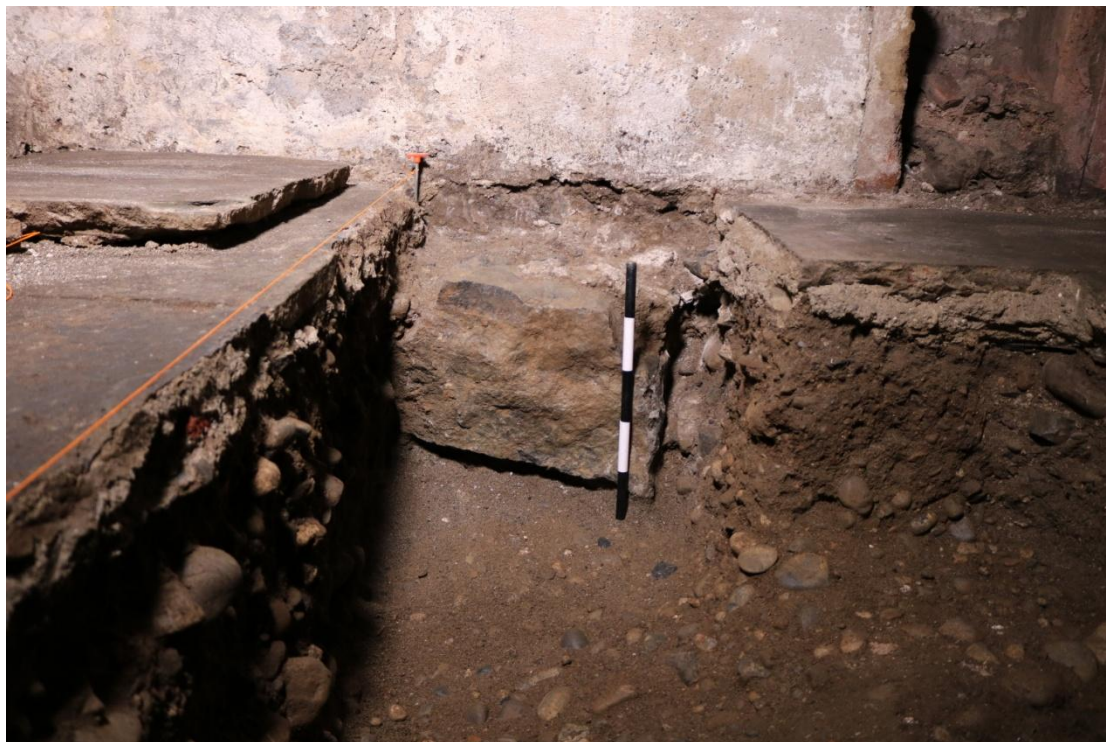
Figure 65: Medieval wall foundation 024 below wall 047 and resting directly on the natural 018, from the west

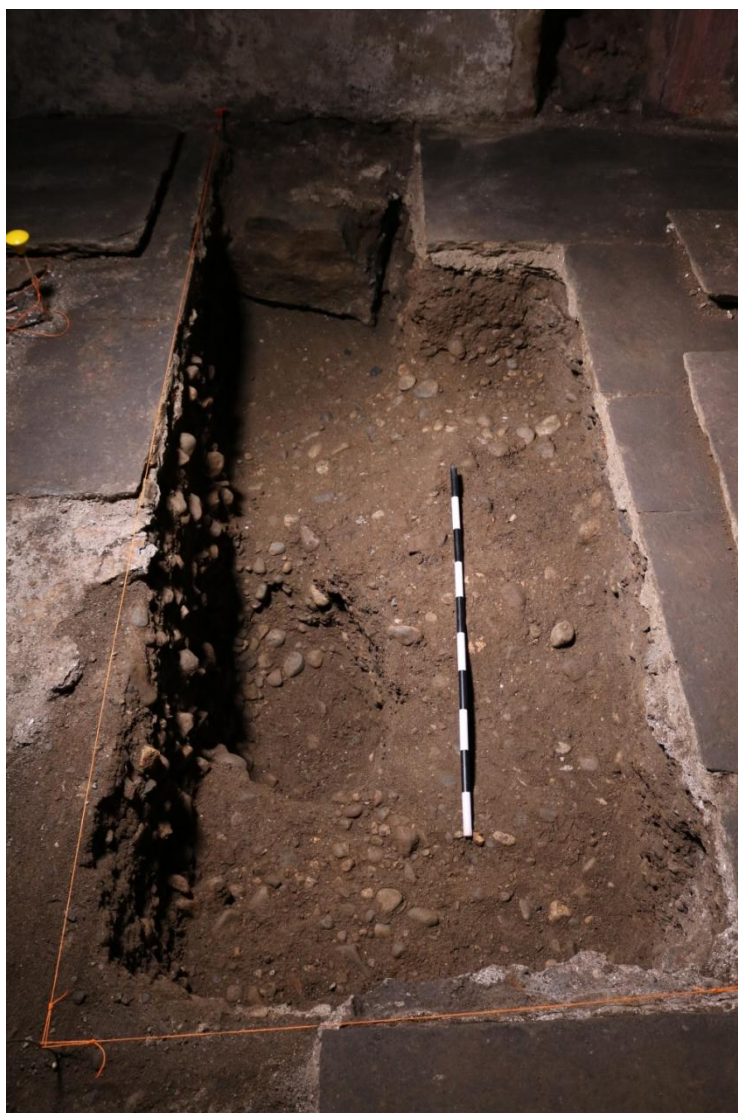
Figure 66: ATT9, sondage into medieval pit 048 and unexcavated pits 053 and 086, from the west

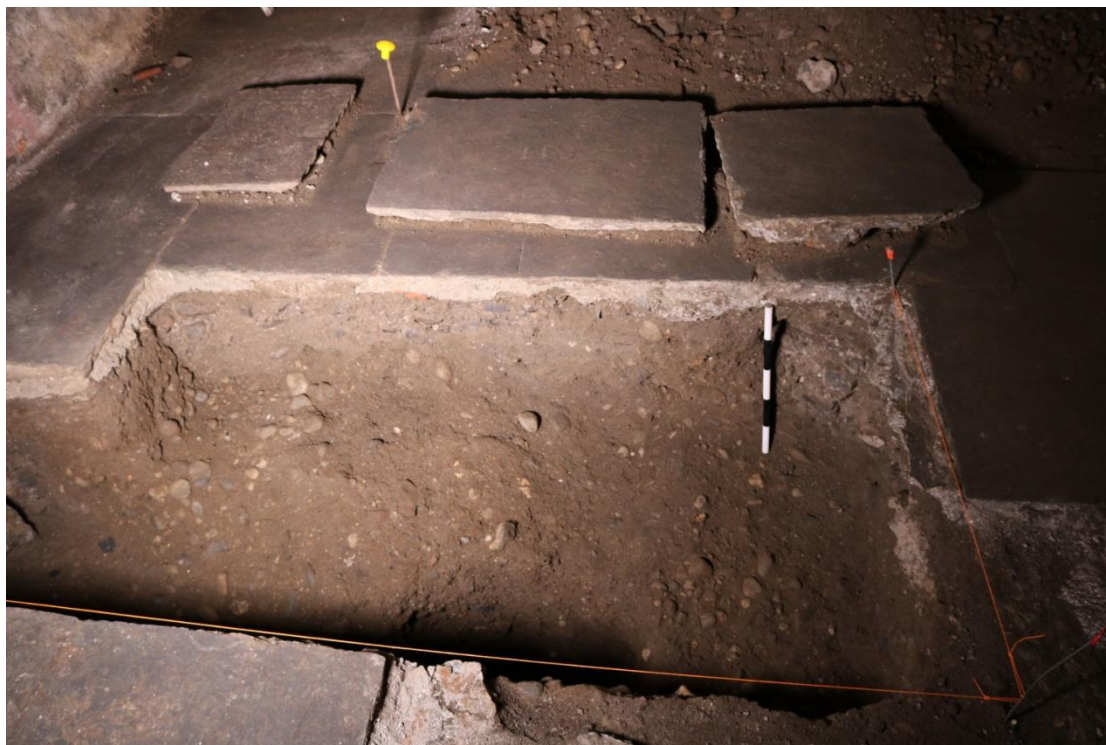
Figure 67: ATT9, post pits 025, 027 and 154 in section, from north

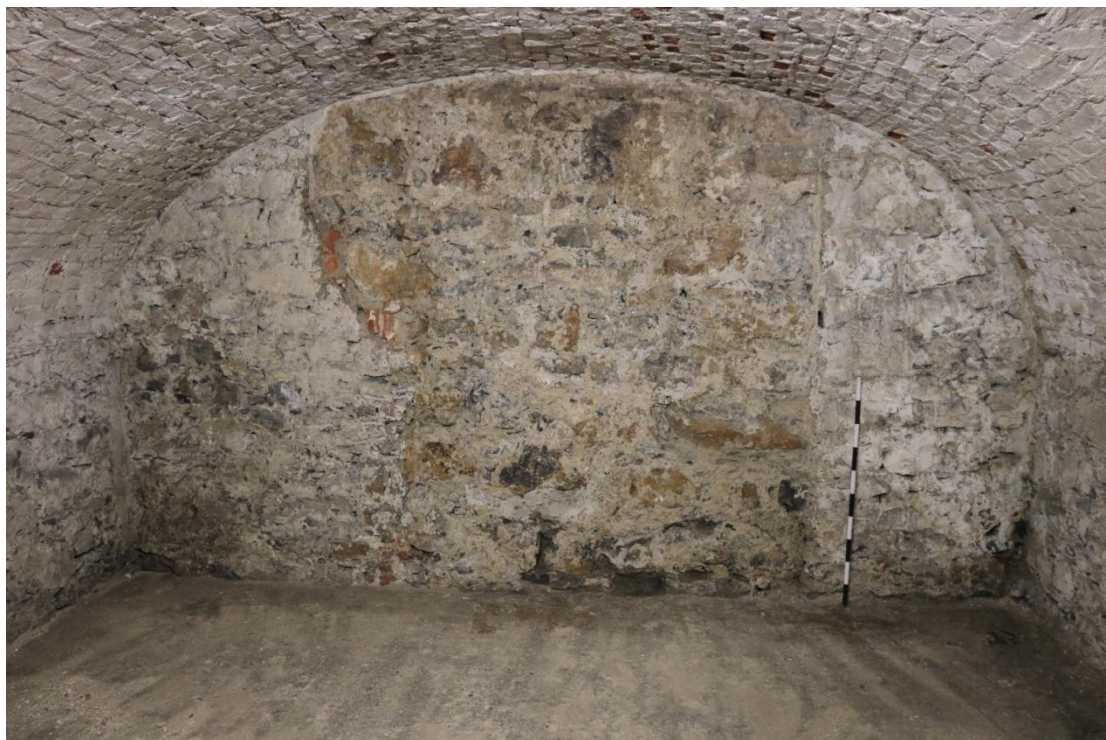
Figure 69: The east wall of the basement in the centre room, showing the wall 159 flanked by the blocking walls 161 and 162, from the west

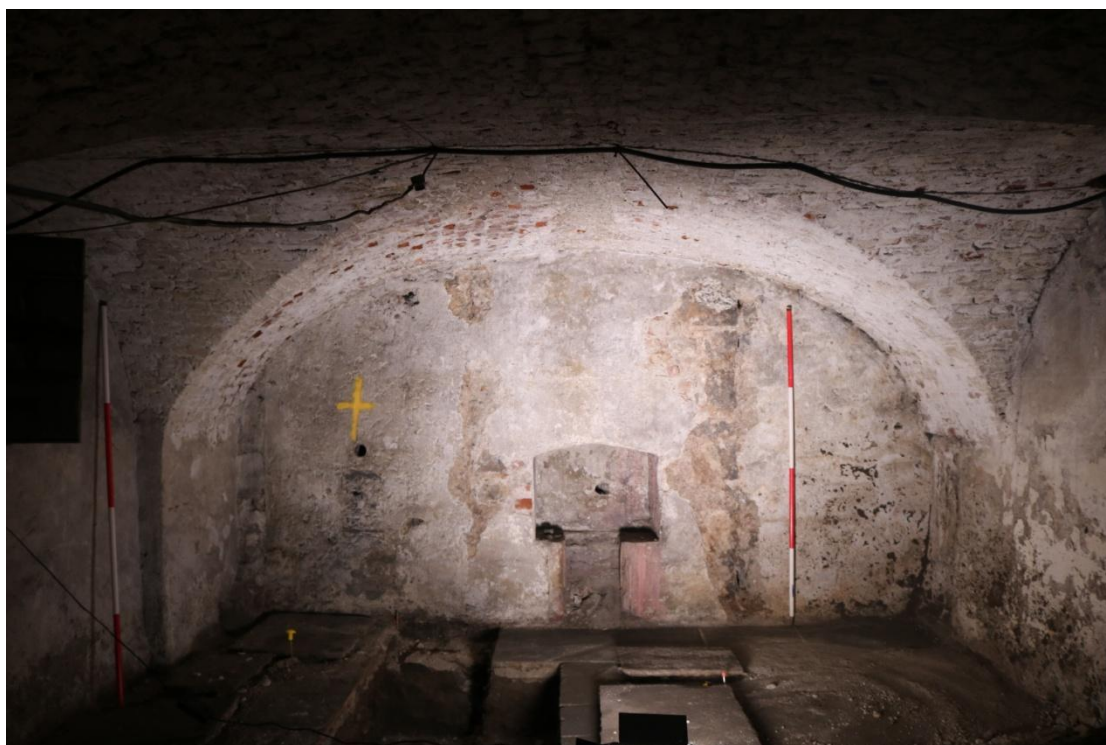
Figure 71: West facing elevation of east basement wall, southernmost bay

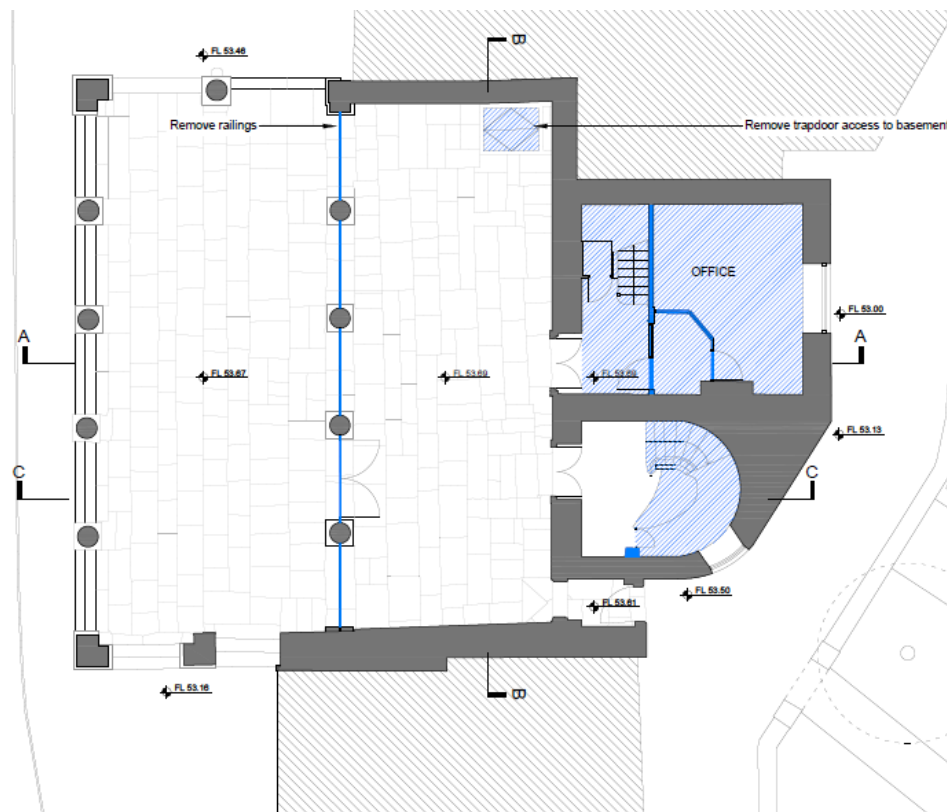
Figure 78: Proposed interventions ground floor (Reddy Architecture and Urbanism)
