Archaeological Impact Assessment of the Redevelopment of the Mayfair Building, Abbey Quarter, Kilkenny

Prepared for Kilkenny County Council
By Dr Richard Clutterbuck

May 2019

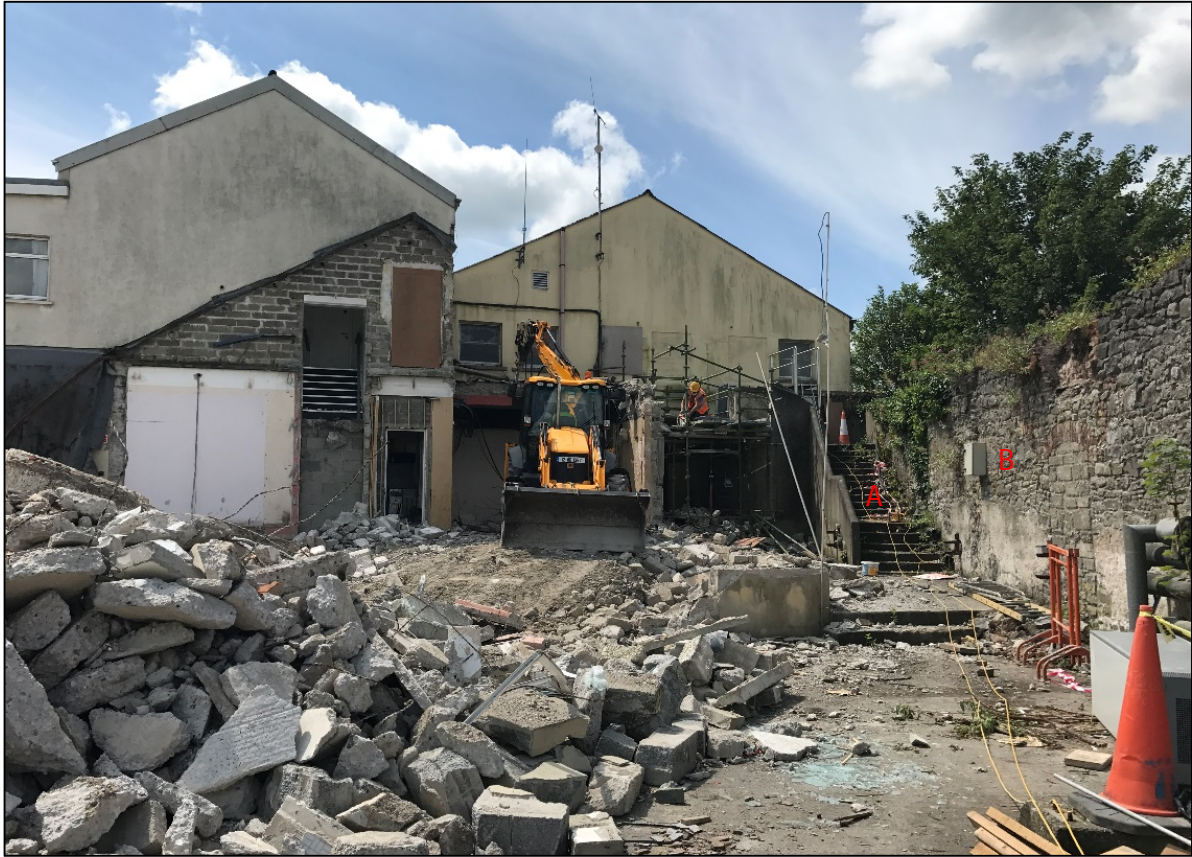
Plate 3: Demolition of eastern portions of the Mayfair Building adjacent to the city wall, looking west in 2017. Note the boiler house and concrete steps remaining *in situ* (A), and the vibration monitor fixed to the wall (B).

In the northeastern corner of the Mayfair Building, a twentieth century single-storey boiler room built of concrete blocks and measuring 16 sq. m abuts the city wall monument, along with contemporary concrete steps used to access a first-floor fire escape and air conditioning unit (Figure 4; Plate 3). As these structures abut the city wall National Monument, they have been retained in the short term to help stabilise the upstanding wall monument.

4. The demolition of a modern concrete boiler house and concrete steps (c.60 sq. m). will impact the upstanding remains of the city wall National Monument. Specifically the walls consist of portions of an eighteenth and nineteenth century Horse Barracks building (features 45 and 46 in **Error! Reference source not found.** and **Error! Reference source not found.**), which form part of the city wall National Monument, with demolition removing modern concrete elements (features 44, 74 and 75 in **Error! Reference source not found.** and **Error! Reference source not found.**), which also potentially act as support for the older masonry structure of city wall National Monument (AMS 2018).

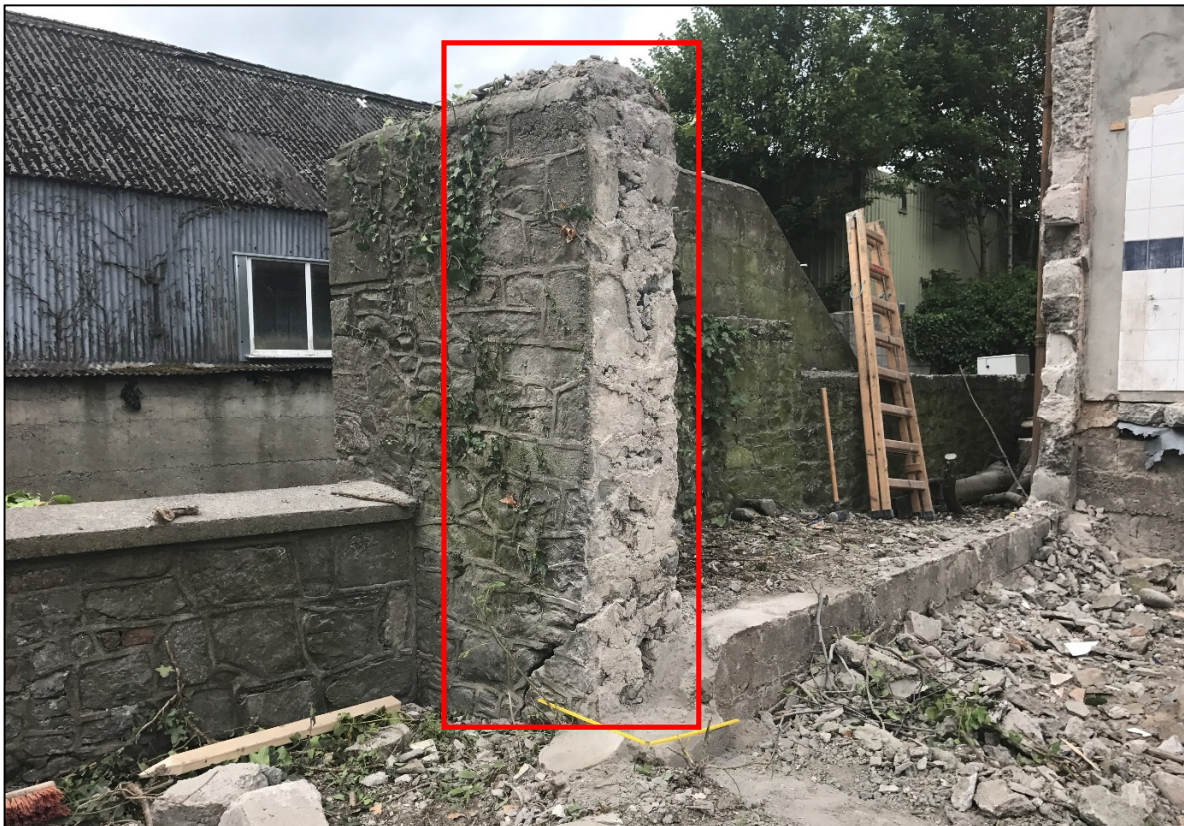
Plate 5: Projecting section of wall (Feature 67 in Appendix 2 and Figure 26) to be removed (red outline)

7. The short 1m section of masonry wall projecting from the city wall (feature 67 in Appendix 2, and Figure 26) to be removed should be taken down by hand following a methodology agreed with the project's Conservation Engineer and under the supervision of the project's monitoring archaeologist, and the stone retained for use to repair the city wall National Monument.

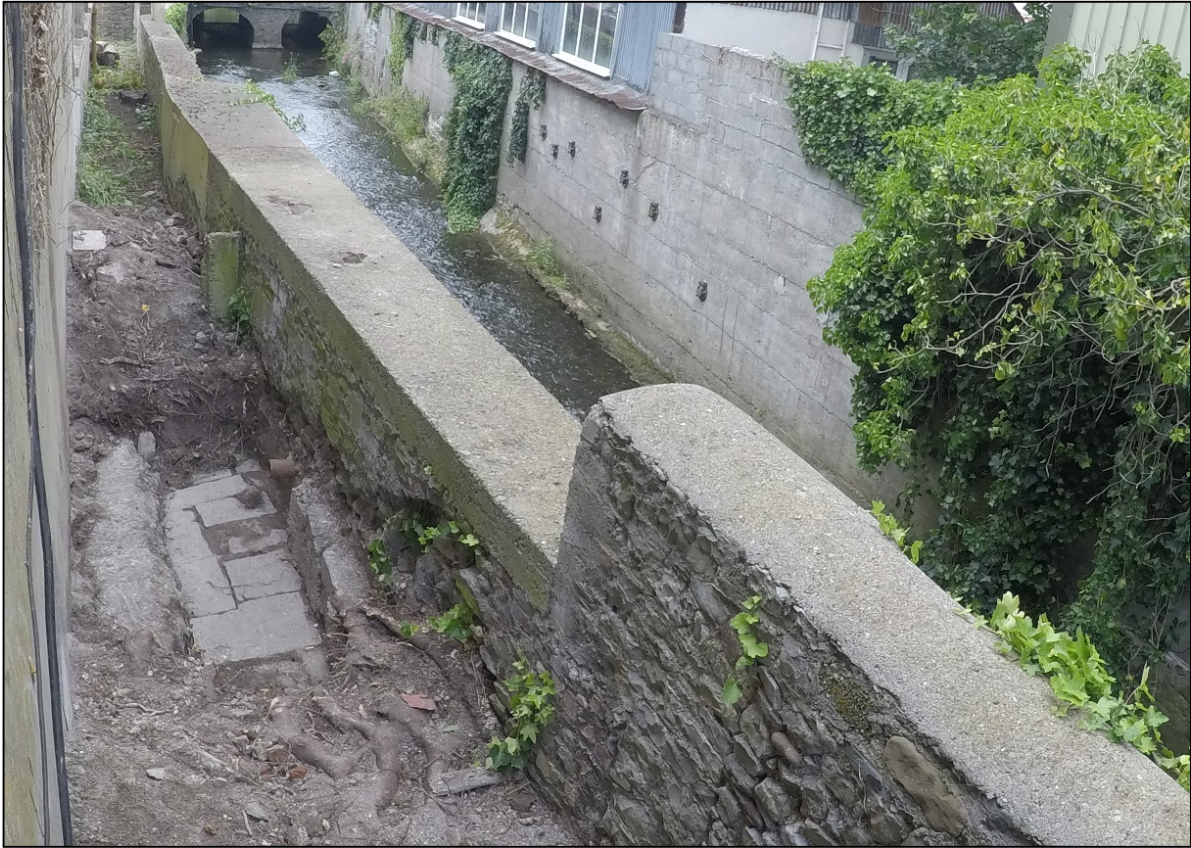
Plate 6: ACSU Test Trench 10:2, looking west, along the narrow space between the Mayfair Building and the city wall National Monument

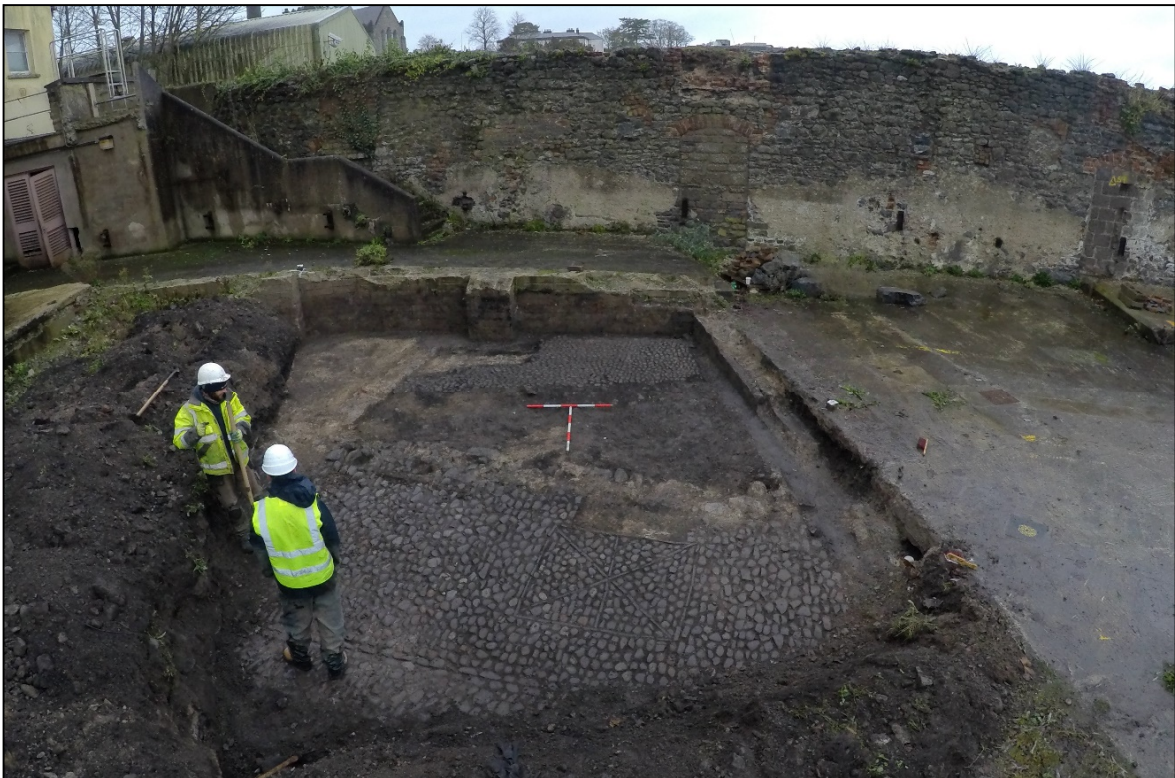
Plate 7: Cobble surfaces and walls of the Horse Barracks exposed by AMS in late 2018

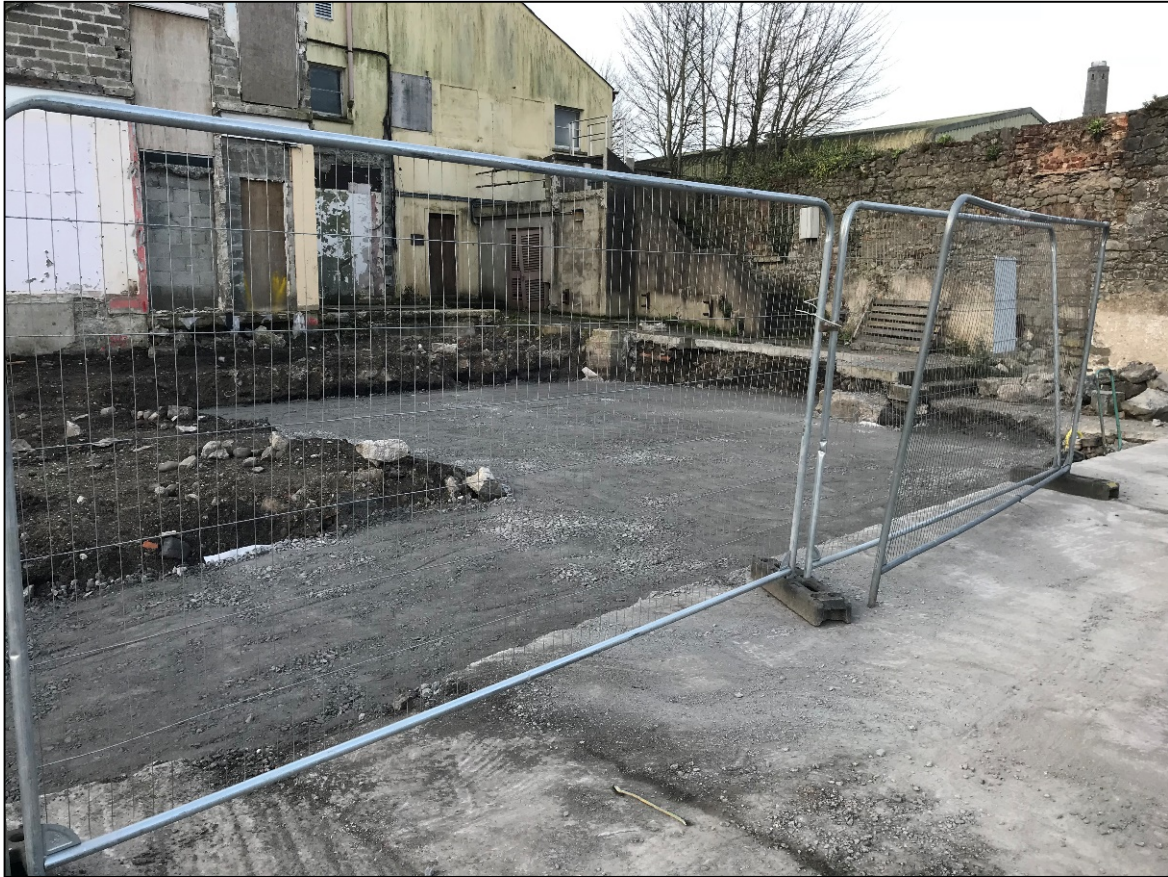
Plate 8: Area of the ESB substation and switching room excavated by Colm Flynn, 2019

Further works involving the expansion of the area for the ESB substation,⁷ and excavation of a 100m service trench to the ESB substation were undertaken by Colm Flynn in 2019, under the further extension to Ministerial Consent (C789; E4822) (Flynn 2019) (Figure 13). In the area of the ESB substation Flynn's work further exposed the cobbling and several masonry walls identified by ACSU and AMS. In addition, the articulated remains of a bovine were discovered in a pit post-dating the Horse Barracks building (Figure 18). The cobbling and masonry walls were recorded and preserved *in situ* beneath the level of the ESB substation (Plate 8).

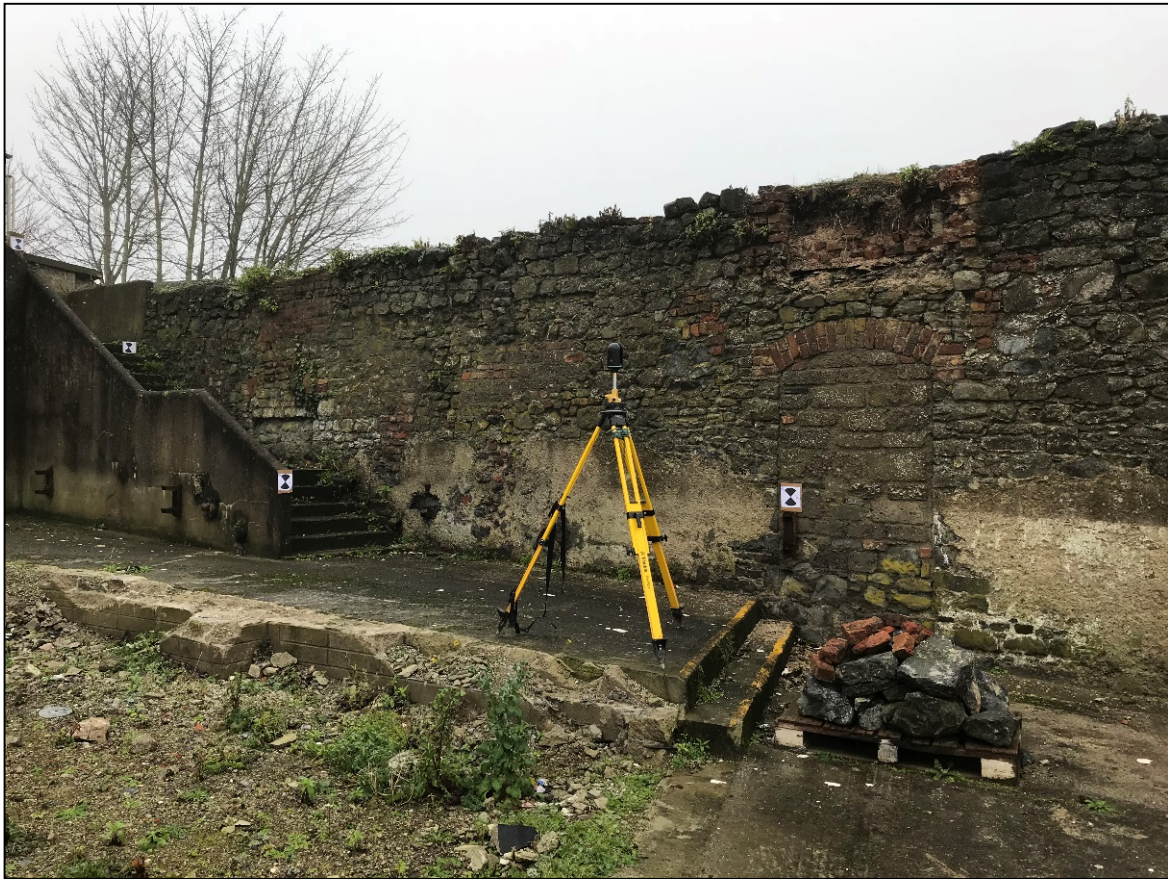
Plate 9 Laser scan of the city wall in progress

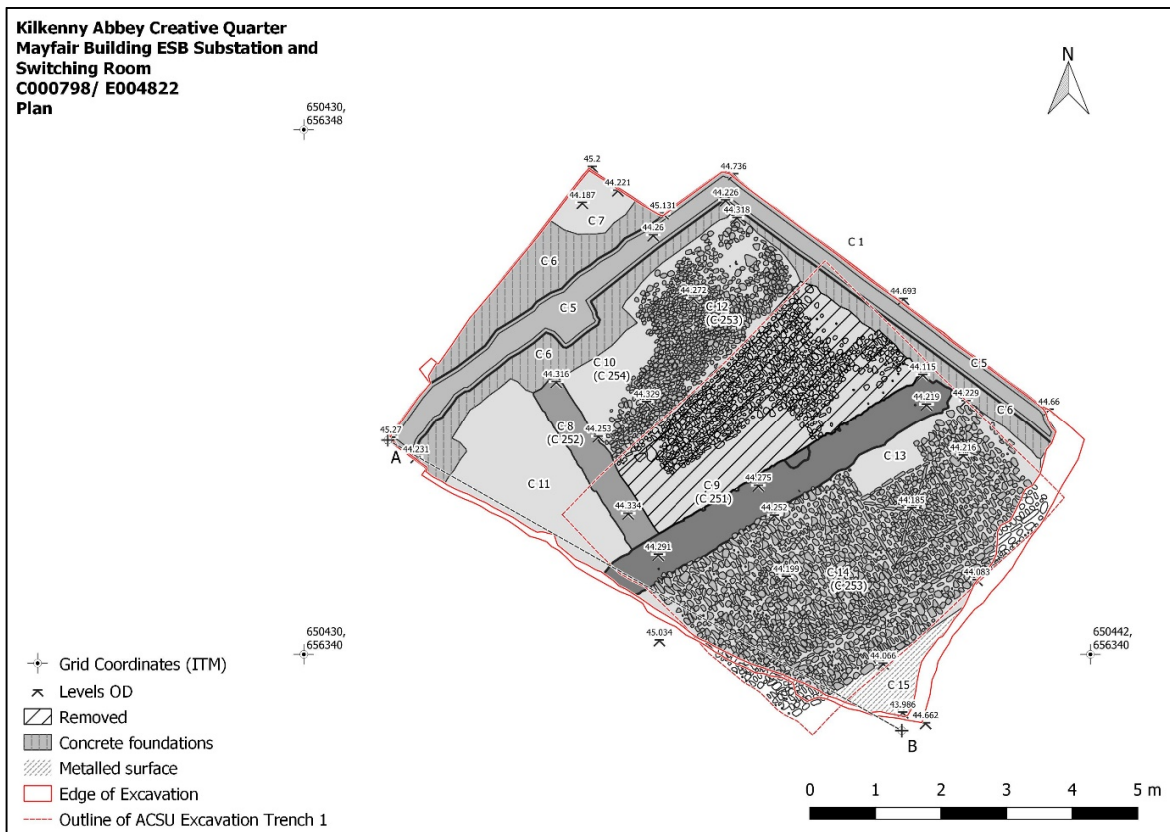
Figure 16: AMS excavation of the footprint of the ESB substation, December 2018 (AMS 2019)

Phase 1 corresponds with the medieval and early modern cemetery found during ACSU's test excavations, and most likely part of the cemetery attached to St Francis' Abbey. This cemetery will be preserved *in situ* and has not been excavated for this project.

Phase 2 consisted of the remains of the Horse Barracks building constructed c.1700. A large external wall of roughly coursed masonry running NE-SW, 0.60m wide and exposed for a length of 5.80m within the excavation area. ACSU confirmed that the foundation of this wall is c.1.55m deep. This wall represents the southern exterior wall of the Horse Barracks, making the Horse Barracks building c.8.5m wide. A perpendicular interior wall abuts the external wall and is narrower (0.45m wide). It is exposed for a length of c.2.82m and was also found by ACSU to be 1.55m deep. This wall divides the interior of the Horse Barracks into rooms or chambers. The interior ground-floor surface consisted of mortar layers, and in one interior, room cobbles. The immediate exterior of the Horse Barracks building also had a mortar and cobble stone surface in a band c.2.8m wide, with a rectangular motif in the cobbles opposite the building's threshold. These external cobbles were laid at a slight slope from the Horse Barracks' wall, sloping to a narrow rainwater gully in the cobbles, 0.36m wide and c.0.5m deep. Beyond the exterior cobbles, a metalled surface appears to have been a yard for the Horse Barracks. This archaeology will be preserved *in situ* and has not been excavated for this project.

Phase 3 consisted of the demolition and removal of the Horse Barracks building and its replacement with made ground sometime after c.1900 (the last time the building walls were depicted on an Ordnance Survey map). The remains of the former Horse Barracks building were removed except that portion of the building fronting onto the Breaghagh River, now part of the city wall National Monument (AMS 2018). Following this demolition, a layer of dark friable cinder material and slag waste was deposited over the former Horse Barracks site.

Phase 4, the final phase, consisted of the construction of a concrete extension to the Mayfair Building following the purchase of the Mayfair Ballroom site by Diageo in c.1970.

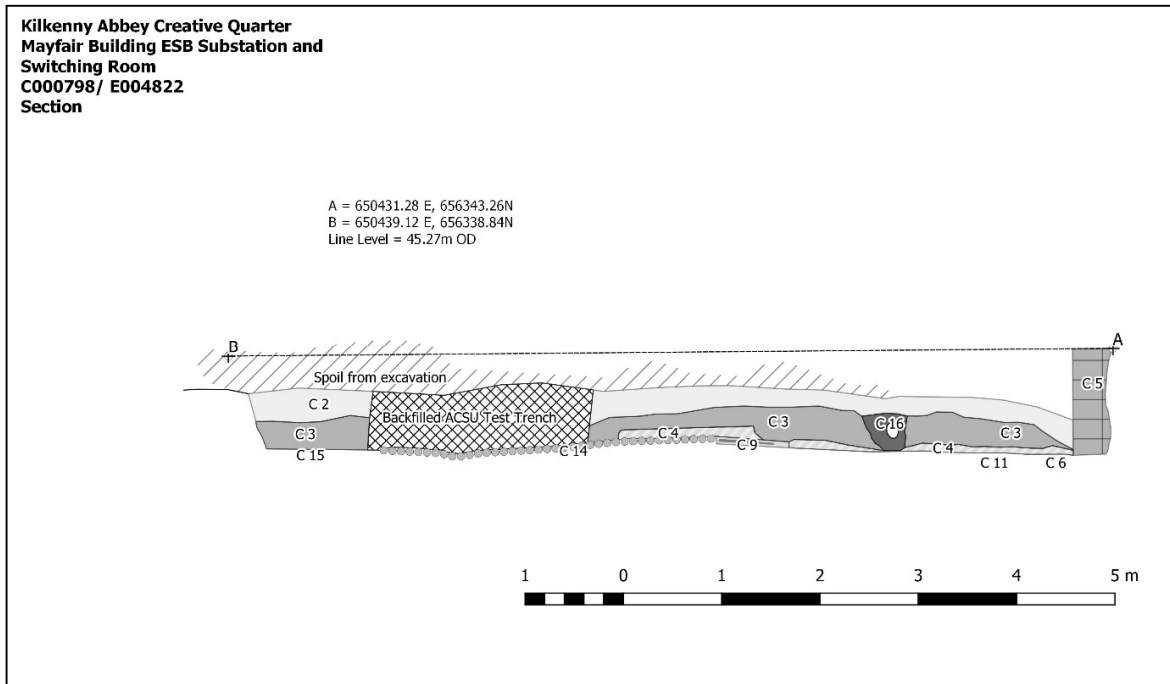
Figure 17: AMS ESB substation excavation section (AMS 2019)

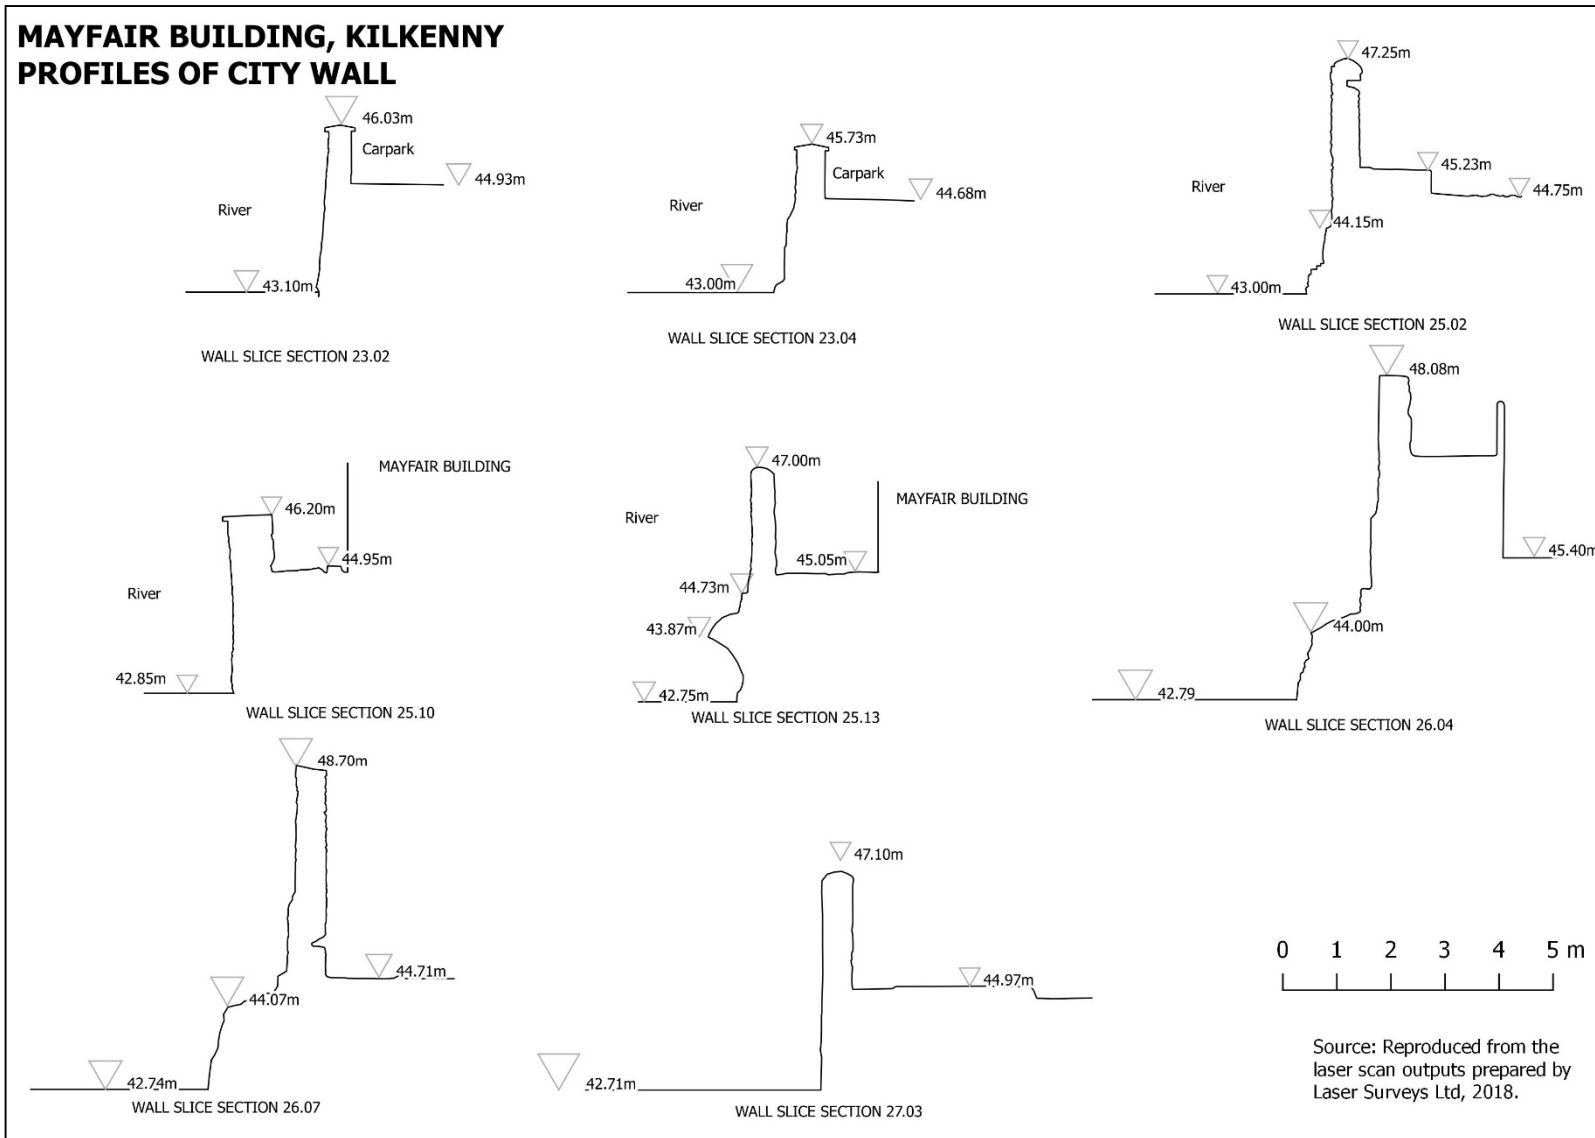
Figure 21: Profiles of the city wall generated from the laser scan survey (AMS 2018); see Figure 20 for locations of these profiles

In 2017 and 2018 AMS undertook an archaeological assessment of a 90m section of Kilkenny city wall adjacent to the Mayfair Building development (AMS 2018). This included a laser scan survey carried out by Kieran O'Shea of Laser Surveys, in December 2017 and January 2018 using a Leica P40 scanner and a Leica BLK 360 scanner, with a Trimble S6 Total Station and Trimble Dual Frequency GPS receivers used to insert ground control points (Plate 9 **Error! Reference source not found.**). The laser survey captured both the river side (A) and the land side (B) of the city wall. A photogrammetry survey of the city wall was also undertaken, which combined with the laser survey and CAD elevations, was used to produce interpreted elevations (Figure 19). The laser survey was also used to produce accurate sections through the city wall (Figure 20).
