Eirspan TO 302 N78 Castlecomer Footbridge Options Report

CASTLECOMER FOOTBRIDGE

Options Report

MCT0759RP0003
Eirspan TO 302 - N78
Castlecomer Footbridge
A02
02 July 2019

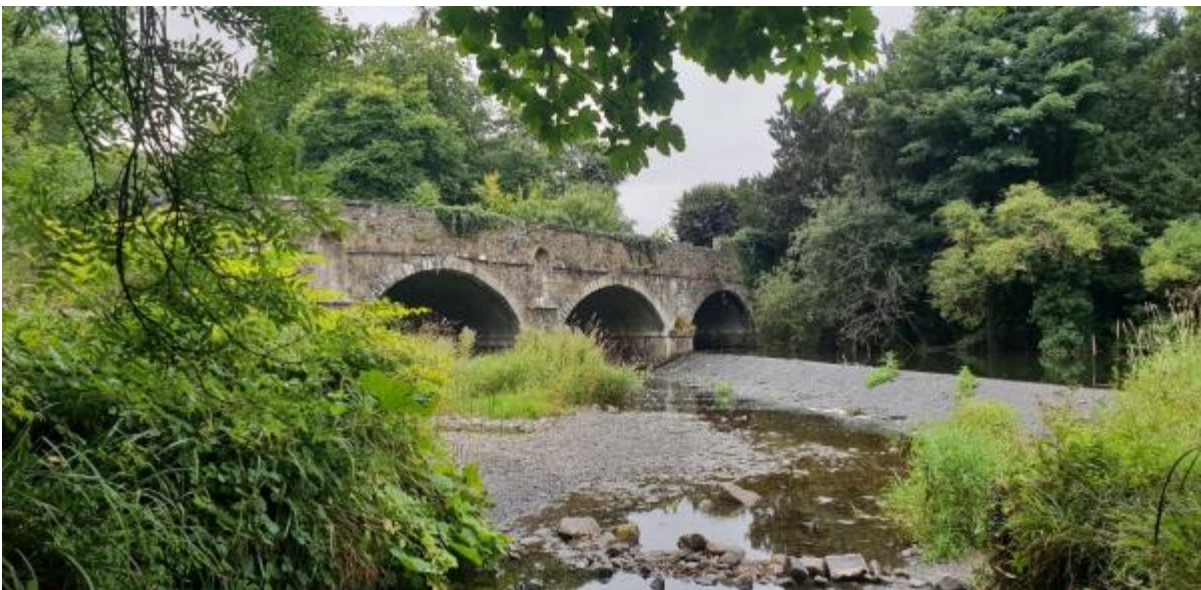
Figure 1-1: Elevation of North Side of existing N78 Castlecomer Bridge from Castlecomer Discovery Park

The existing River Dinin Bridge was constructed in 1767 and it is approximately 6.7m wide between parapets (see Figure 1-1 & 1-2). It caters for both vehicular and pedestrian traffic movements on the N78. As the bridge was constructed in 18th Century it was never intended to cater for modern vehicular traffic consequently the existing bridge is too narrow to cater for a safe modern road cross section complete with footway.

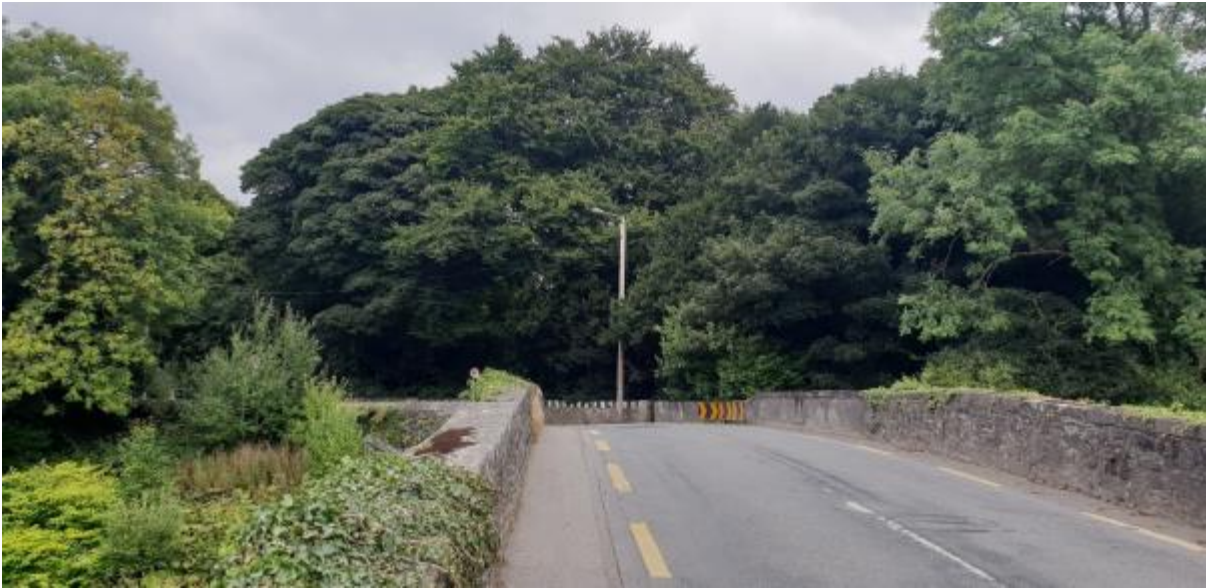
Figure 1-2: View Eastwards along existing N78 Carriageway crossing the Castlecomer Bridge

There is only one footpath on the existing bridge which is sub-standard and varies 650-900mm in width. It is hazardous for both road users and pedestrians particularly on the east end of the bridge where the turning movements of HGV's encroach on the footway due to the tight bend in the road. In order to improve safety at the location KCC intend to remove pedestrians from the existing bridge and provide a new dedicated facility for pedestrians to cross the Dinin.

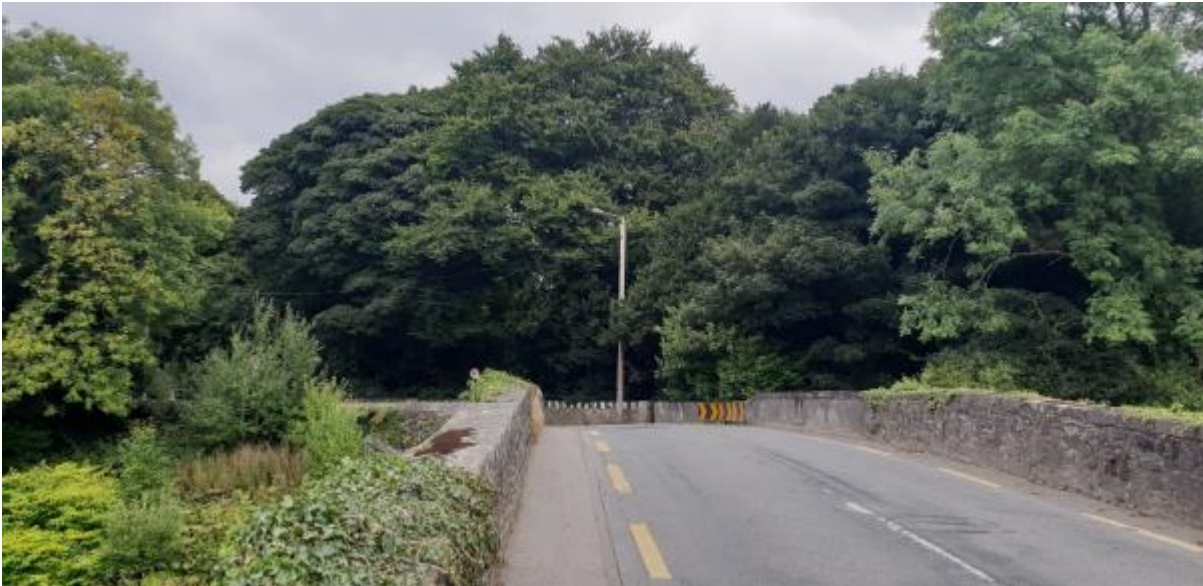
Figure 2-1: View Eastwards along existing N78 Carriageway crossing the Castlecomer Bridge

The existing N78 road bridge is the primary impediment to the provision of a safe pedestrian link across the River Dinin. The existing bridge is narrow, being only 6.7m wide between inside face of parapets. The absolute minimum width required for a new road bridge to current standards with a footway one side is 9.4m. This would consist of a 7m carriageway, 1.8m footpath and 0.6m raised verge, although it would likely be well in excess of this in reality. Consequently, it is evident that as the current bridge does not provide an adequate vehicular cross section and any improved pedestrian link will need to be provided outside the envelope of the existing bridge.

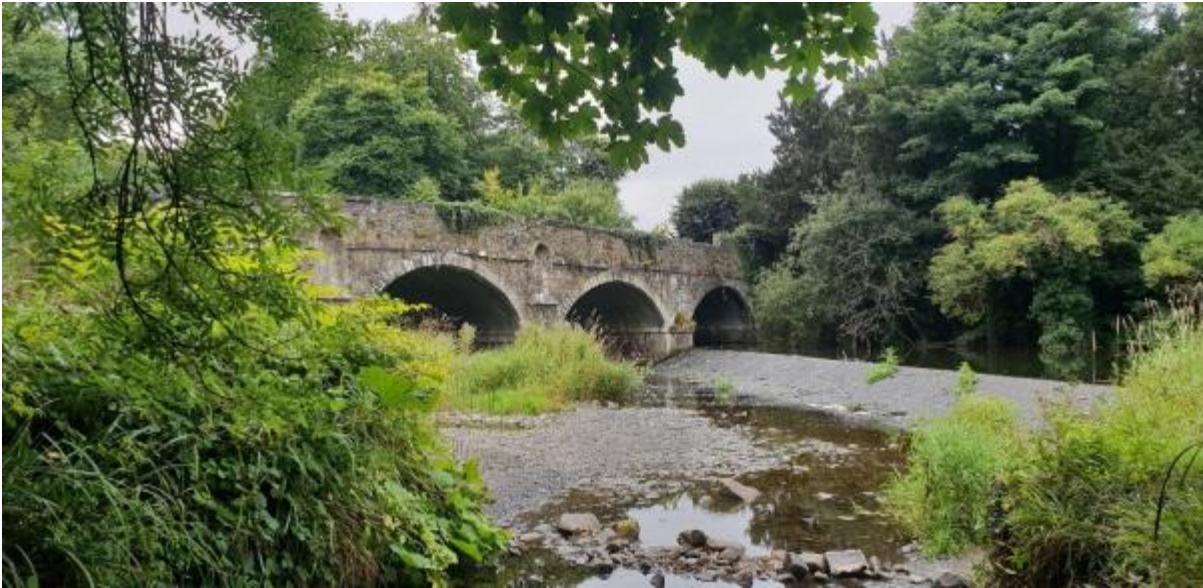
Figure 2-2: River Dinin

The existing watercourse provides a significant physical constraint due to the width of the watercourse, the presence of the weir and that the site is located at the confluence of the Dinin and one of its tributaries. The combination of these factors is a particular issue for an independent bridge as it constrains the locations where the new bridge can be supported.

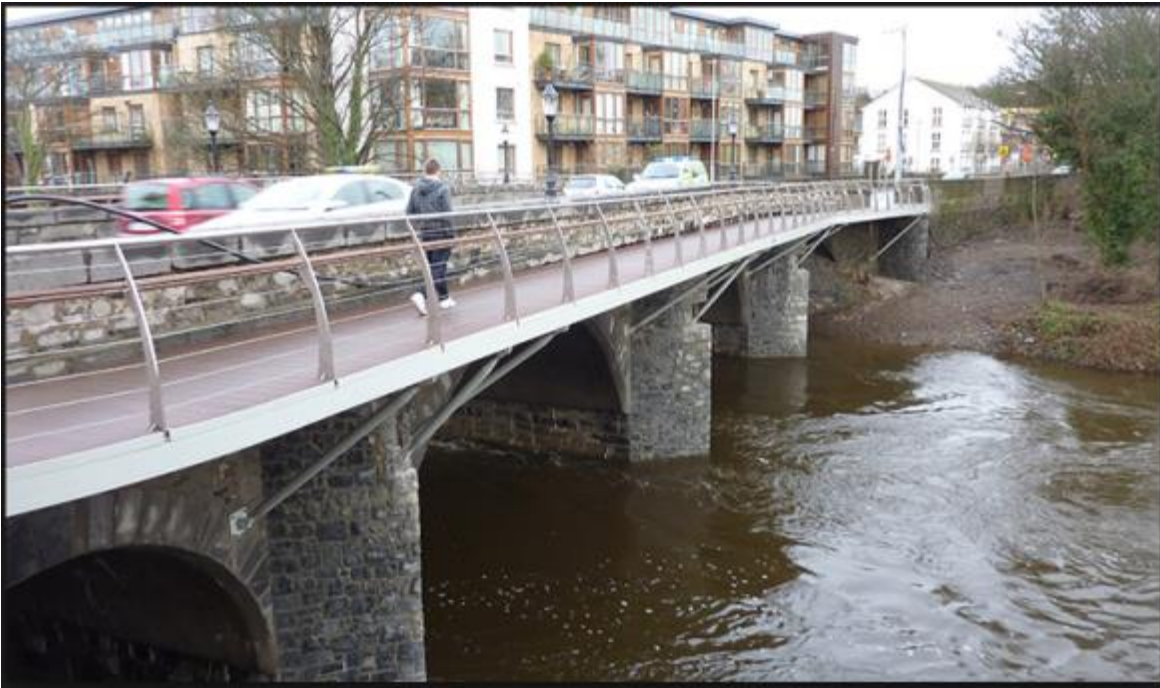
Figure 3-1: Anna Liva Bridge, Dublin [Image copyright Roughan O'Donovan Ltd.]

This option would entail the provision of a new cantilever structure (supported by struts) attached to the existing bridge to provide the proposed pedestrian link. This solution has been used on numerous occasions in Ireland, examples are outlined below in Figures 3-1 and 3-2. This option would potentially require works across the existing carriageway to provide a dead-end anchor or tie bar to restrain the walkway along the elevation of the bridge.

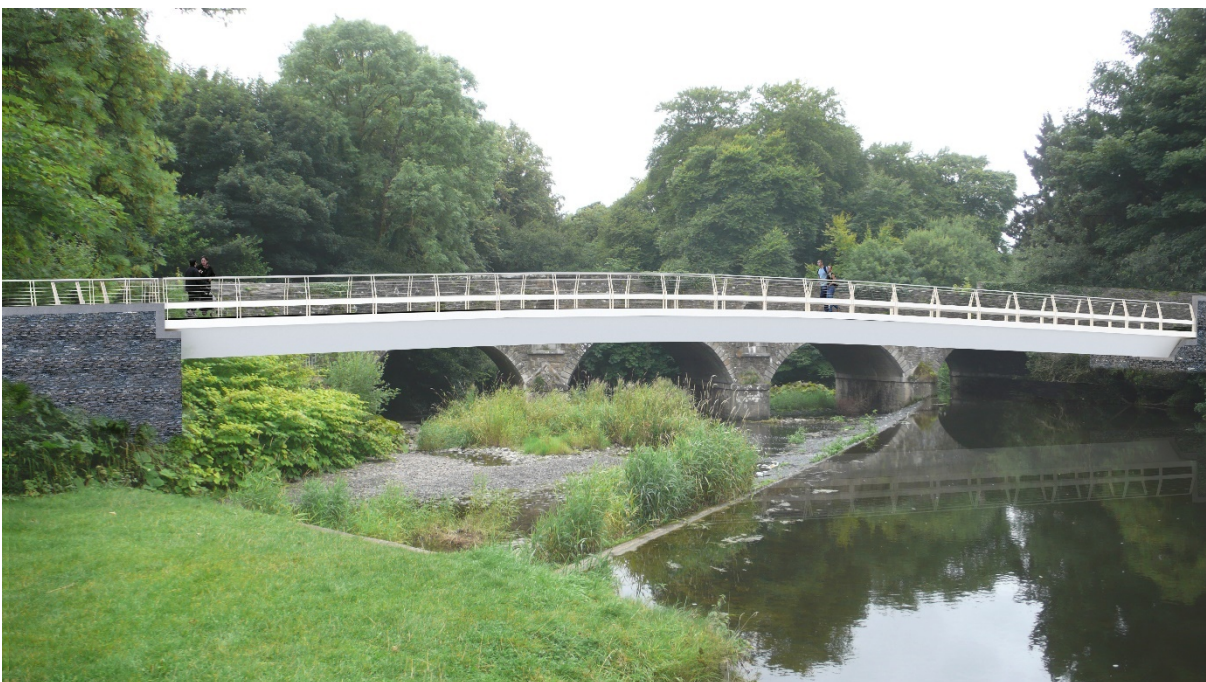
Figure 3-4: Option 2 – Single Span Steel Box Girder Footbridge Photomontage

The single span steel box girder footbridge option represents a feasible option with an uncomplicated structure which maintains views of the masonry arches of the existing masonry arches from Castlecomer Discovery Park. The bridge has a significant structural depth due to the long span and to ensure it satisfies dynamic performance requirements.

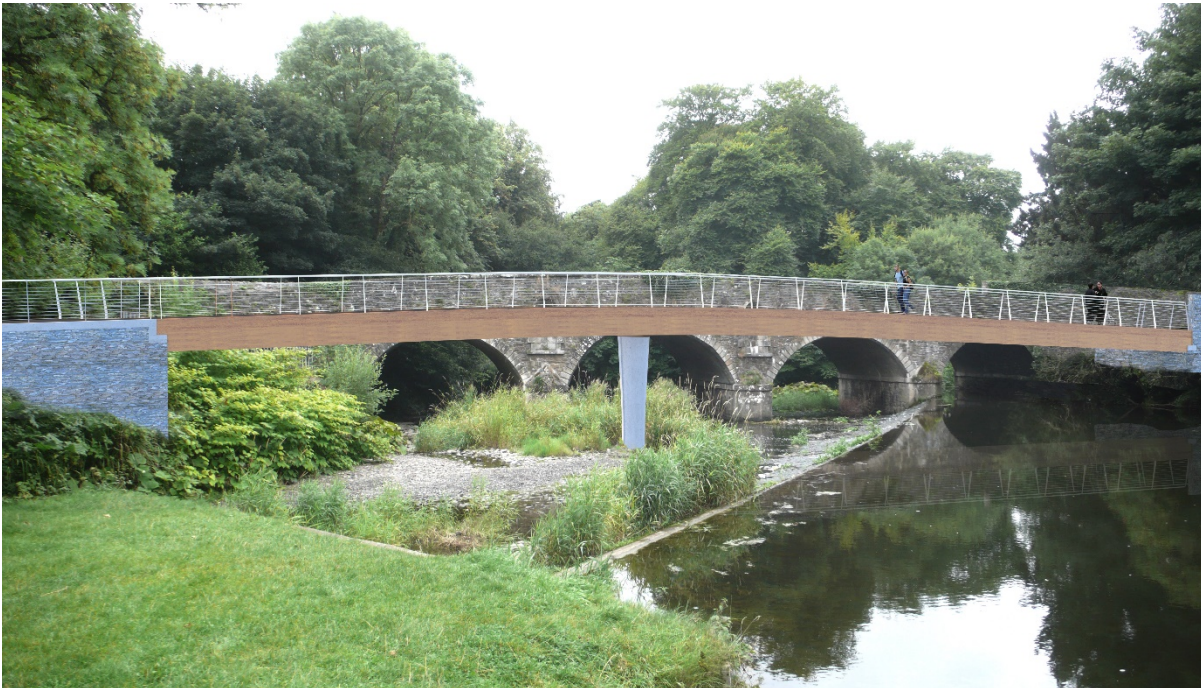
Figure 3-5: Option 3 – Two Span Timber Glulam Footbridge Photomontage

A two-span timber glulam beam footbridge presents another feasible option. The pier location will be aligned with one of the existing piers of the masonry arch bridge to minimise the hydraulic impact of the new structure. It will also help to preserve the clear spans between the arches. The eastern and western spans will be approximately 19 and 28m respectively. A two-span bridge with an intermediate support allows for a reduced structural depth which in turn reduces the visual footprint of the structure on elevation, albeit the provision of the pier will impinge on the view of the existing bridge.

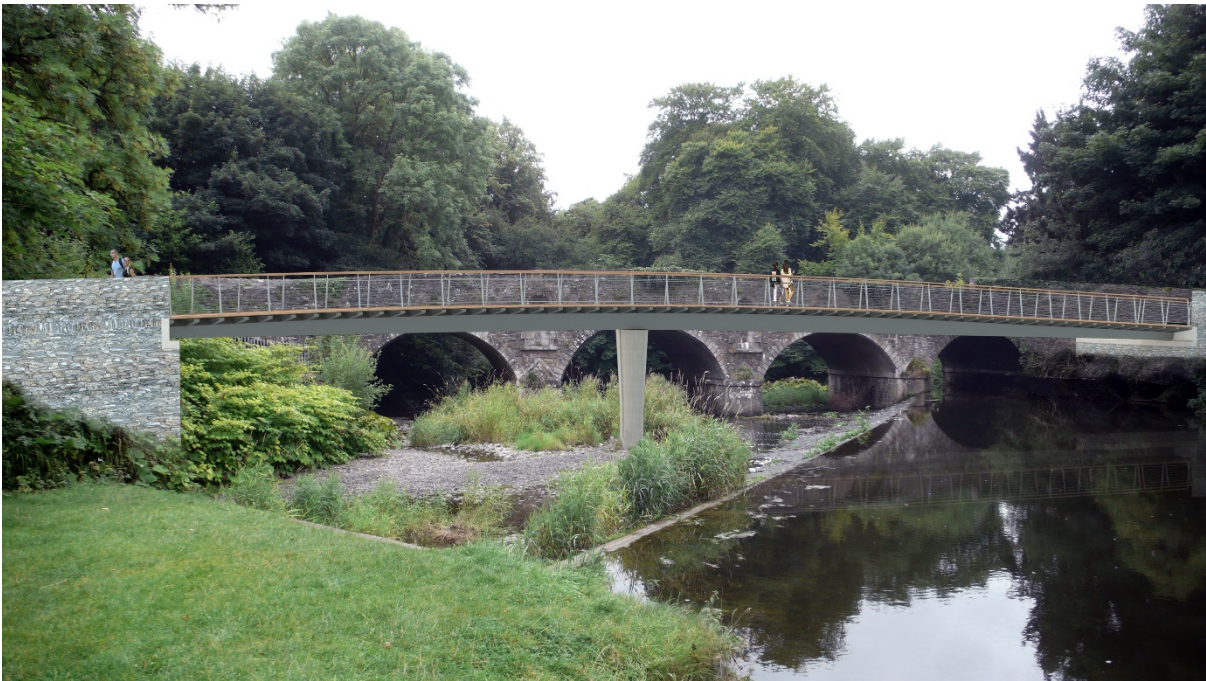
Figure 3-6: Option 4 – Two Span Steel Box Girder Footbridge Photomontage

The two-span steel box girder footbridge presents similar attributes to the two-span glulam bridge. However, as steel has a much higher strength to weight ratio than timber, the structural depth can be reduced further resulting in a smaller visual footprint on elevation.

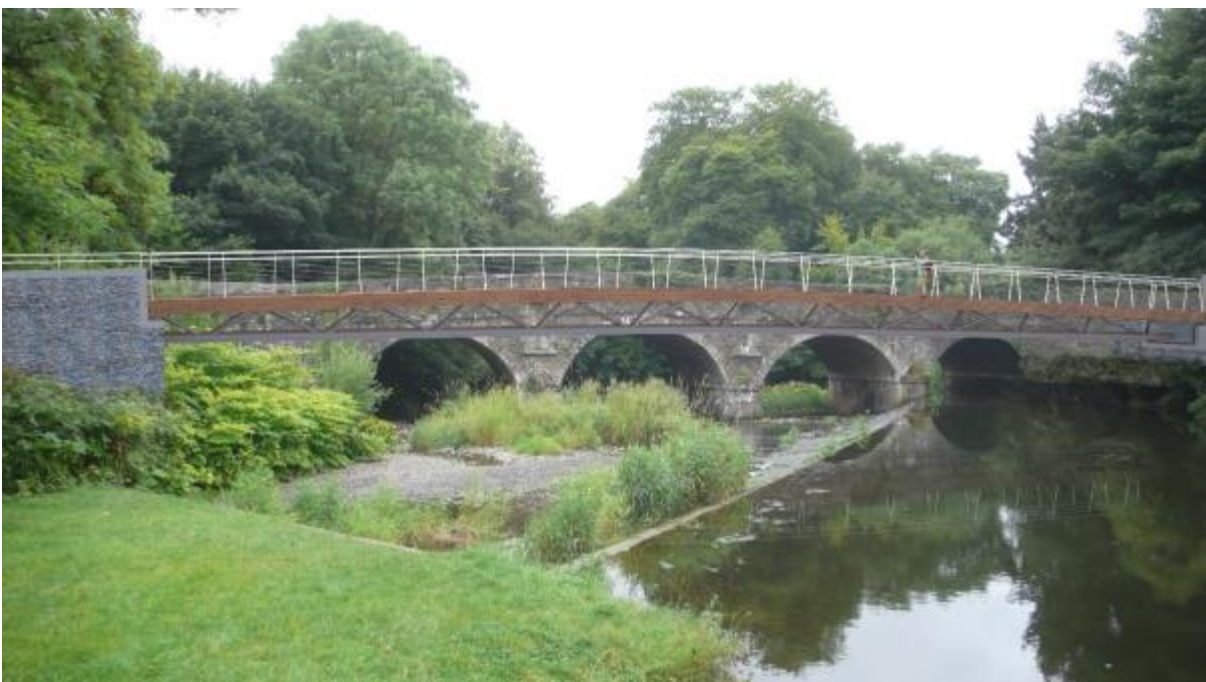
Figure 3-7: Option 5 – Single Span Steel Truss/Glulam Deck Footbridge Photomontage

A single span steel truss footbridge with a glulam deck presents another viable and attractive option. It takes the structural efficiencies of a steel truss and couples it with the aesthetic merits of a timber glulam structure. In addition, the glulam also provides additional mass to the structure to improve the dynamic performance of the structure.

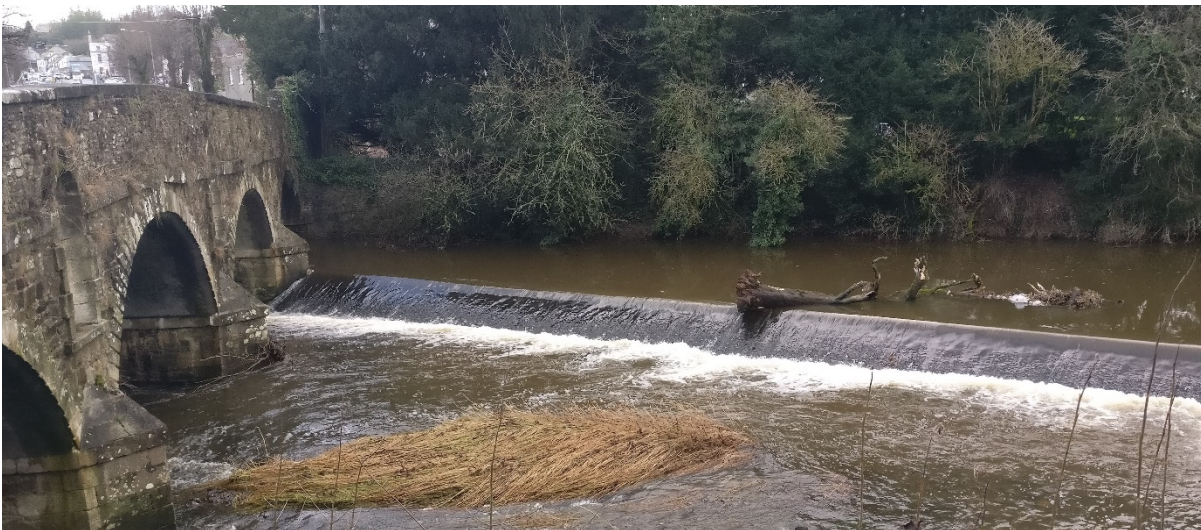
Figure 7-1: Debris located at the Weir from a Flood Event in December 2018

As seen in Figure 7-1, the weir crosses the watercourse at an angle to the river such that it runs in a southwest/northeast direction from the riverbank adjoining the Discovery Park to the first western pier of the existing bridge. The majority of the water flow is consequently directed through the western most span of the existing bridge, particularly in lower flow times. As a result, maintaining the flood level and minimum free board in this span is considered critical to avoiding maintenance issues where debris could become lodged in this span.

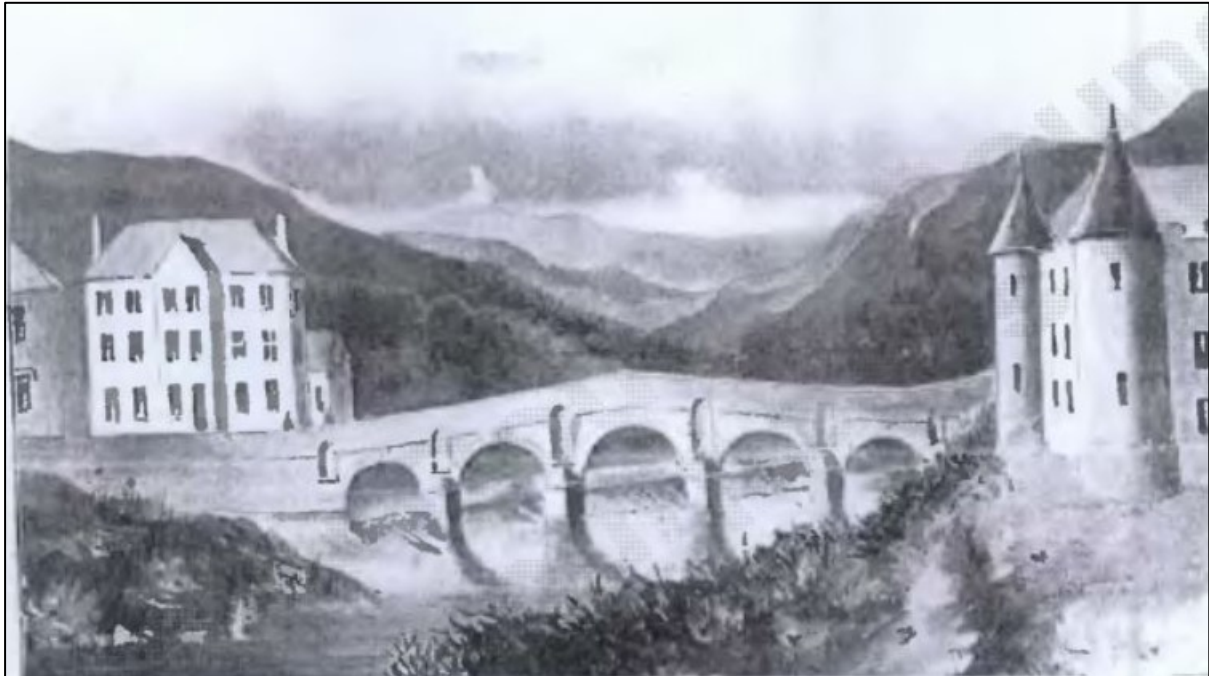
In 1896, Susannah Proctor Flory publish a book titled *Fragments of Family History* in which she describes houses situated adjacent to the bridge prior to their destruction during the 1798 rebellion. These descriptions were sourced from first-hand accounts of occupants and include several sketches drawn based on their descriptions. The sketch shown in **Figure 4** shows the existing bridge structure and the houses to the east and west which were burned to the ground in 1798.

Figure 4: The bridge of Castlecomer prior to the rebellion of 1798 (after Proctor Flory 1896)

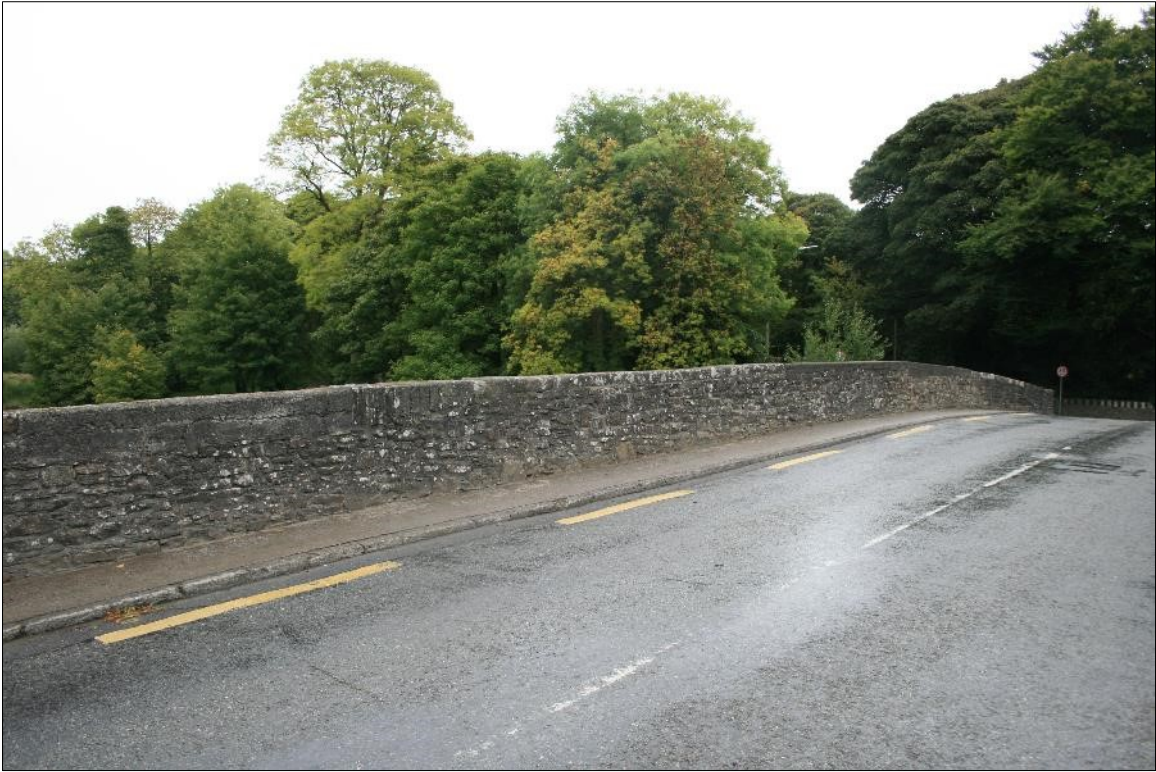
Plate 3: Detail of interior of north parapet wall

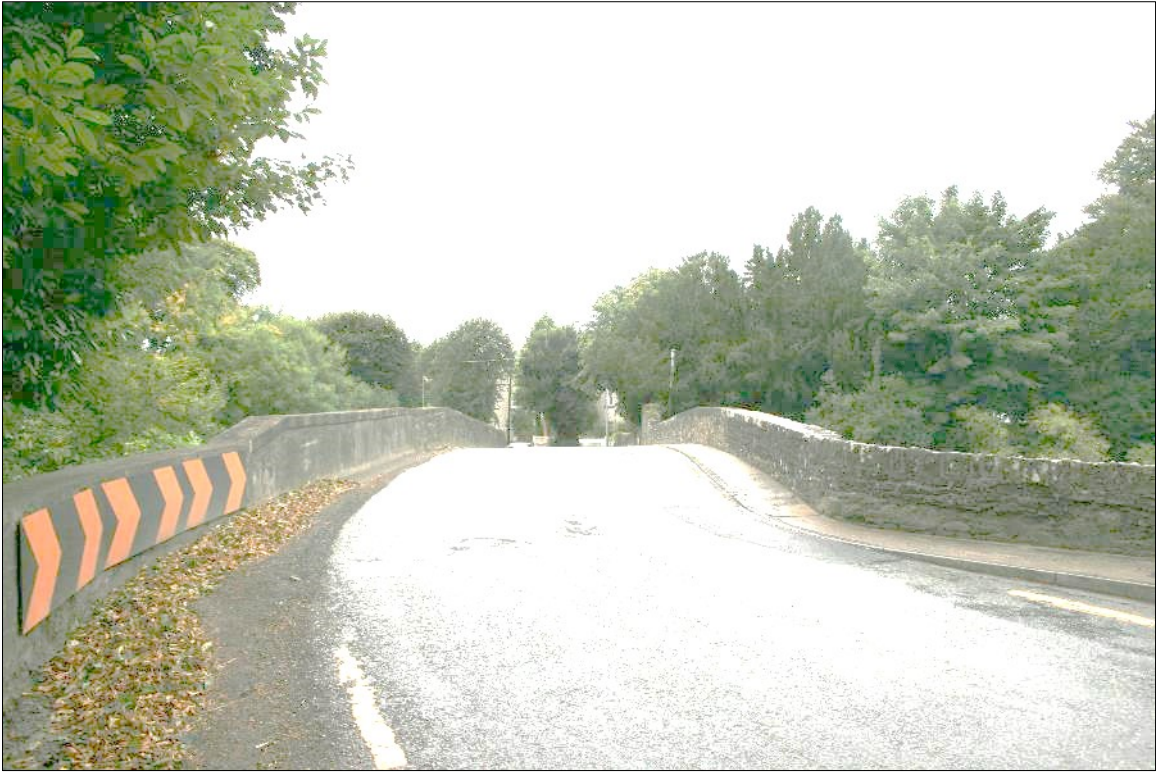
Plate 5: Approach to bridge from east with some ongoing damage to deck surface above springing point above east-most pier.

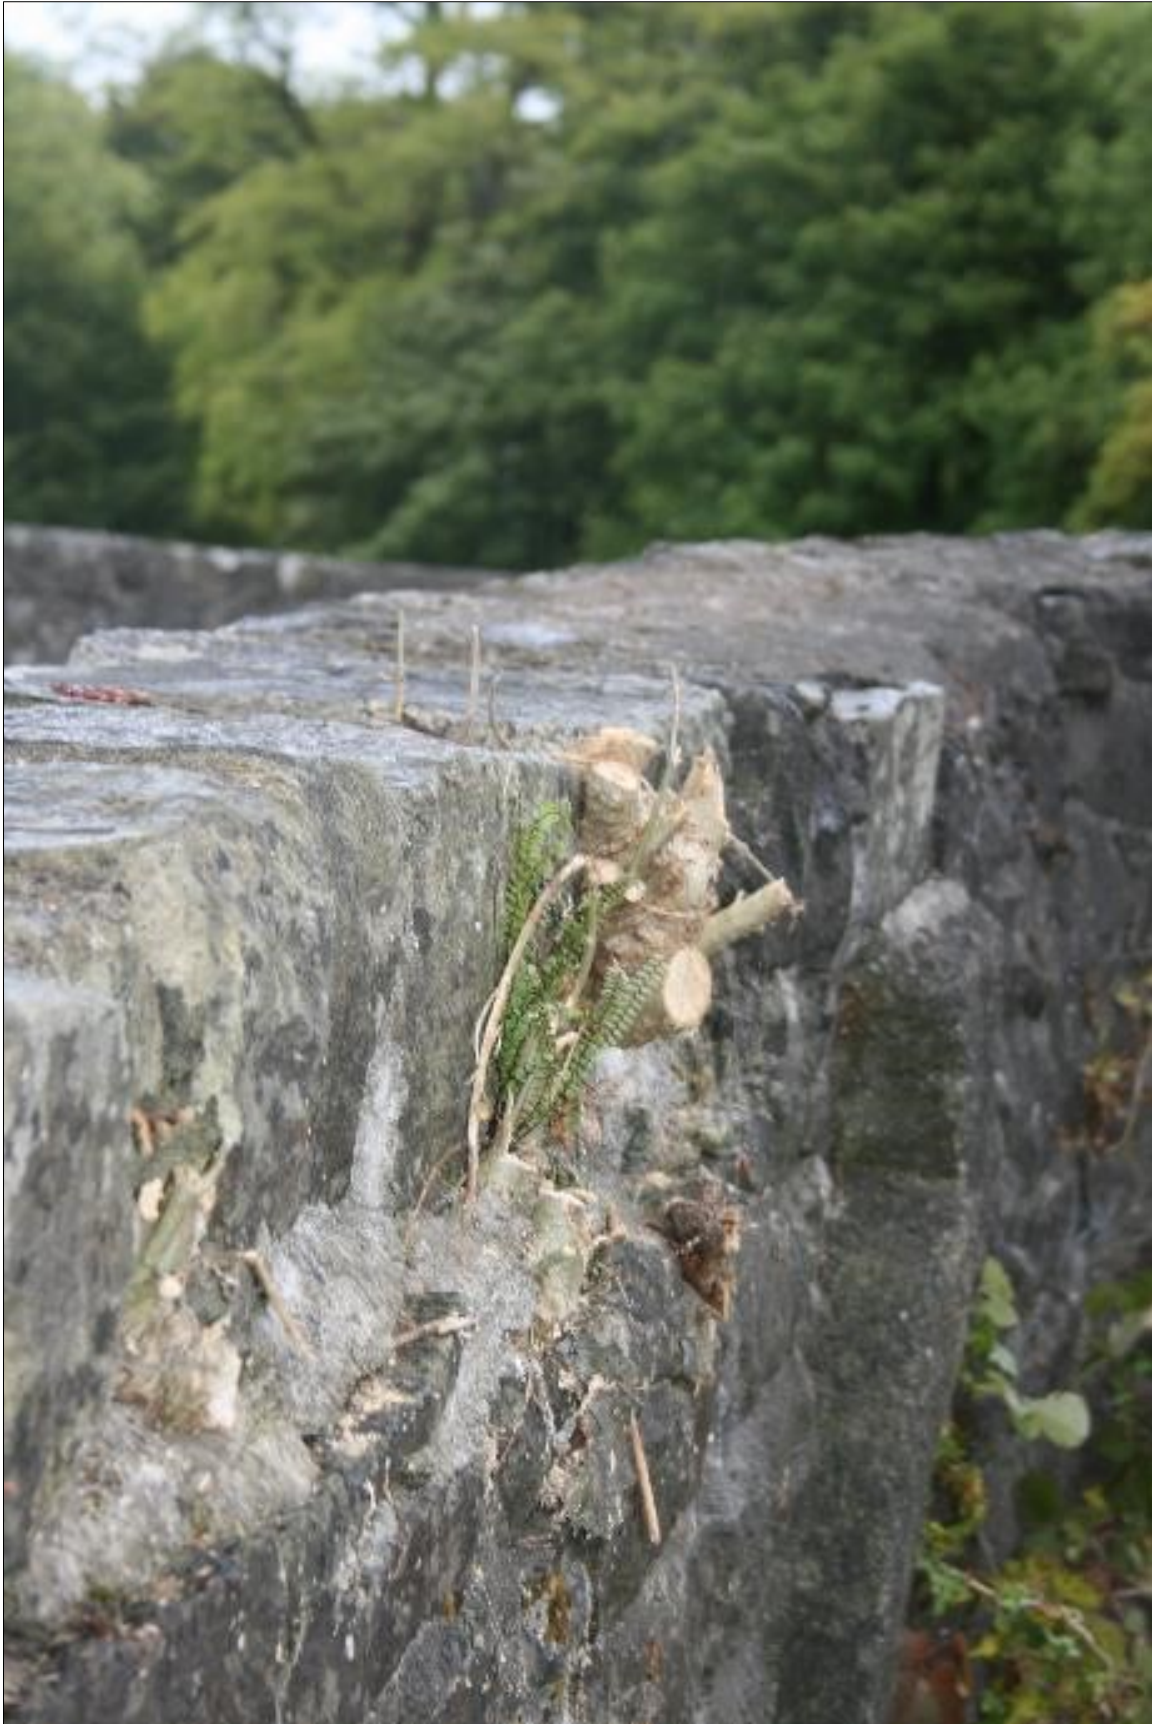
Plate 7: Localised deep-rooting vegetation on parapet exterior being kept trimmed back to restrict its development until it can be fully removed and affected masonry repaired.

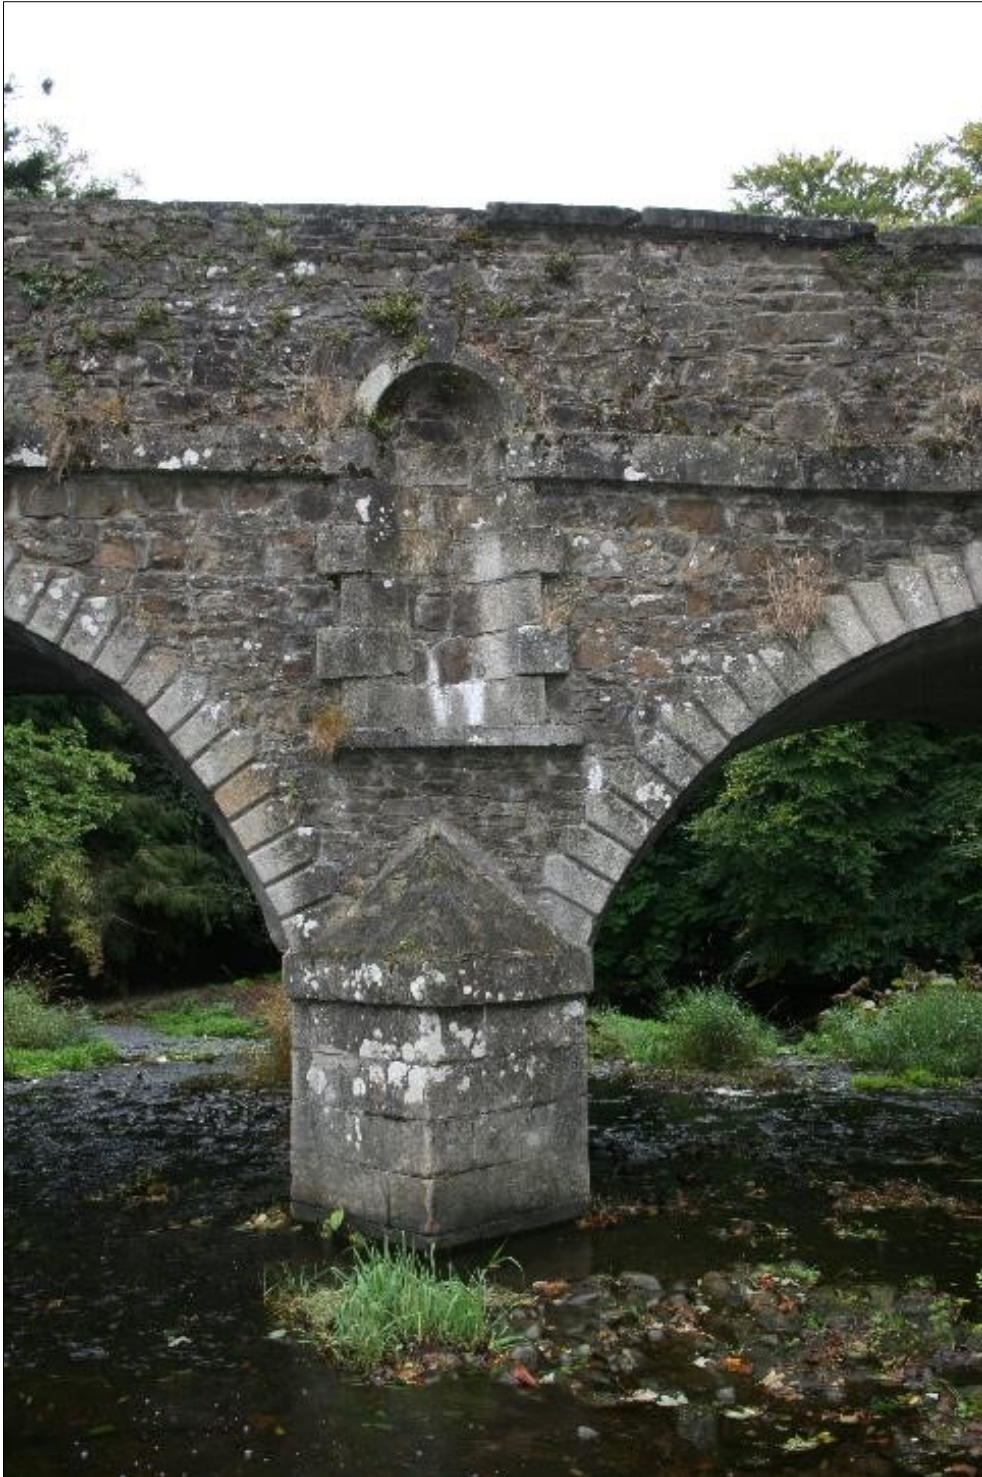
Plate 14: Detail of north elevation of spandrel and 2nd pier from west abutment

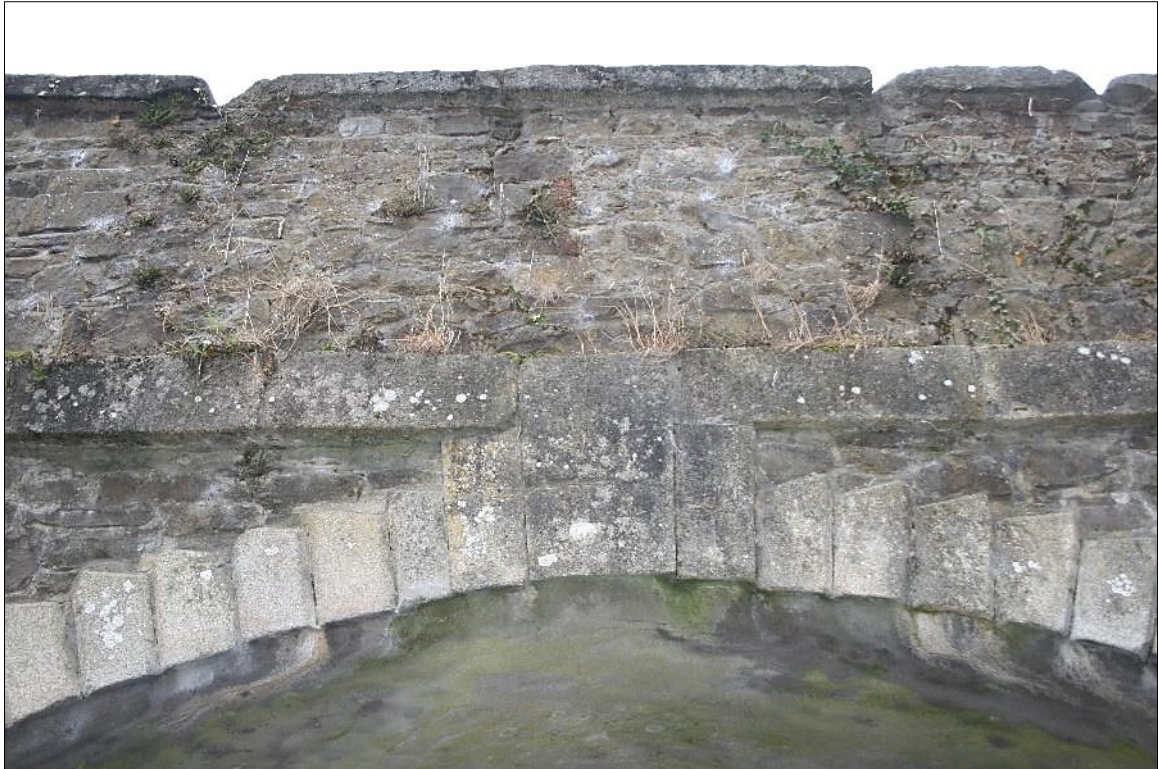
Plate 15: Keystone, voussoirs, string course and exterior parapet detail over 2nd arch from west abutment

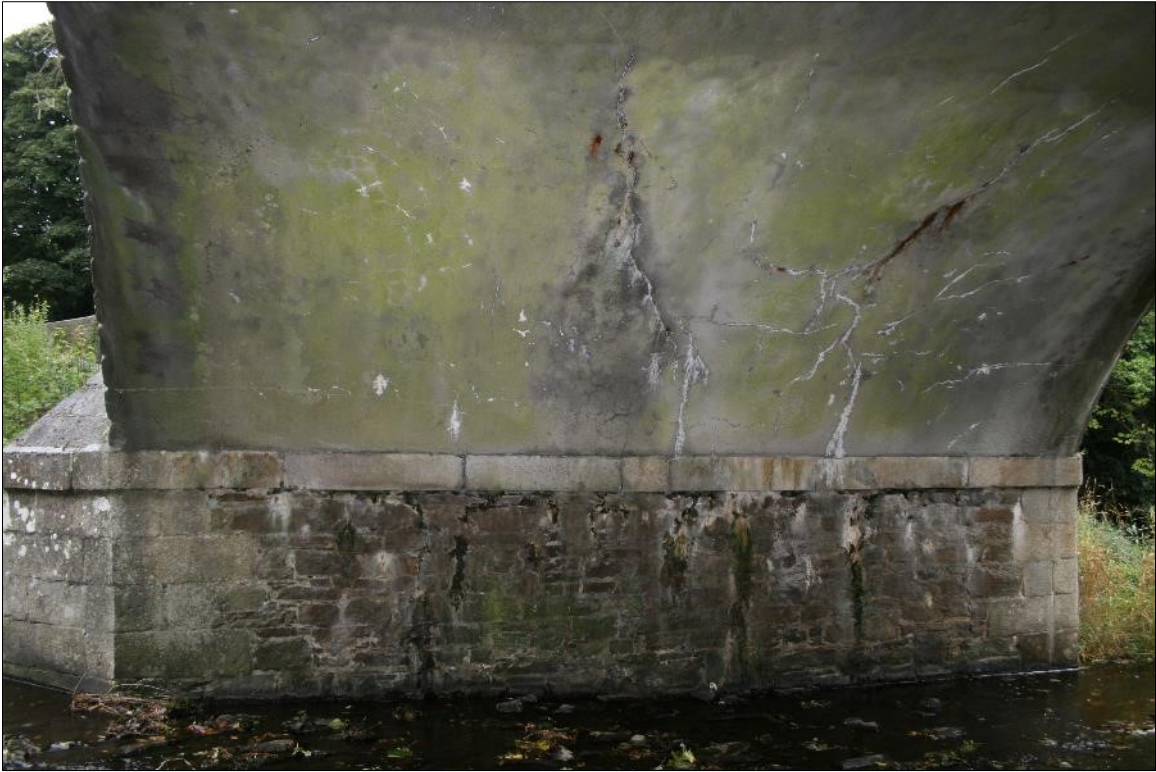
Plate 17: West shoulder of arch soffit within 2nd arch from west abutment. Limited moisture ingress from bridge deck is escaping through pier masonry and also through cracks in gunited arch soffit.

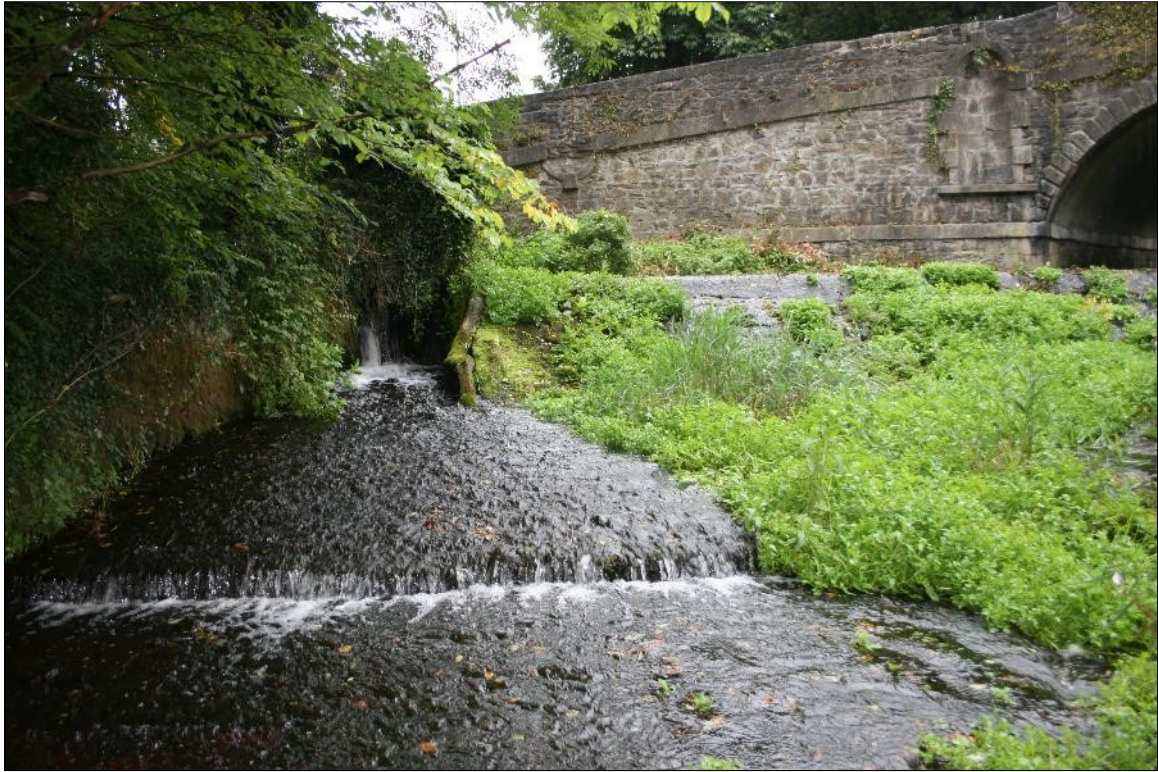
Plate 19: Sluice at west end of south downstream side of bridge.

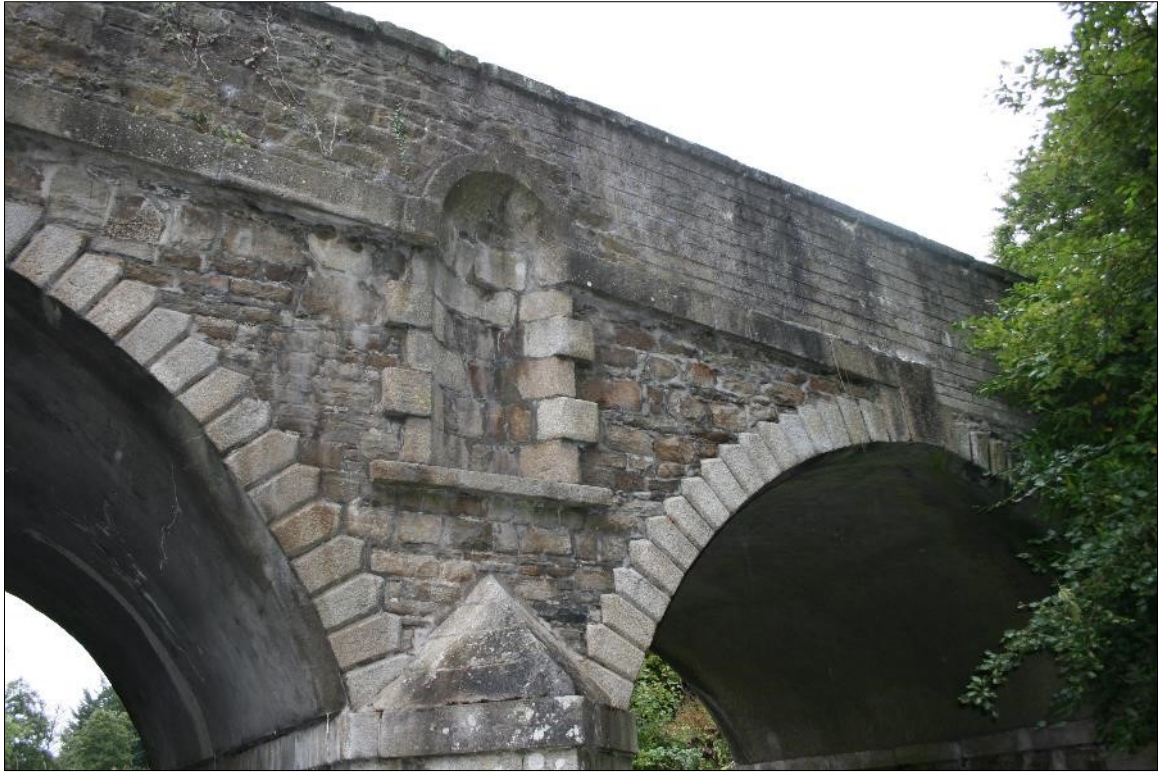
Plate 21: Detail of spandrel over 2nd pier from east abutment. Parapet here was partially reconstructed with concrete blocks sometime within last 30 years

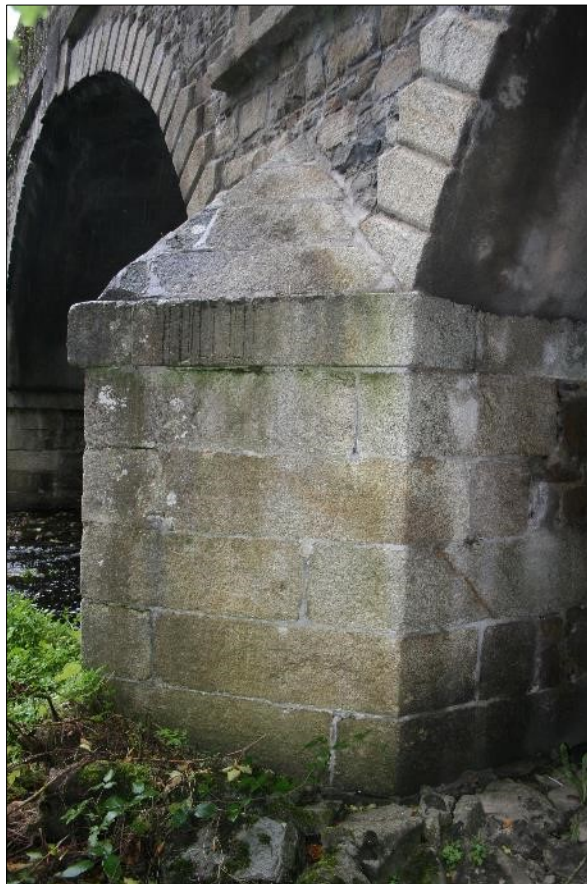
Plate 22: Detail of downstream cutwater on south elevation

*Five-arch road bridge (with slight hump-back) over river, built 1763. ... (uncoursed rubble sandstone) walls centred on granite ashlar triangular cutwaters to piers having pyramidal capping [see **Plate 22**] with lichen-spotted cut-granite stringcourses supporting parapets having lichen-spotted cut-granite coping (several sections of which have been replaced with cast concrete). Series of five round or segmental arches between round-headed niches [see **Plate 20**] with rusticated granite ashlar crows stepped voussoirs centred on lichen-spotted cut-granite triple keystones [see **Plate 15**]. Sited spanning Dinin River with wooded banks to river.*

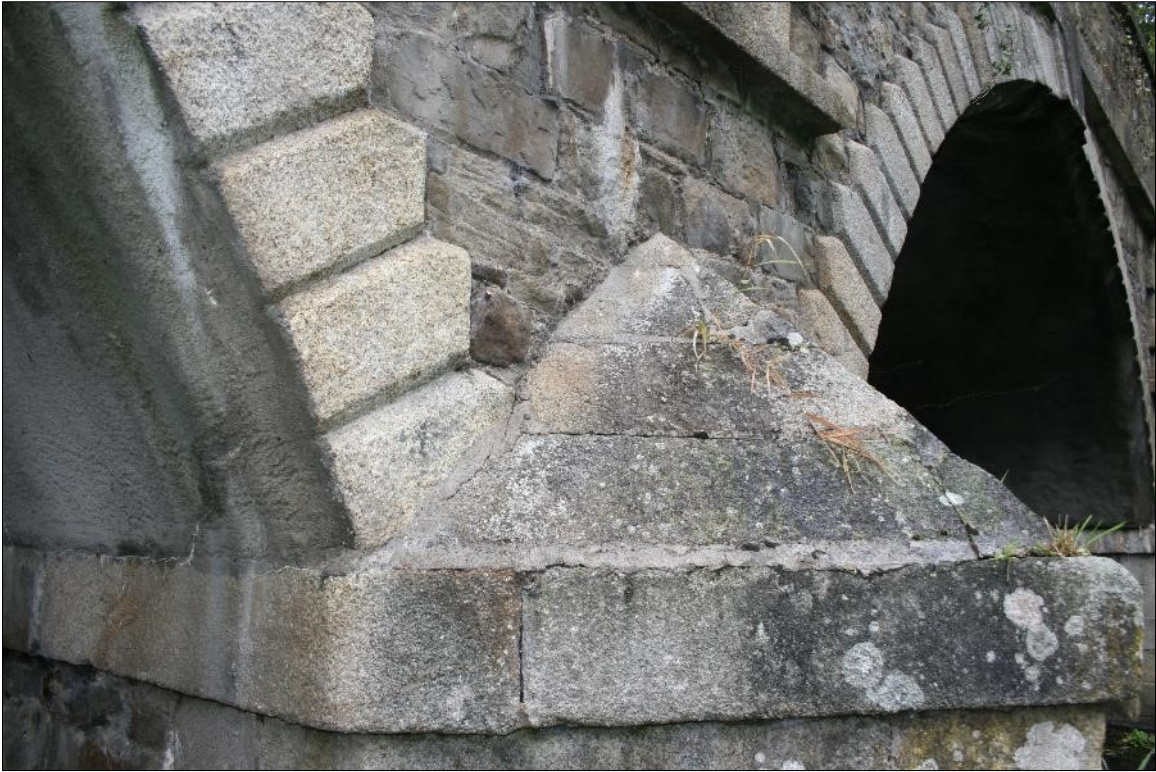
Plate 23: Detail of downstream cutwater cap (on south elevation). Inappropriate cement pointing here and over all elevations poses a long-term risk to the proper performance of masonry.

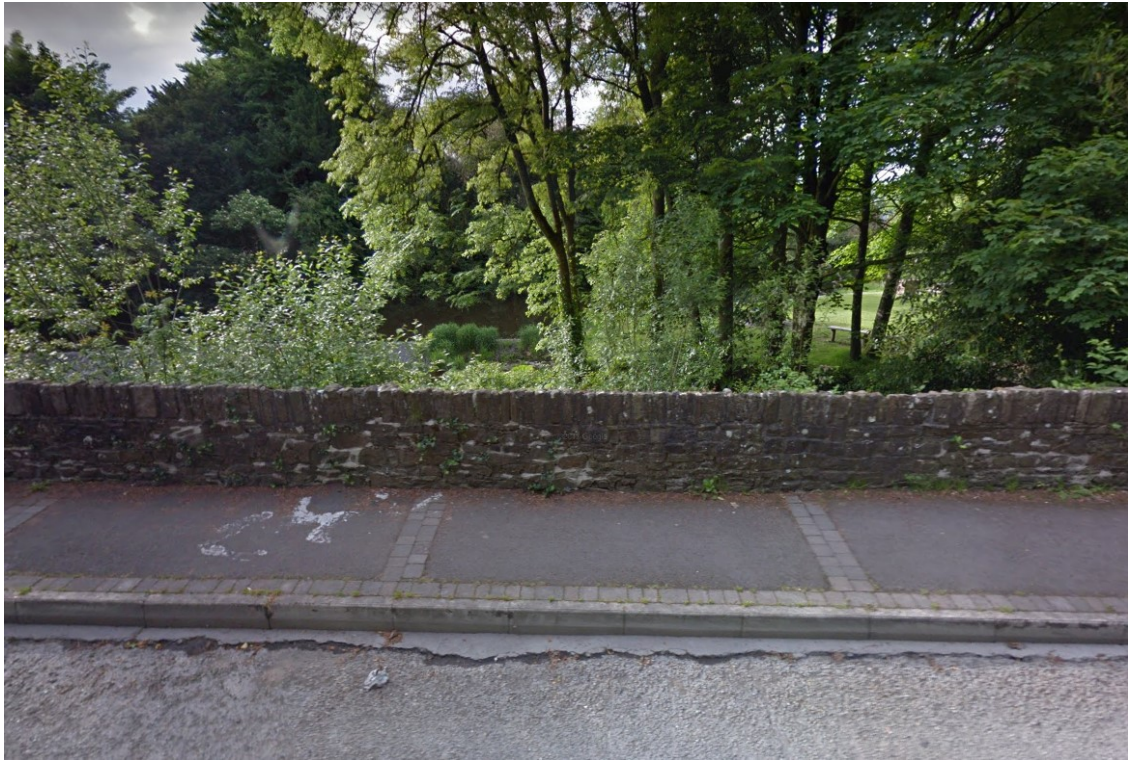
Plate 23: View of section of low walling to be removed on the approach/wing wall to the north-east of the existing bridge to facilitate eastern end of proposed new pedestrian bridge (Source: Google Streetview)

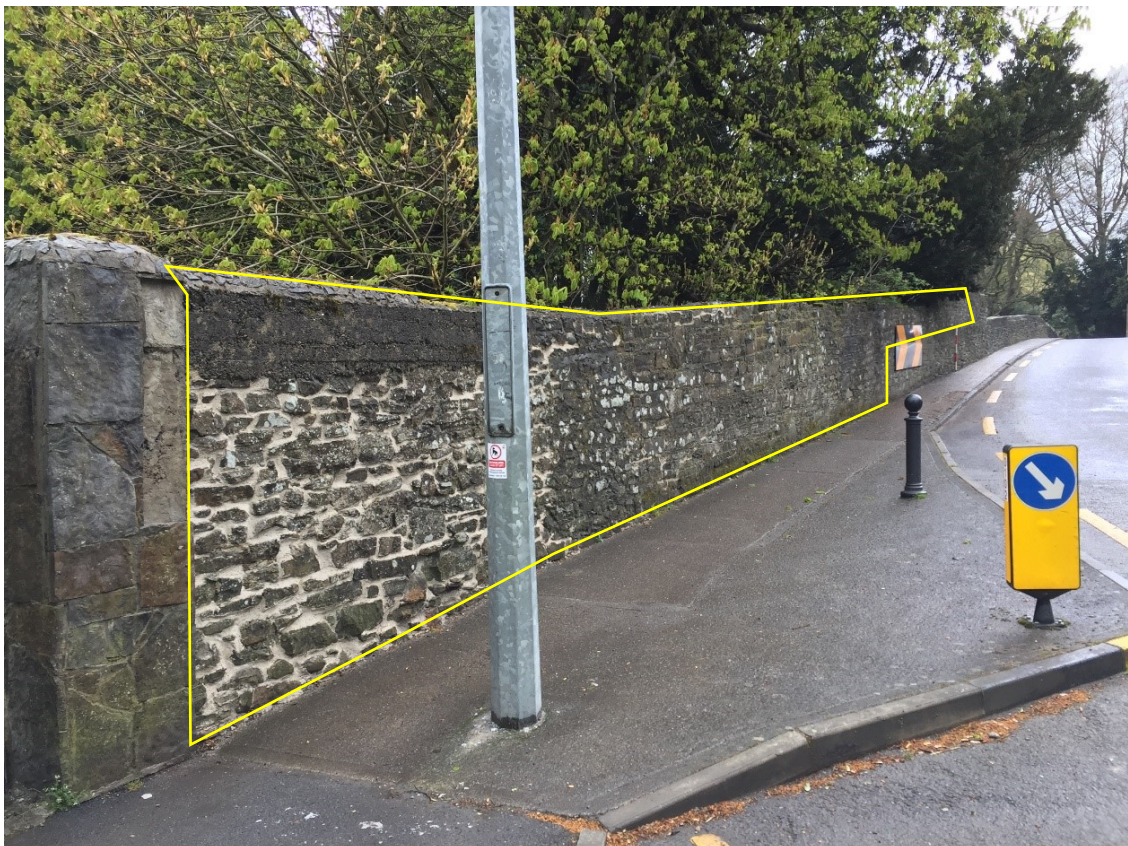
Plate 26: Extent of proposed new opening in masonry wall to accommodate western end of pedestrian bridge – the westernmost wall section is largely rebuilt and incorporates a portion of cast-concrete capping
