Eirspan TO 302 N78 Castlecomer Footbridge Options Report

CASTLECOMER FOOTBRIDGE

Options Report

MCT0759RP0003
Eirspan TO 302 - N78
Castlecomer Footbridge
A02
02 July 2019

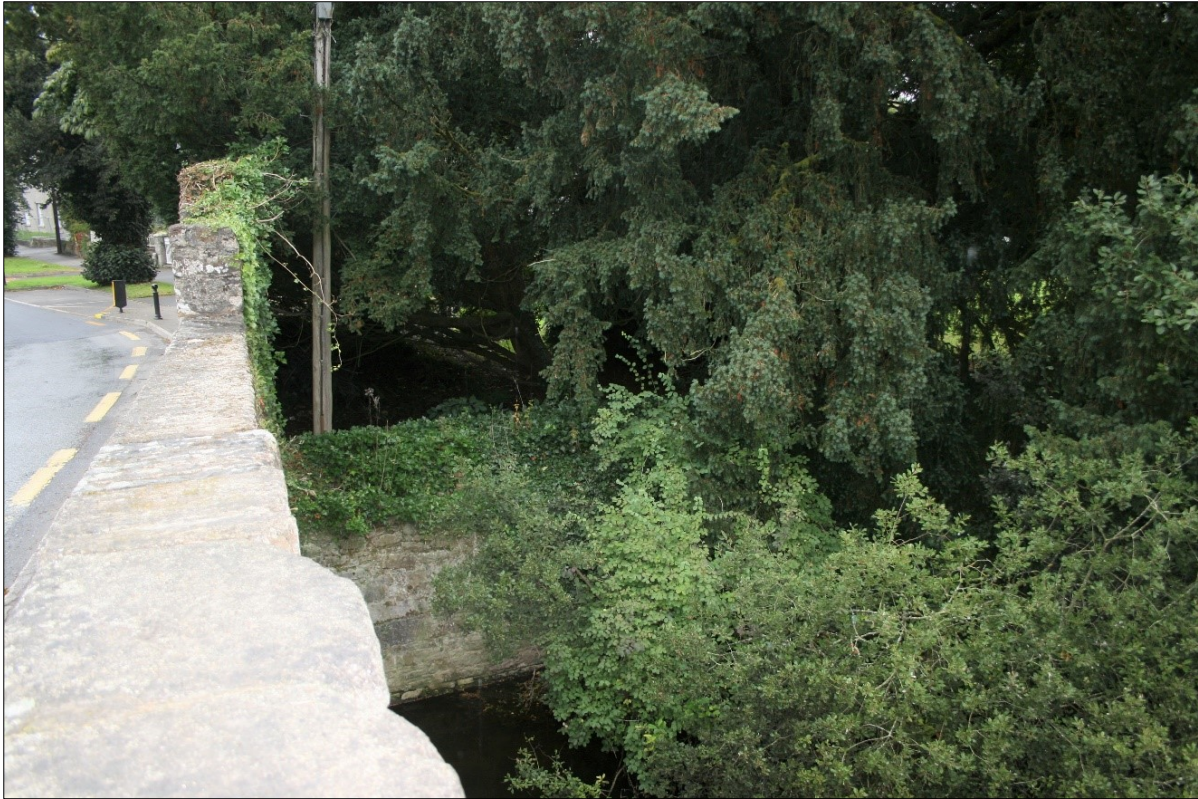
Plate 27: View to north-west to area of garden (of No. 16 High Street) behind opening to be created in west end of north parapet wall. No structure evident behind this raised section of masonry.

While the proposed pedestrian bridge will not be attached to the existing bridge structure, sections of the western and eastern approach walls on the northern side of the bridge will have to be removed to create access to the new independent pedestrian bridge. On the northern side of the bridge, the section of masonry to be removed to facilitate the pedestrian connection is in relatively poor condition with a large concrete capping and it has likely been truncated to create present timber-sheeted gate which has stone-tiled concrete piers and appears to date from c.2000. Furthermore, this portion of walling is part of the boundary wall of No. 16 High Street as opposed to part of the masonry parapet of the bridge. This proposed intervention will result in a *direct, slight, negative impact* on the curtilage of No. 16 High Street (Protected Structure Ref. C491). East of the section to be removed, the existing wall will be reduced in height to allow for passive surveillance; the wall will be reduced to an earlier parapet height as defined by a row of vertical coping stones (see **Figure 8** below). This will result in a *neutral impact* as it will involve the removal of a portion of walling that is not original to the construction of the bridge.
