**PRELIMINARY ECOLOGICAL APPRAISAL – COOTES LANE TO
RING ROAD PEDESTRIAN/CYCLIST SCHEME, KILKENNY CITY**

**Report Prepared for
Kilkenny County Council**

September 2022

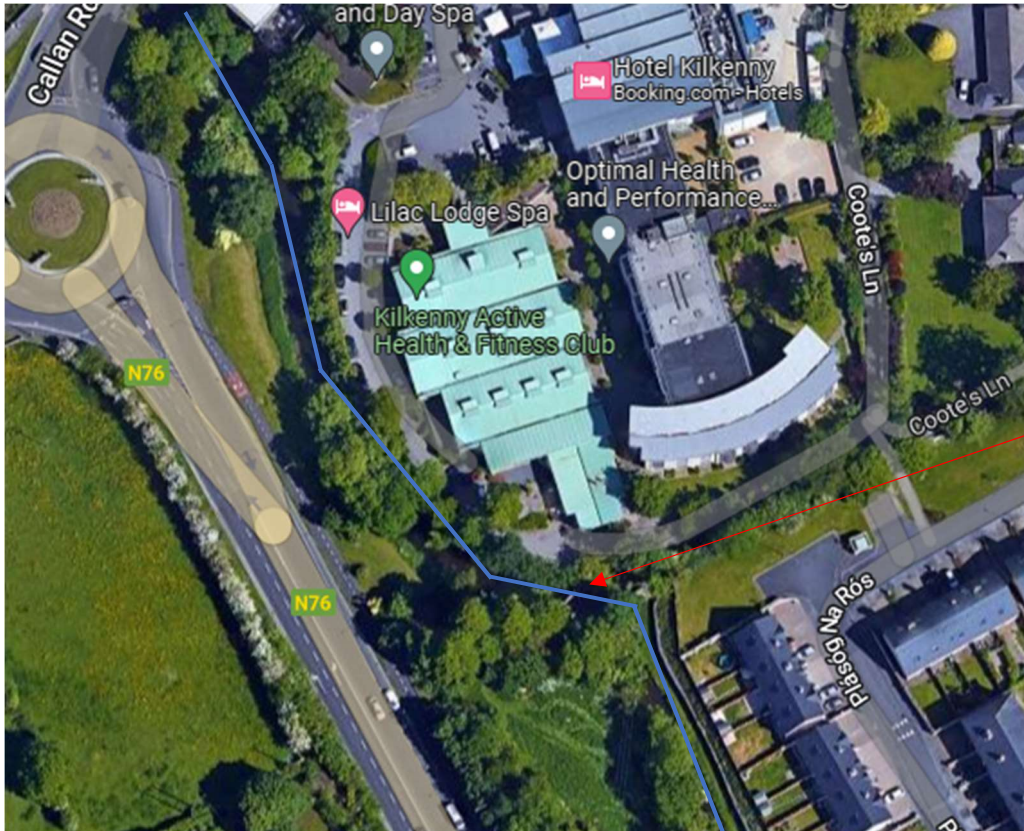
Figure 3 – aerial photo of survey site at Cootes Lane. The original crossing of the Breagh River is indicated and an outline of the path of the Breagh River. The treelines along Cootes Lane and along banks of the Breagh are obvious in this photo.

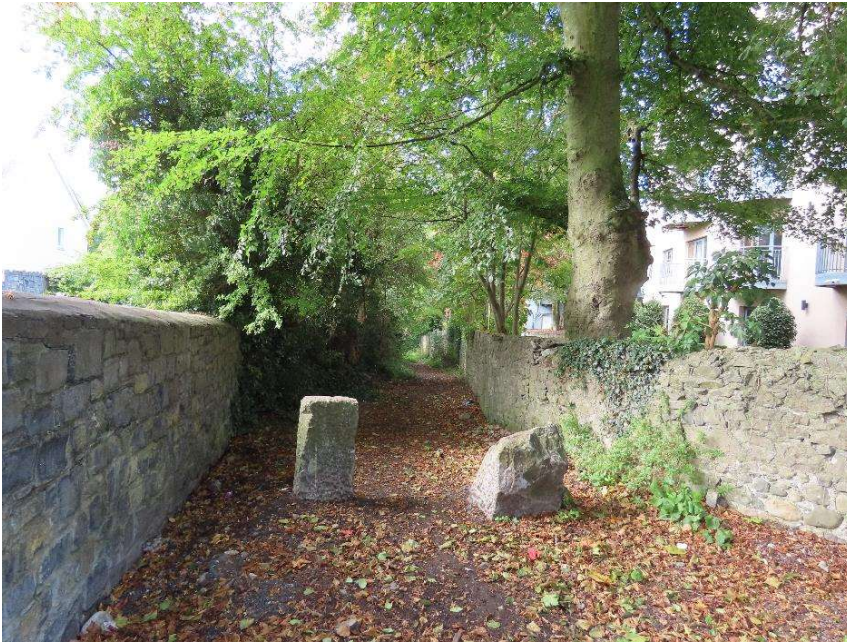
Photo 1 – easternmost point on Cootes Lane running behind (south of Hotel Kilkeny). Mature beech tree with some roosting potential for bats in garden of Hotel Kilkeny. Stone walls on both sides of track were surveyed and considered to have no potential for bats.

Habitats present – BL1 (Stone walls & other stonework), WL2 (Treelines)

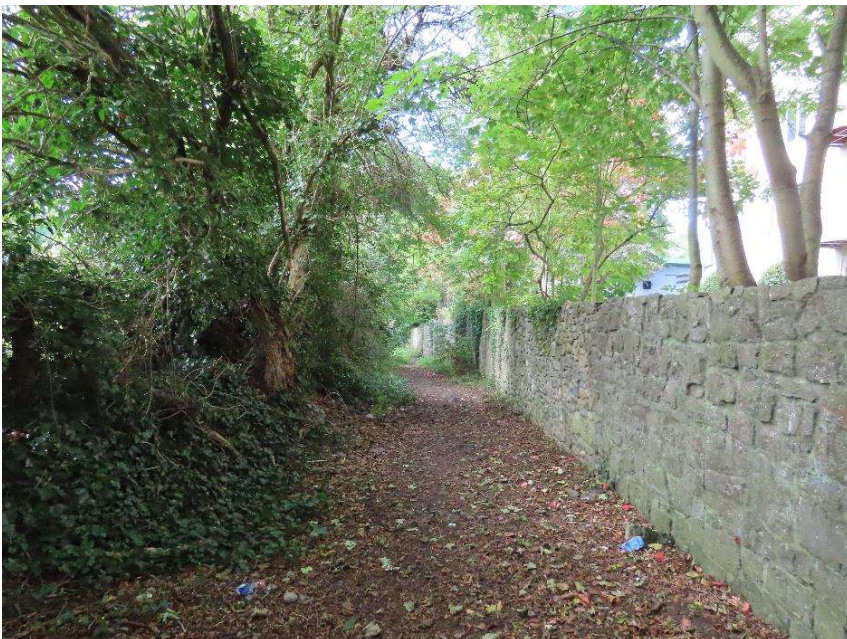
Photo 2 – high stone wall to rear of Hotel Kilkeny running along northern boundary of lane is very well pointed and has no potential for roosting bats. Ash and beech trees on southern lane edge growing on earthen bank.

Habitats present – BL1 (Stone walls & other stone work), WL2 (Treelines), BL2 (Earth banks)

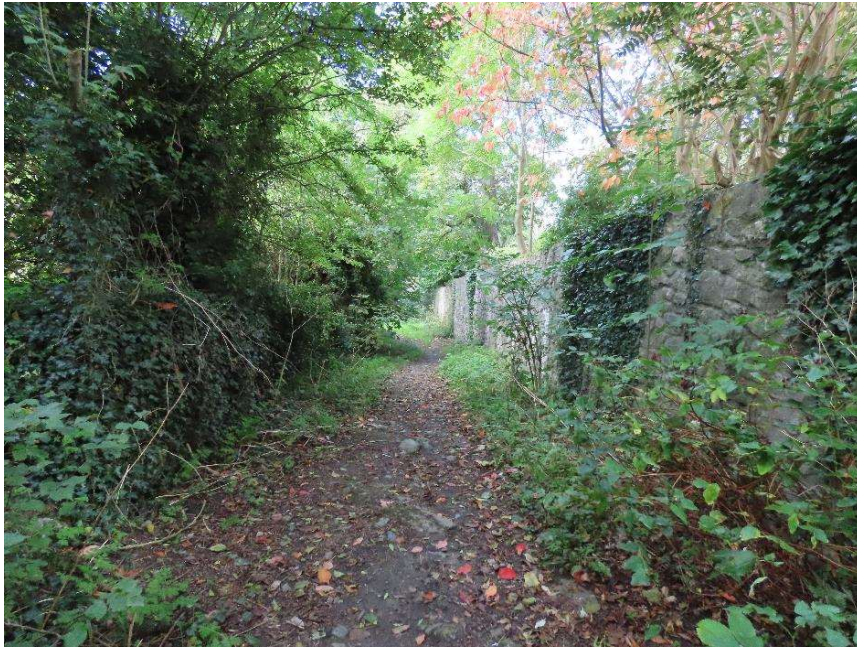
Photo 3 – high stone wall to rear of Hotel Kilkenny running along northern boundary of lane is very well pointed and has no potential for roosting bats

Habitats present – BL1 (Stone walls & other stonework), WL2 (Treelines), BL2 (Earth banks)

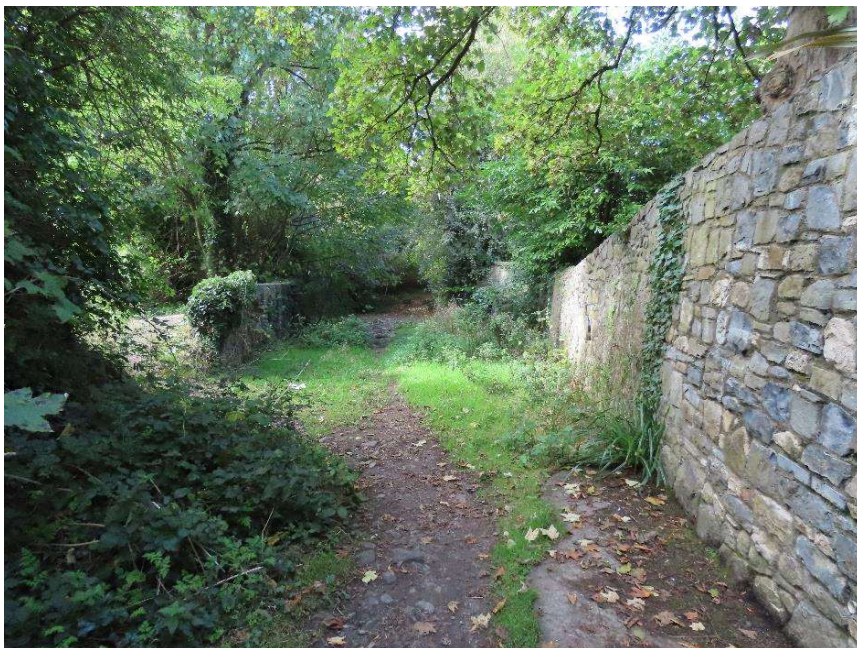
Photo 4 – Cootes Lane to east of existing ford on Cootes Lane with sycamore trees either side of lane

Habitats present – BL1 (stone walls & other stone work), WL2 treelines

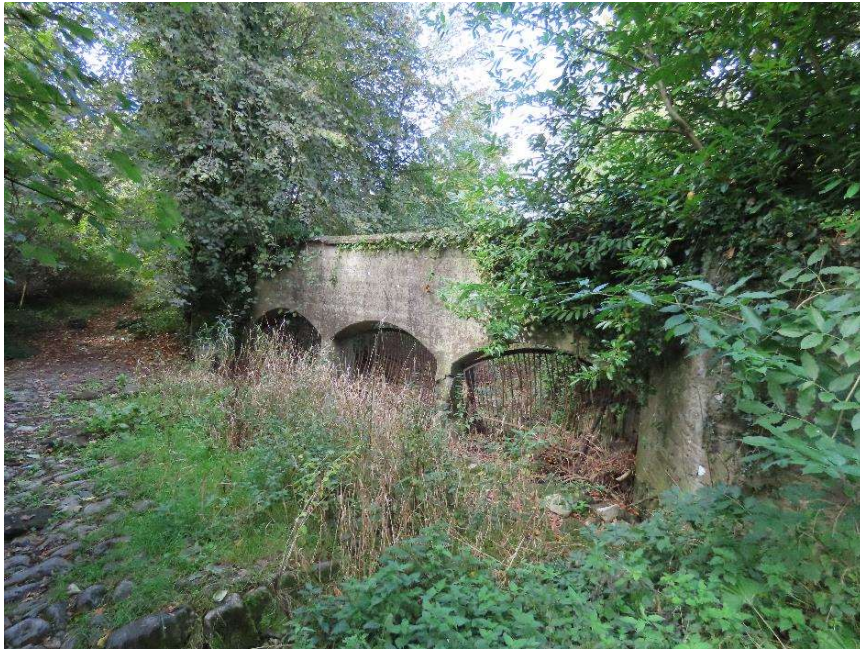
Photo 5 – upstream (southern) elevation of former bridge structure on Cootes Lane
Habitats present – BL3 (Buildings and artificial surfaces) – concrete wall of ford

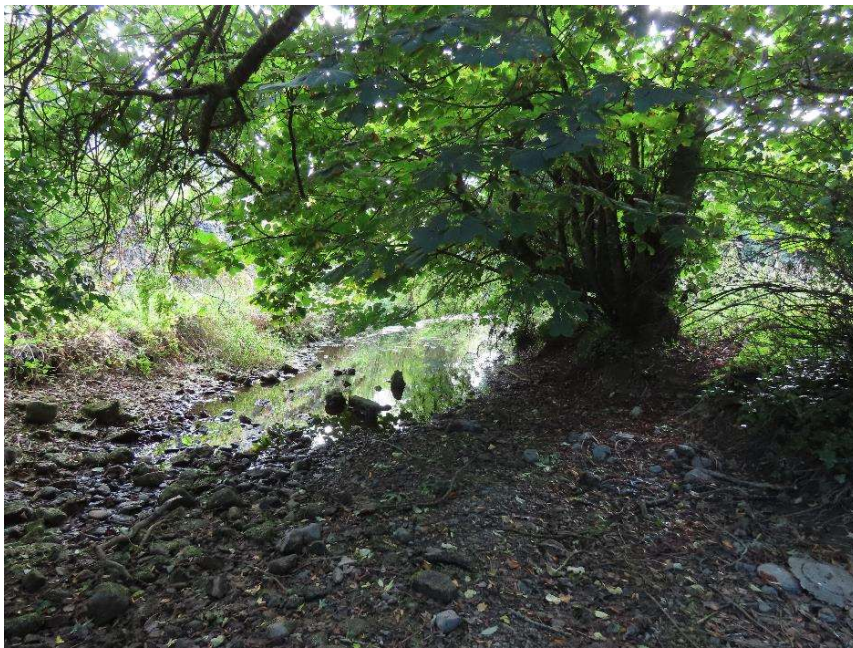
Photo 6 – Breagh River upstream of old ford. Water was not flowing under ford on date of survey
Habitats present - FW2 (Depositing lowland river), WL2 (Treelines)

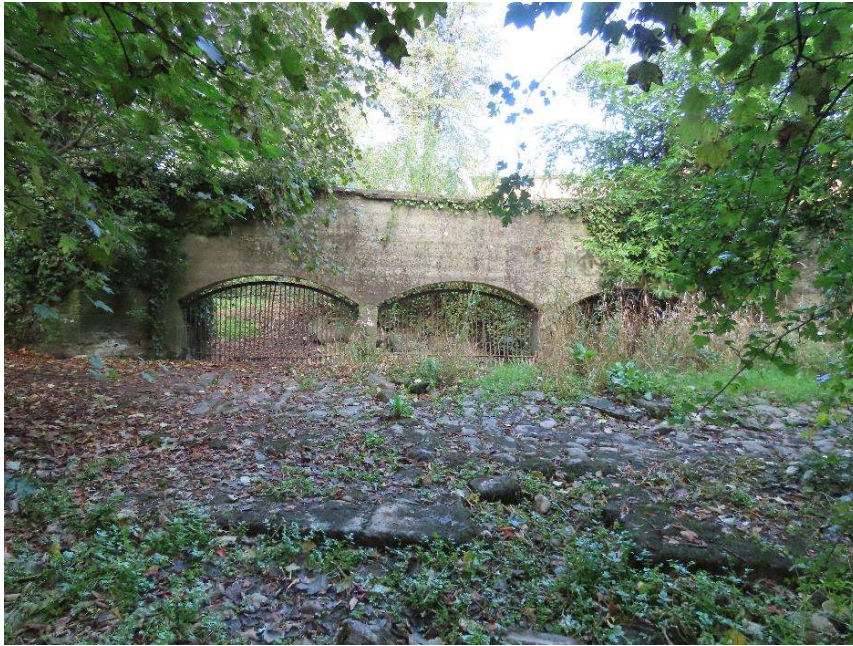
Photo 7 – southern elevation of old ford on Cootes Lane

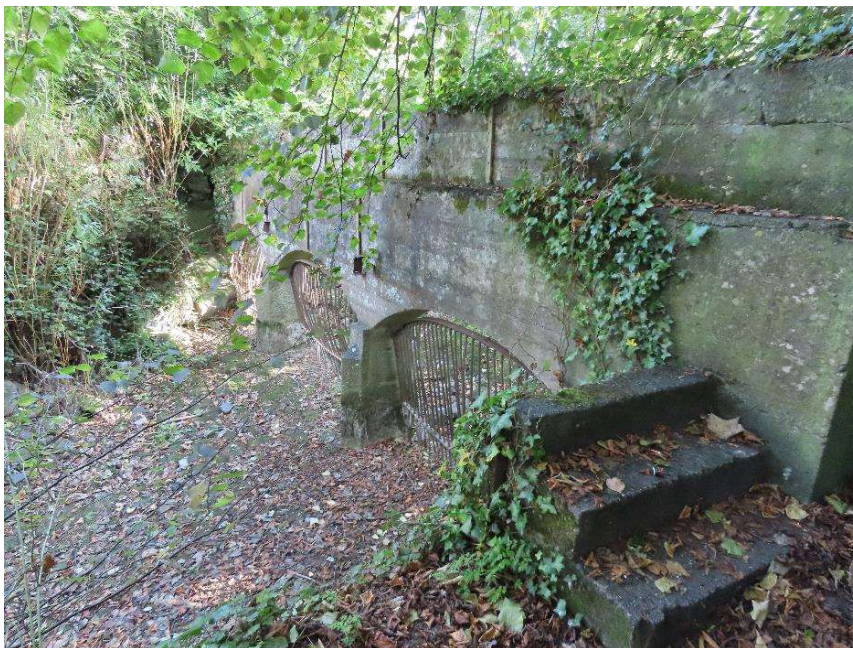
Photo 8 – northern (downstream) elevation of old ford – this structure was surveyed as assessed as having no potential as a bat roosting site

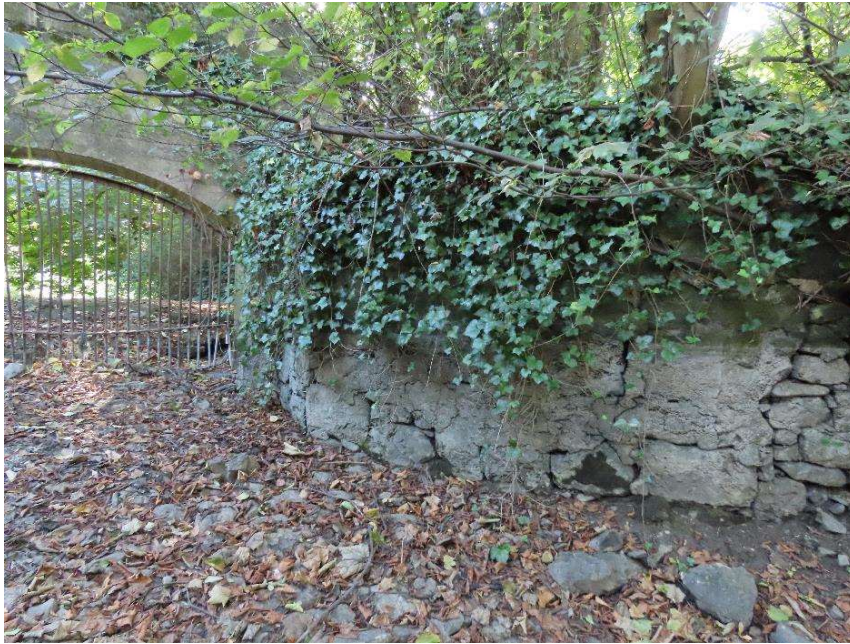
Photo 9 – fissures in wall on northern side of old ford – no potential for bats
Habitats present – BL1 (Stonewalls and other stonework)

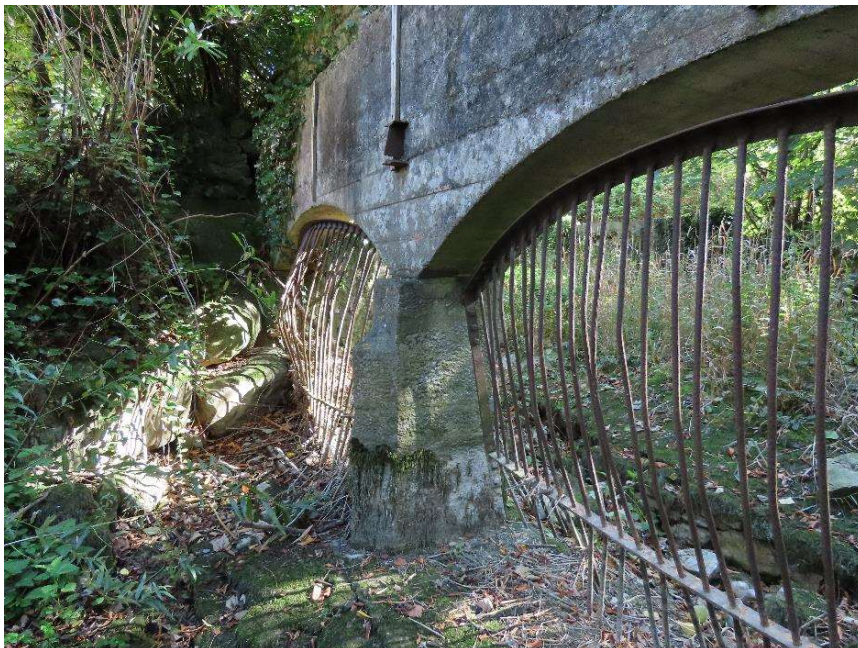
Photo 10 – Concrete structure inspected and assessed as having no potential for roosting bats
Habitats present - BL3 (Buildings and artificial surfaces)

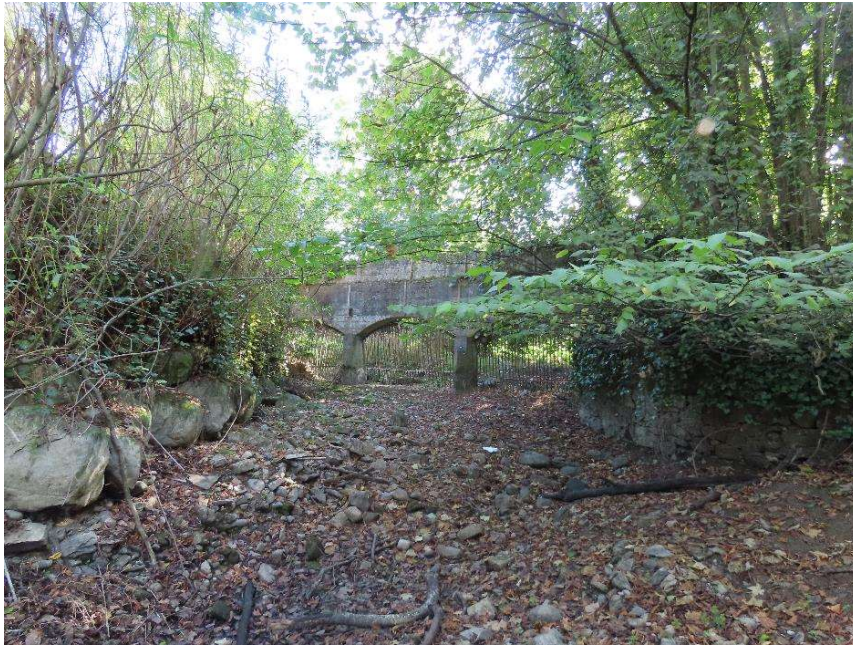
Photo 11 – stone embankment downstream of ford was searched for signs of otters. None were recorded.

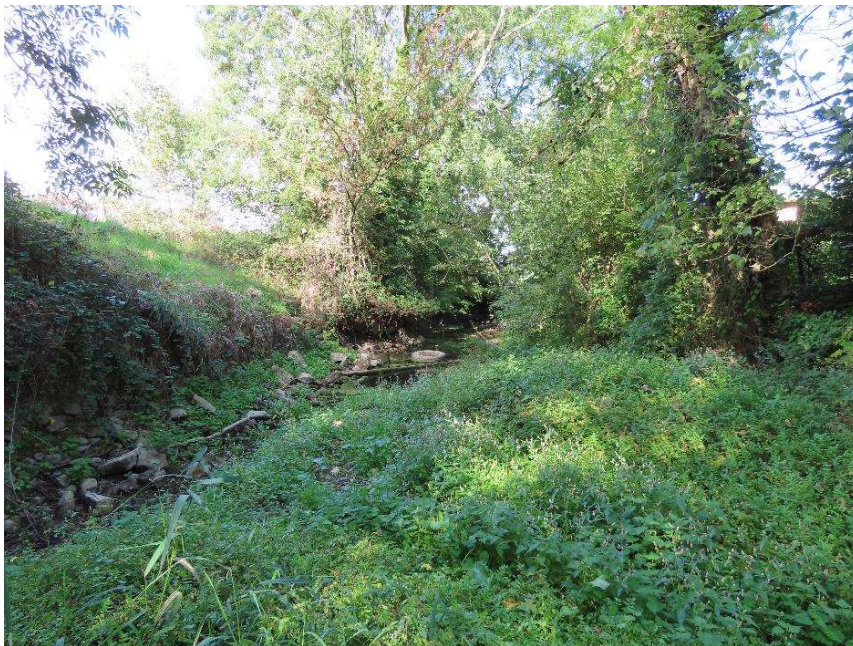
Photo 12 – Breagh River downstream of ford. This section of the river was searched for signs of otters – none were recorded.

Habitats present – FW2 (Depositing lowland rivers), WL2 (Treelines)

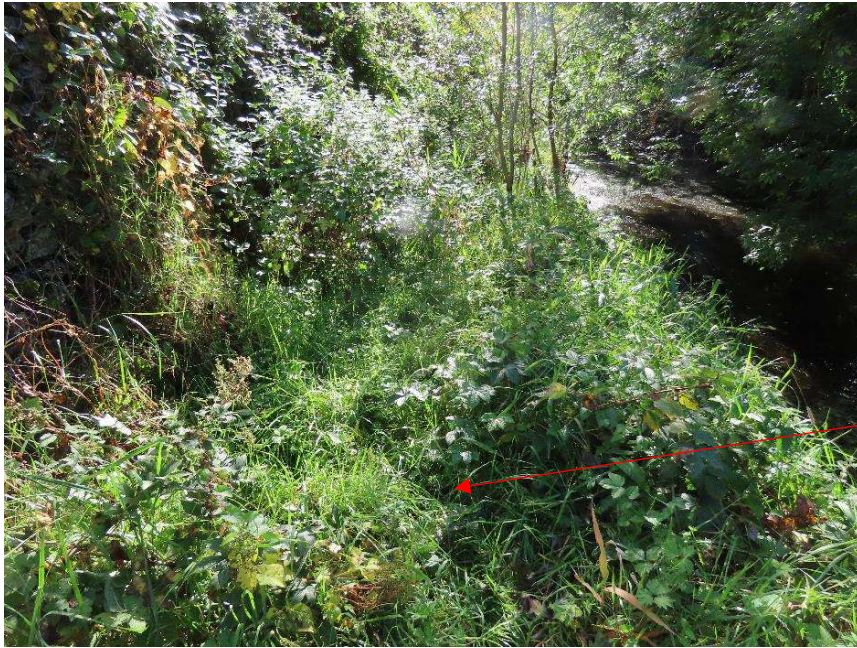
Photo 13 – Breagagh River upstream of ford with animal trail – most likely otter - running along eastern river bank

Habitats present – FW2 (Depositing low land rivers), WL2 (Treelines)

No invasive plant species were recorded on site during the present survey. No signs of badgers were recorded on site. An animal trail (most likely otter) was recorded on the eastern bank of the Breagagh River upstream of the ford. Otters will not be adversely affected in the

long term by the proposed pedestrian/cyclist facility. There may be some temporary disturbance during the construction of the new bridge.

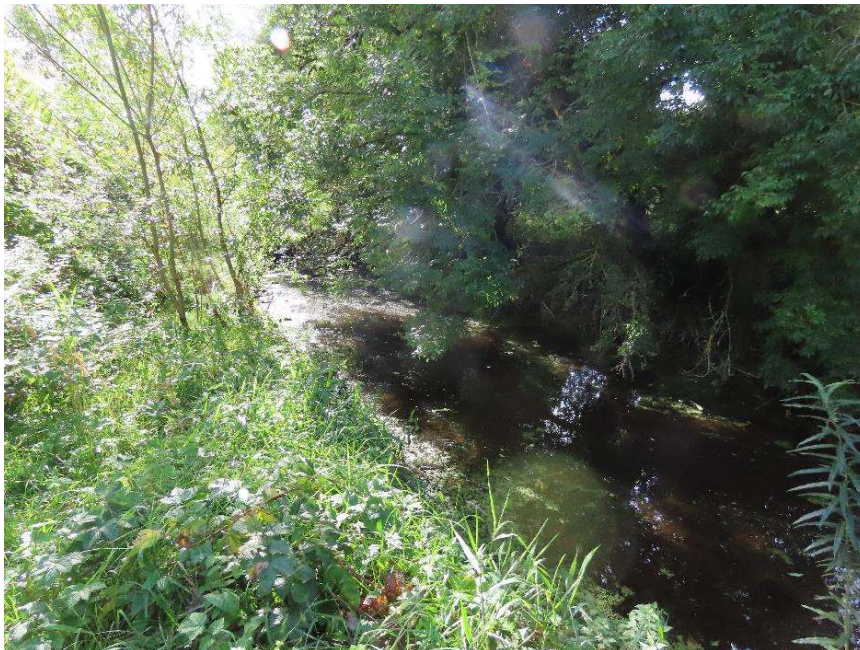
Photo 14 – Breagagh River upstream of ford

Habitats present – FW2 (Depositing low land rivers), WL2 (Treelines)

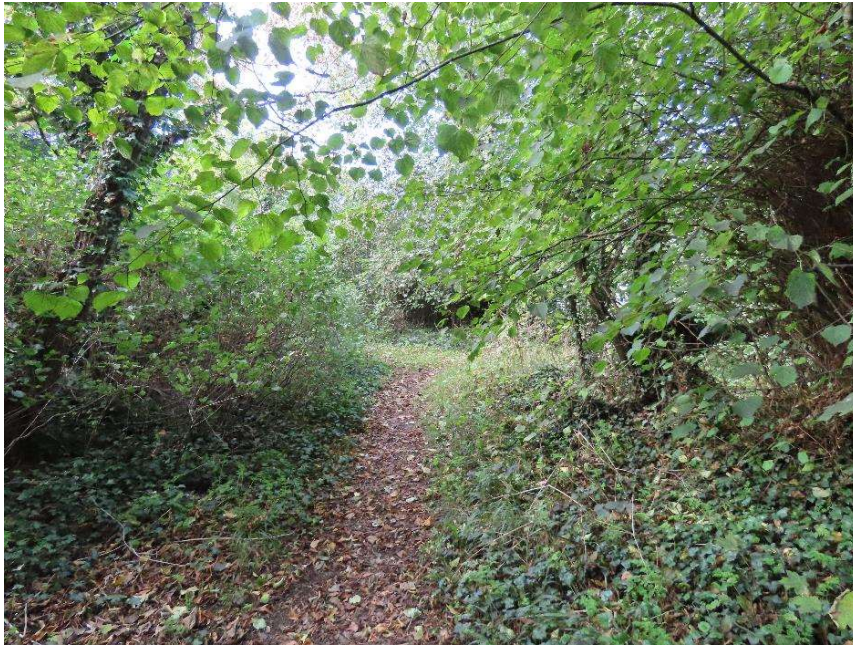
Photo 15 – lane between ford and ring road with mature lime trees either side of lane
Habitats present – WL2 (Treelines) and WS1 (Scrub)

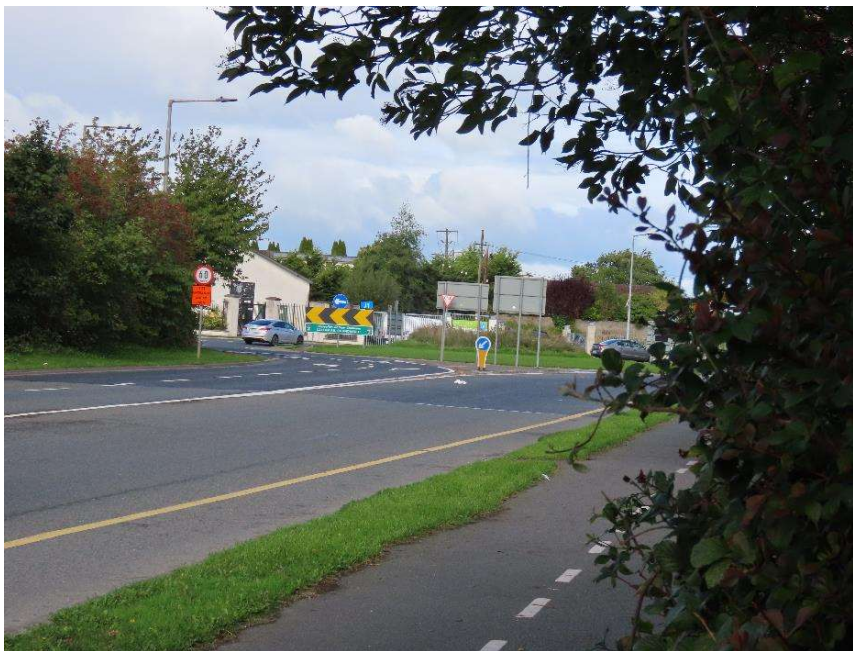
Photo 16 – point where Cootes Lane meets N77 ring road south of Callan Road Roundabout
Habitats present – BL3 (Buildings & Artificial surfaces)

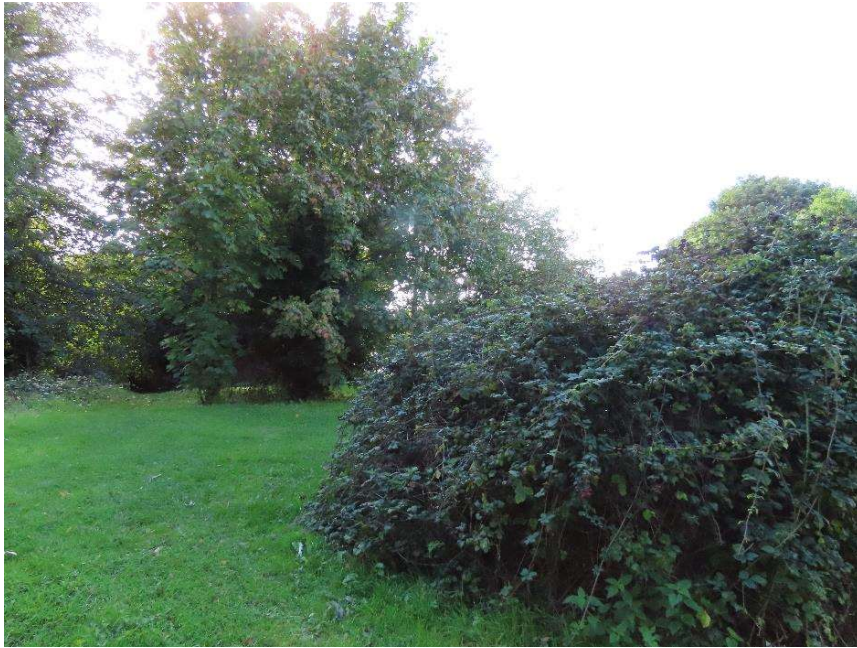
Photo 17 – green amenity area to north of Cootes Lane adjacent to N77 ring Road. Mature sycamores and stand of brambles

Habitats Present – GA2 (Amenity grassland), WL2 (Treelines)

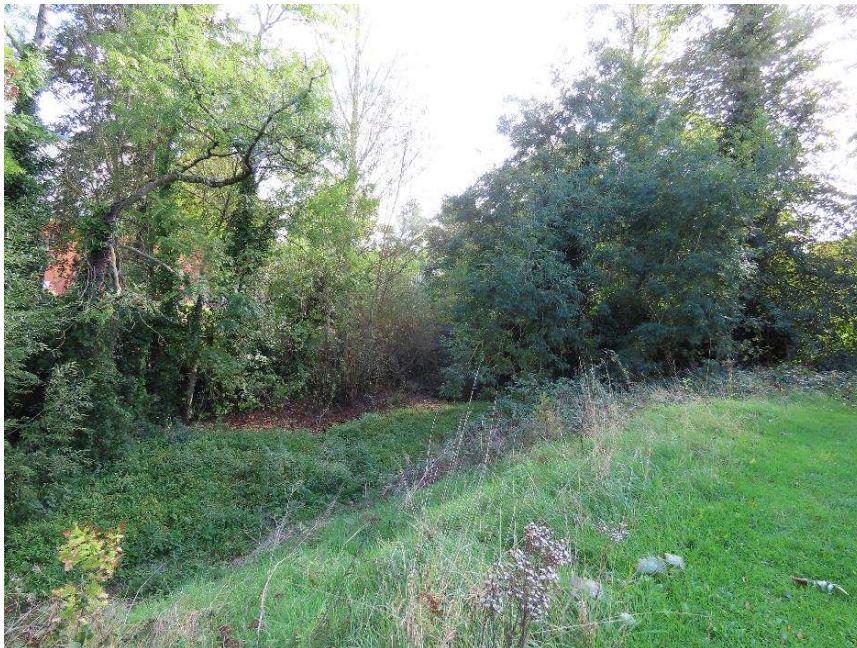
Photo 18 – looking east from amenity area towards Breagagh River

Habitats present – WL2 (Treelines) WS1 (Scrub)
