APPENDIX A: St Francis' Abbey Historic Sources

Appendix G – Conservation Drawings

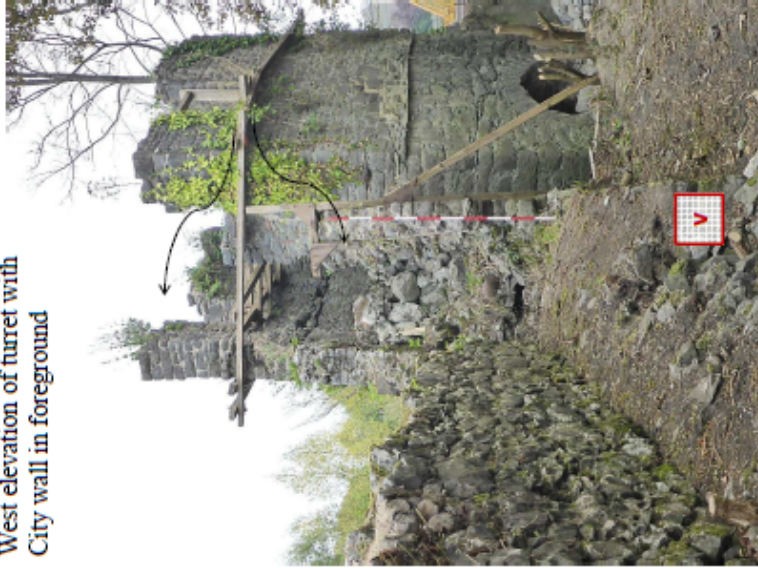
West elevation of turret with City wall in foreground

Stabilisation works required listed in assumed sequence of installation

i) Install 2 vibration monitors, one on tower and one on City wall. Locations to be agreed on site with Engineer and may require additional bracketry to be fixed to masonry to ensure monitor properly secure. Approximate locations shown thus V

A vibration cut off threshold of 4 mm/s peak particle velocity (PPV) will be adhered to. The vibration monitors should be linked to alarm systems such that any exceedance in vibration level is clearly instantly visible and is sufficiently audio alarmed that any personnel in the large car-park area to the west of the tower is alerted. A full record of the monitoring is to be kept and downloaded at regular intervals (minimum daily) and/or on request and made accessible to the design team. Any exceedance of pre-set vibration limits will result in work stoppage, assessment of cause of exceedance and future avoidance of such.

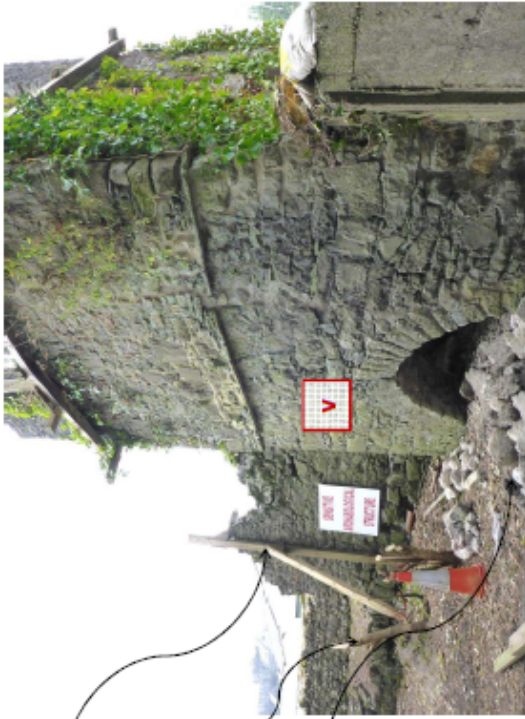
South elevation of turret

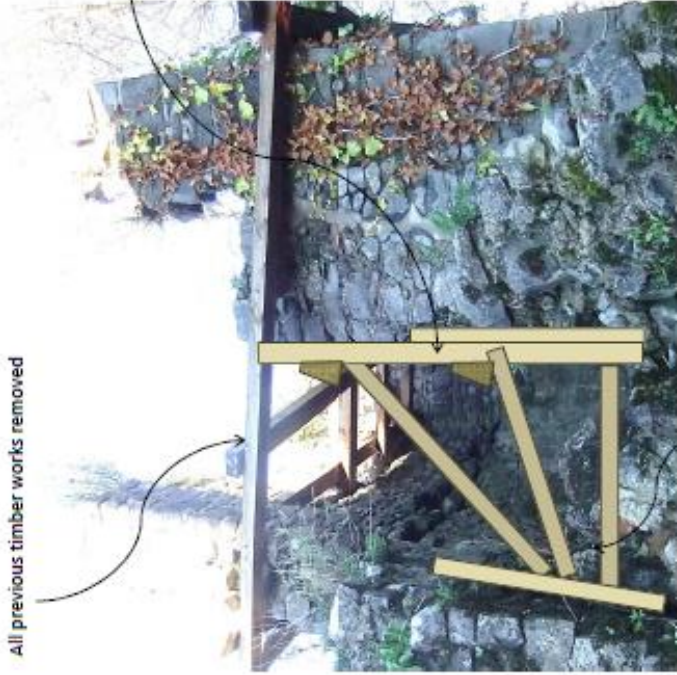
All previous timber works removed

Timber propping:-

- drape plastic approx 300mm wide down / against wall to be propped
- Install timber propping limiting any fixings into existing to the minimum
- Apply gusset plates of plywood and timber folding wedges as necessary to secure propping
- Inject expanding foam between propping and plastic to ensure tight fit to masonry
- Cut back foam and plastic flush with sides of timber

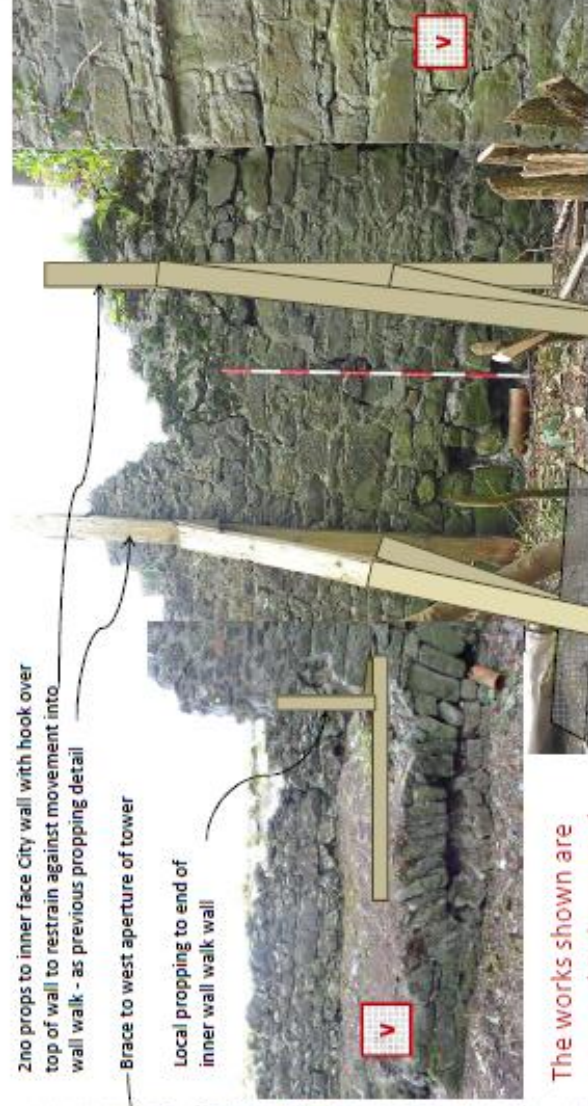
2no props to inner face City wall with hook over top of wall to restrain against movement into wall walk - as previous propping detail

Brace to west aperture of tower

Local propping to end of inner wall walk wall

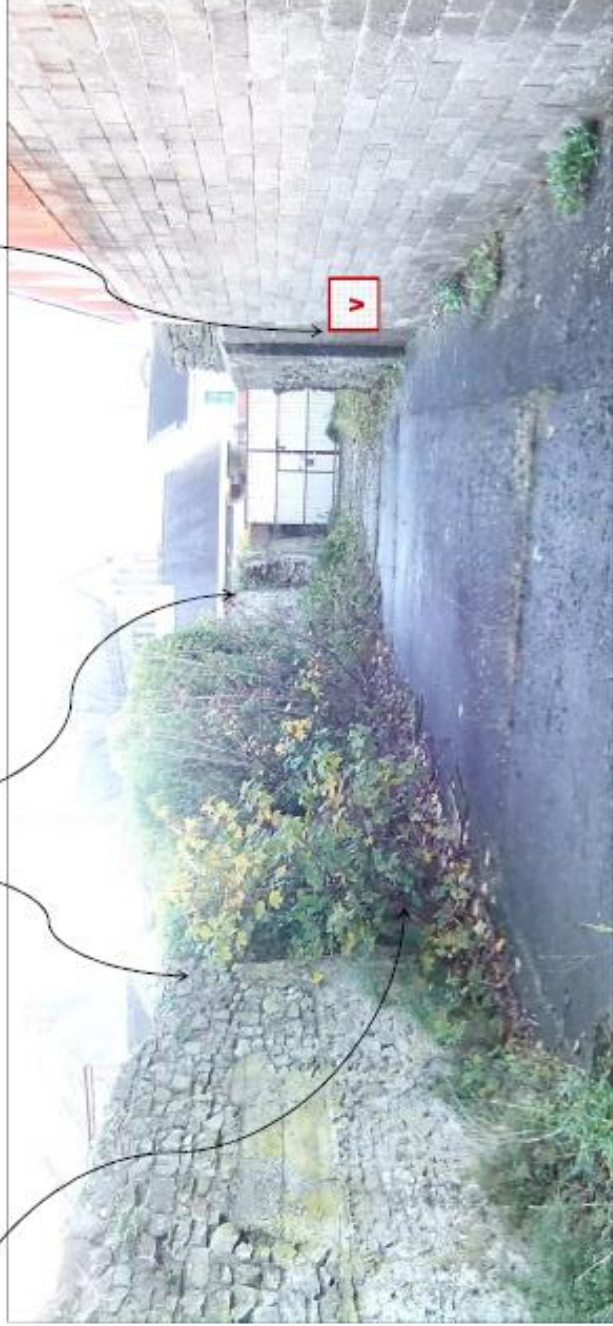
All stone walls not specifically marked for demolition to have
 plant growth contained as noted here and to be protected from
 demolition works with suitable exclusion zones or hoardings

- ii) Cut back all tree trunks to approximately 100mm from face of masonry
- iii) Drill approx 16mm diameter holes 75-100mm deep in all trunks greater than 35mm diameter. Hole to be vertical or no more than 30 degrees to the vertical. Where trunks greater than 100mm diameter drill numerous holes
- iv) Insert 300-400mm length 16mm outside diameter coilplex or similar piping into holes. Note - Do not use copper or any piping with significant scrap value
- v) Carefully pour Glyphosate such as Round-up Pro Biactive or similar approved herbicide into pipes such that minimum 100mm head above trunk end. Tape ends with waterproof tape to prevent accidental release of herbicide
- vi) Brush cut ends of all trunks less than 35mm diameter with Glyphosate

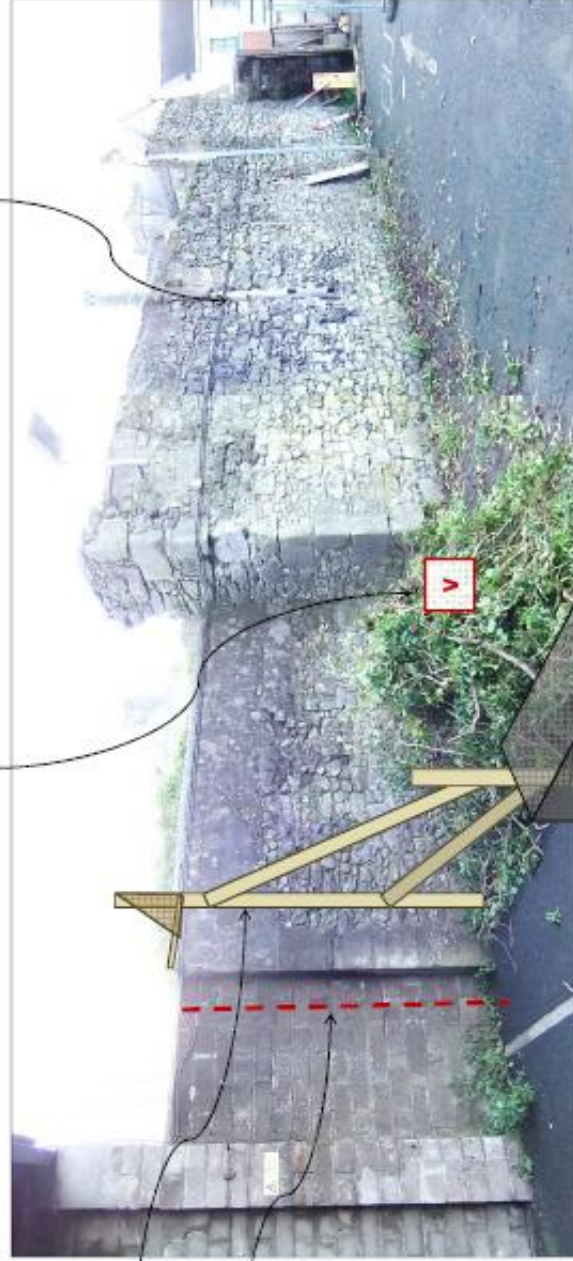
Stabilisation works required listed in assumed sequence of works

- i) Install 1 vibration monitor at the wall base. Approx location shown thus v Actual location to be agreed on site with Engineer
A vibration cut off threshold of 4 mm/s peak particle velocity (ppv) will be adhered to. The vibration monitor should be linked to alarm systems such that any exceedance in vibration level is clearly instantly visible and is sufficiently audio alarmed that any personnel in the vicinity is alerted. A full record of the monitoring is to be kept and downloaded at regular intervals (minimum daily) and/or on request and made accessible to the design team. Any exceedance of pre-set vibration limits will result in work stoppage, assessment of cause of exceedance and future avoidance of such.

- ii) Install propping to wall in location shown - see drg 204
- iii) Saw cut blockwork immediately to left hand side of random rubble wall
- iv) Proceed with adjoining demolition works watching for any exceedance in vibration levels
- v) Leave propping in place at handover of works

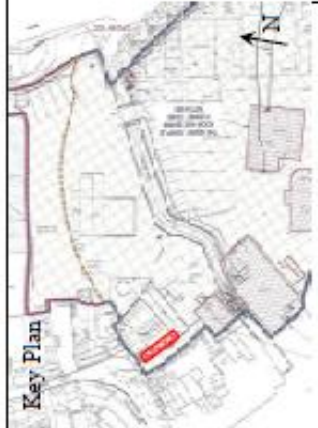
Bull Inn Wall

Random rubble wall left as is but to be protected from demolition works with suitable exclusion zones or hoardings
 Note five pipe built into wall to be left in place even if deemed to be asbestos containing as removal will damage wall. Pipe to be removed as part of repair works (Not part of Demolition contact)

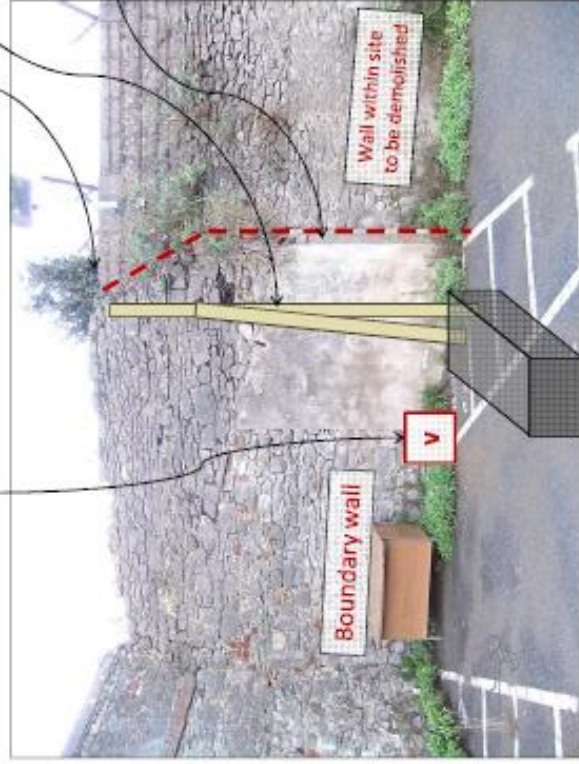
- i) Install 1 vibration monitor temporarily near wall base. v
Approx location shown thus

All vibration cut off thresholds etc to be as for other walls of significance ref Dig 202 but in this case only need to be specifically monitored when works immediately adjacent / or to the wall

West facing elevation

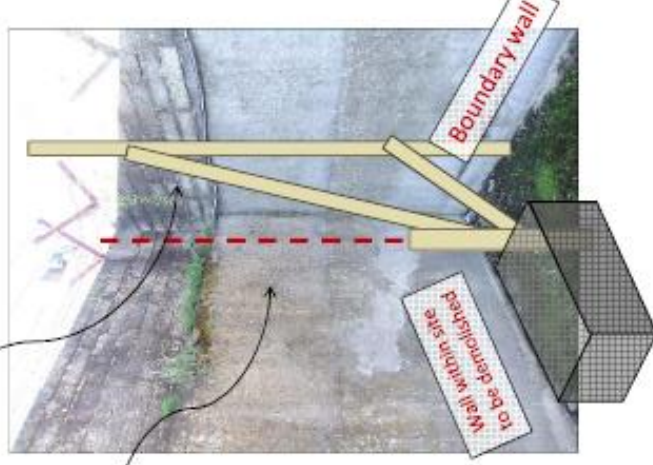
South and east facing elevations

- iv) Carefully dismantle wall to be demolished immediately adjacent to retained boundary wall by hand with concrete saw cuts as necessary through well cemented blockwork ---
All natural stone and clay brick and any artefacts to be saved. Blockwork may be discarded.

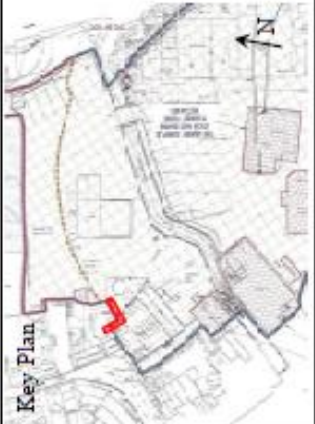
Boundary Wall north end of site adjoining link road

- v) Store all stone removed from wall on pallets within 25m of the wall from whence it came but not closer than 5m to any standing wall (This is to allow future access to walls when repair works commence (not part of demolition contract).

Note there may be a requirement to store tooled stone / artefacts separately - refer to Archaeologists

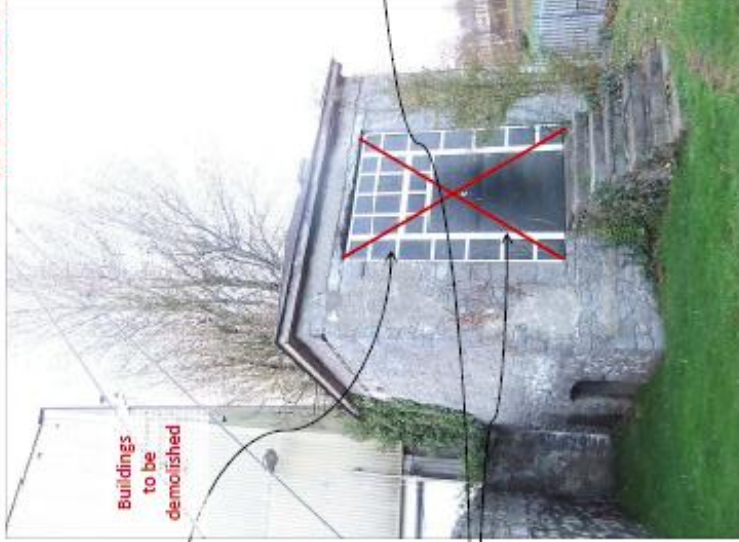
South elevation

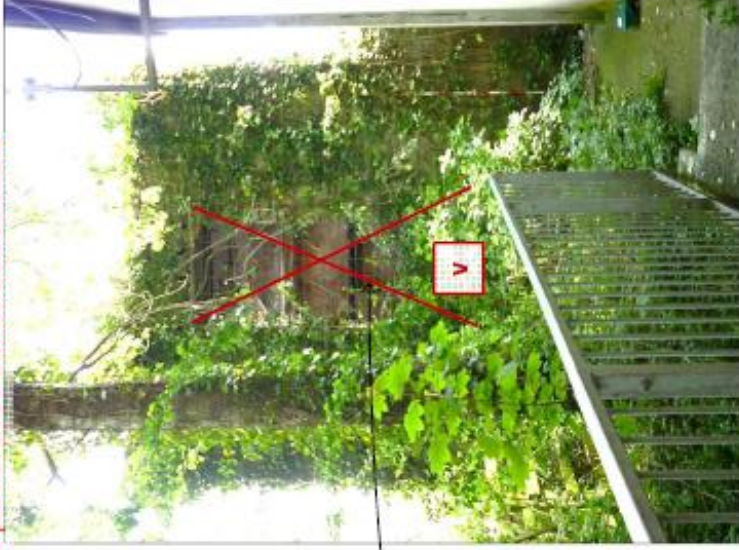
North elevation - vegetation to be close cropped

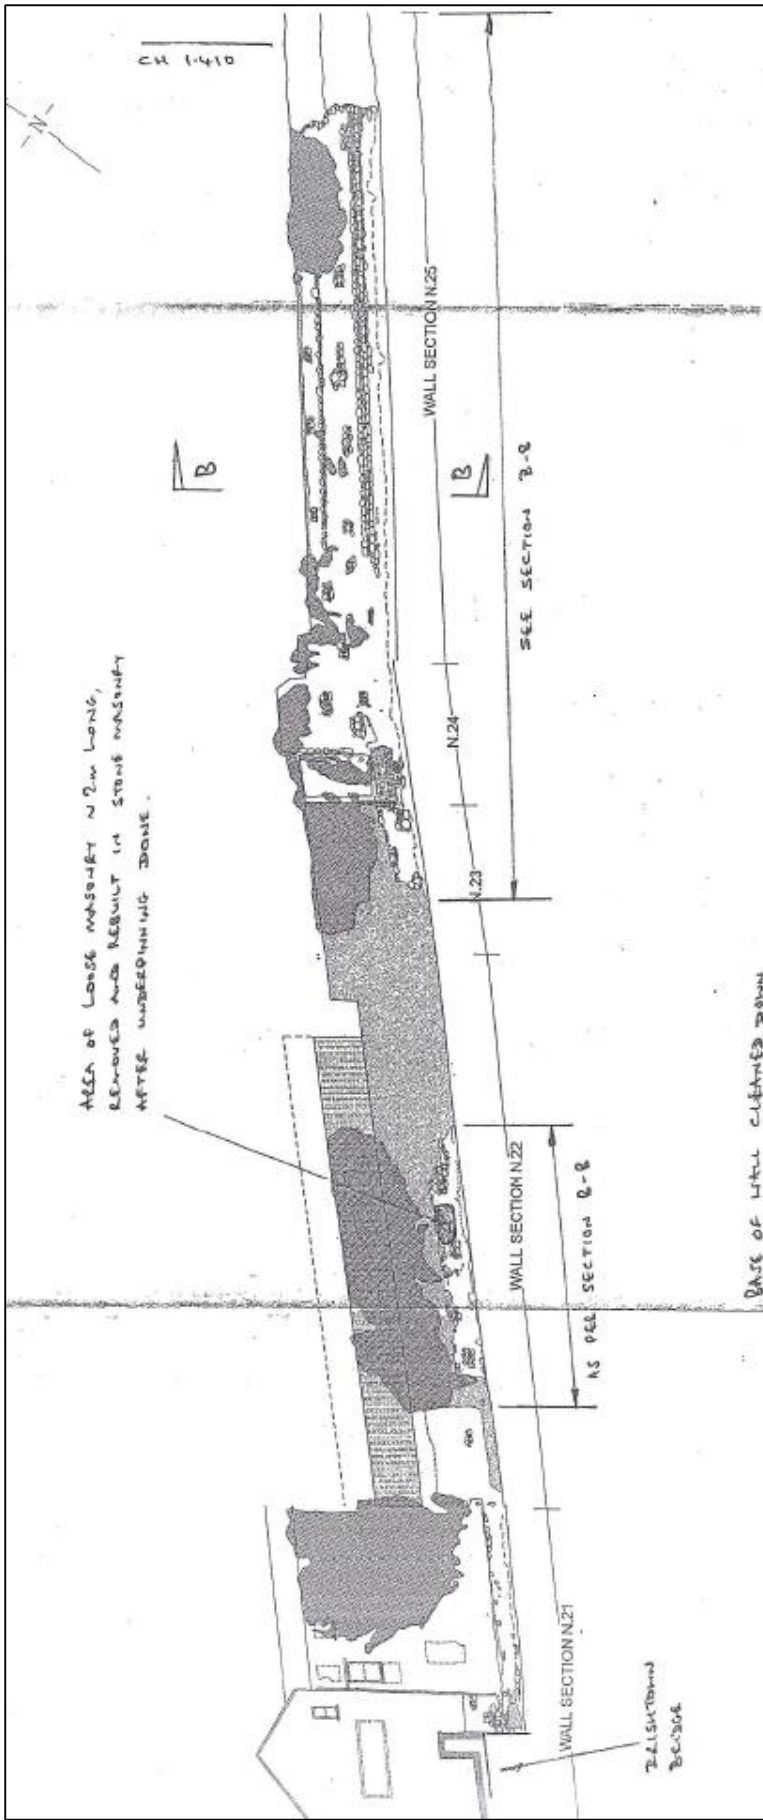
SKETCH NO. SITE / BRELINGH / 020
MASONRY WALLS DOWNSTREAM OF IRISH TOWN BRIDGE
- LEFT BANK
DATE 27 / 7 / 04

AREA OF LOOSE MASONRY 2.0m LONG,
REMOVED AND RESULT IN STONE MASSIFY
AFTER UNDERPINNING DONE.

BASE OF WALL CLEANED DOWN
TO SOLID GROUND,

EXISTING FOUNDATION UNDERPINNED
BY FILLING WITH C25 CONCRETE
AND FINISHED IN STONE,
FINISHED AT 1:1 SLOPE WITH
STONE PITCHING TO THE SURFACE

SECTION B-B

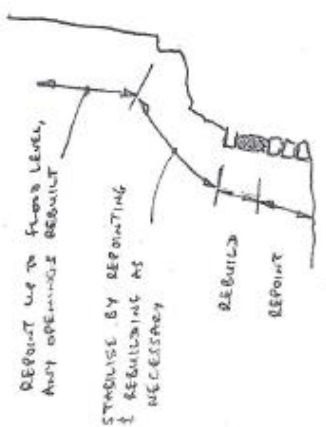
SECTION A-A

REPOINT UP TO FLOOD LEVEL,
AND OPENINGS REBUILT
STABILISE BY REPOINTING
REBUILDING AS
NECESSARY
