## SECTION III: UNDERSTANDING THE PLAN AREA

## SECTION III: The ARCHAEOLOGICAL CONTEXT

### 3.1 INTRODUCTION

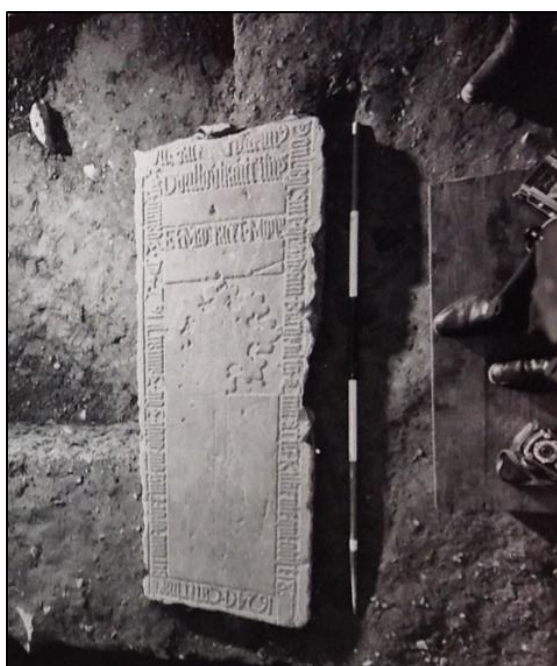
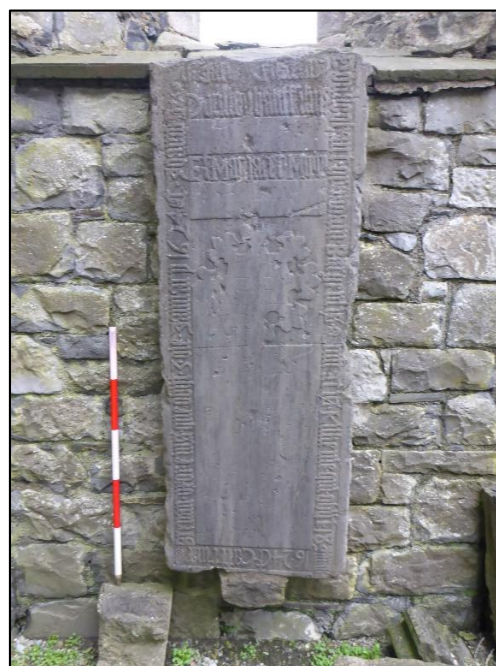
Plates 26 and 27 Photo of Delahunty grave slab as recorded by in situ by Ó hEochaidhe in the 1963 Excavation (on the left) and as existing (on the right).

The potential for human remains was verified by Sweetman in the proceeding monitoring briefs of the 1970s. Interestingly, Con Manning, in an article on the Delahunty grave slab in the *Old Kilkenny Review (2007)*, notes that; "burial at the site continued as late as 1687, as shown by a recorded inscription, but may have ceased after 1698, when the site was given over for use as military barracks"<sup>1</sup>.

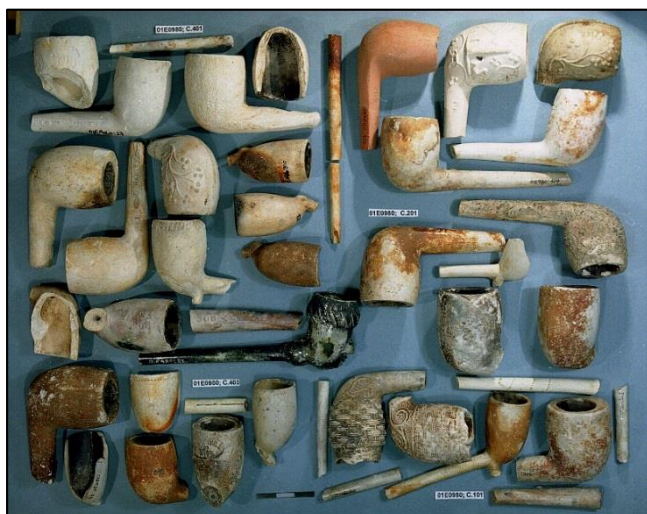
*Plate 28 Collection of clay pipes uncovered during the River Nore Flood Alleviation Scheme (courtesy of Margaret Gowen & Co. Ltd.)*

An extensive programme of archaeological testing, monitoring and excavation was undertaken by Margaret Gowen & Co. Ltd as part of the River Nore Flood Alleviation Scheme between 2001 (License No. 00E0406 and 00E033 and 00E0405, 01E0608, 01E0821) and 2005. The drainage scheme covered approximately five kilometres of rivers running through the medieval city, and the subsequent twenty excavations, and vast amount of varied stray finds give a unique insight into the city's prehistory and history. As part of this programme archaeological excavations were carried out at Green's Bridge, Mill Island and Green's Bridge Weir. Between 2001 and 2002 Mill Island and Green's Bridge Weir were excavated in advance of removal of the island and remodelling of the weir. This site formed part of a large milling complex that spanned both sides of the River Nore (Figure 21).

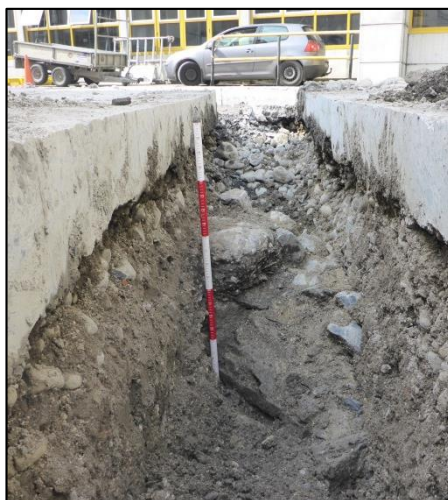
*Plate 29 Monitoring ESB trench, culvert section 1*

century date. Remnants of a number of walls were identified, many of which appear to correspond with walls depicted on the early OS mapping of the area. Most of the walls were similar in size and construction, and date to the 19<sup>th</sup> century, with possibly one or two walls dating to the 18<sup>th</sup> century. A culvert identified at the north end of section 1 of the trench may relate a structure depicted possibly on Rocque (1758) and on the 1st ed. OS 6-inch map. This culvert may represent the line of an earlier mill stream which issued to the River Nore (Plate 29). The culvert was oriented west-northwest – east-southeast and was constructed of large limestone blocks measuring up to 0.4m x 0.5m. It was present at 0.45m deep, was 1m wide and was cemented in on both sides.

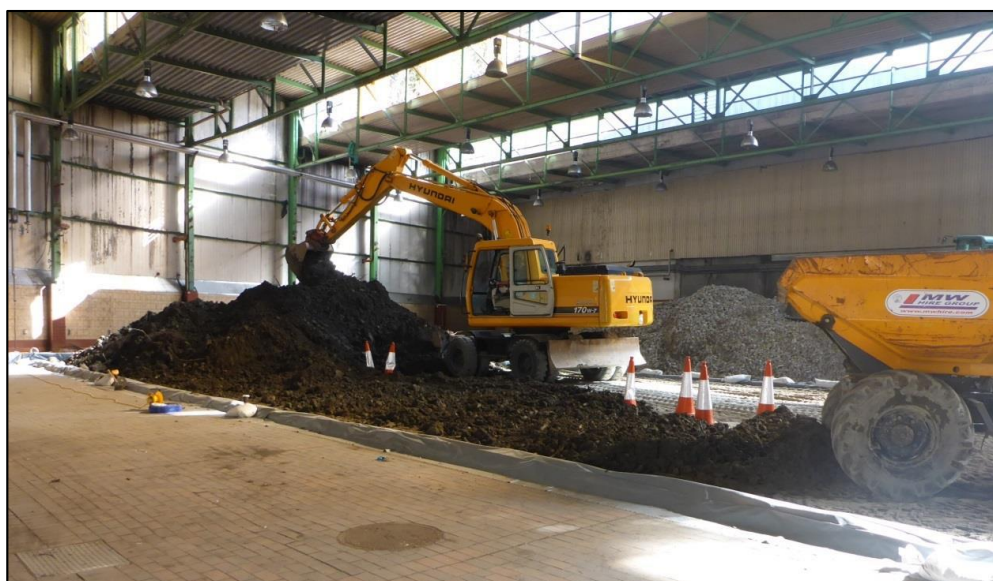
*Plate 30 Metal Detection of Spoil*

Archaeological monitoring, under Ministerial Consent took place in 2014 on the south bank of the River Breagagh adjacent to the confluence of the River Nore. The works involved the removal of contaminated soil from the riverbank. During these works all excavated spoil was spread for inspection and metal detected for the purpose of finds retrieval. In order to facilitate the excavation, a sheet pile screen and two sheet piled coffer dams were installed to prevent collapse into the river and to protect the works from inundation by the river. Within the sheet piled screen, the area was excavated to a depth of 0.5m and within that area, the two coffer dams were excavated to a depth of 4m. The sheet piles were located c.9m from the nearest point of Evan's Tower.

The riverbank soil proved to be very disturbed with the upper c.1.3m comprising a mix of organic river silts, rubbish and stones. Included in this material were some dumped structural stones, roughly squared limestone similar to those used in the tower. In total nine stones were retrieved and have been stored adjacent to the tower. They ranged in size from 0.27m x 0.15m x 0.16m to 0.57m x 0.35m x 0.26m. Below 1.3m the material comprised loose grey river gravels, which for the most part appeared to be undisturbed and at c. 3m the river gravels changed to a yellow grey colour.

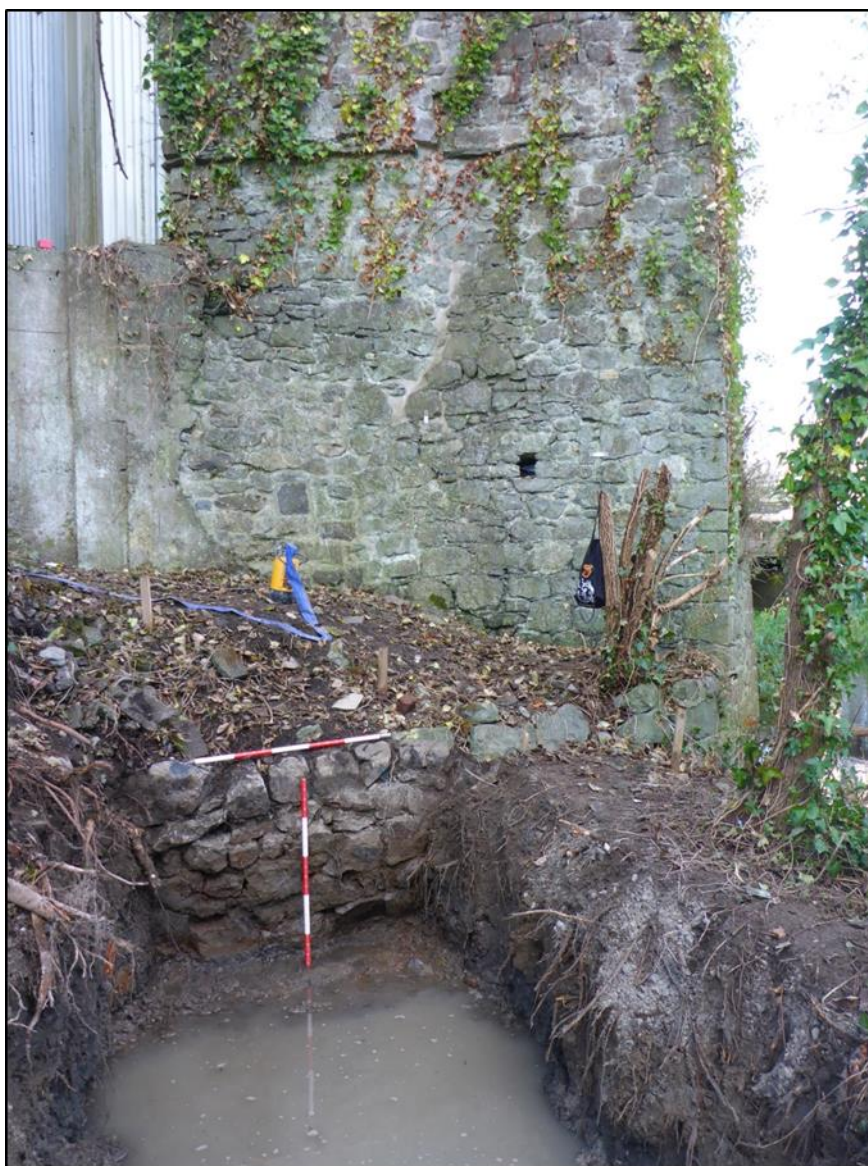
*Plate 31 Revetment wall at Evan's Tower*

Excavation revealed the continuation of a stone wall which adjoined the northeast corner of the tower and was partly visible prior to excavation. This wall was constructed of similar stone to that used in the tower and appears to represent a riverbank revetment. It is unclear whether this feature is contemporary with the

tower or not. Average dimensions of the stones were 0.45m x 0.2m and five rough courses were uncovered, with the wall extending below the depth of the excavation. The wall was exposed for a length of 1.6m, depth of 1.1m and was oriented northwest-southeast. It continued beyond the excavation area to the southeast and remains in situ. The thickness of the wall was not established as it extended outside of the scope of the remediation works. It was not possible to draw the section of exposed wall due to rapidly rising water levels from the river within the trench. After cleaning and photographing, the wall was covered in a layer of terram and the excavation area was backfilled with clean stone. The layer of terram will protect the wall for any future investigations. No artefacts of an archaeological interest were recovered from this area.
