SECTION IV: UNDERSTANDING THE MONUMENTS & BUILDINGS

4.1 THE MASTERPLAN AREA

4.2 DESCRIPTION OF THE BUILDINGS AND FABRIC

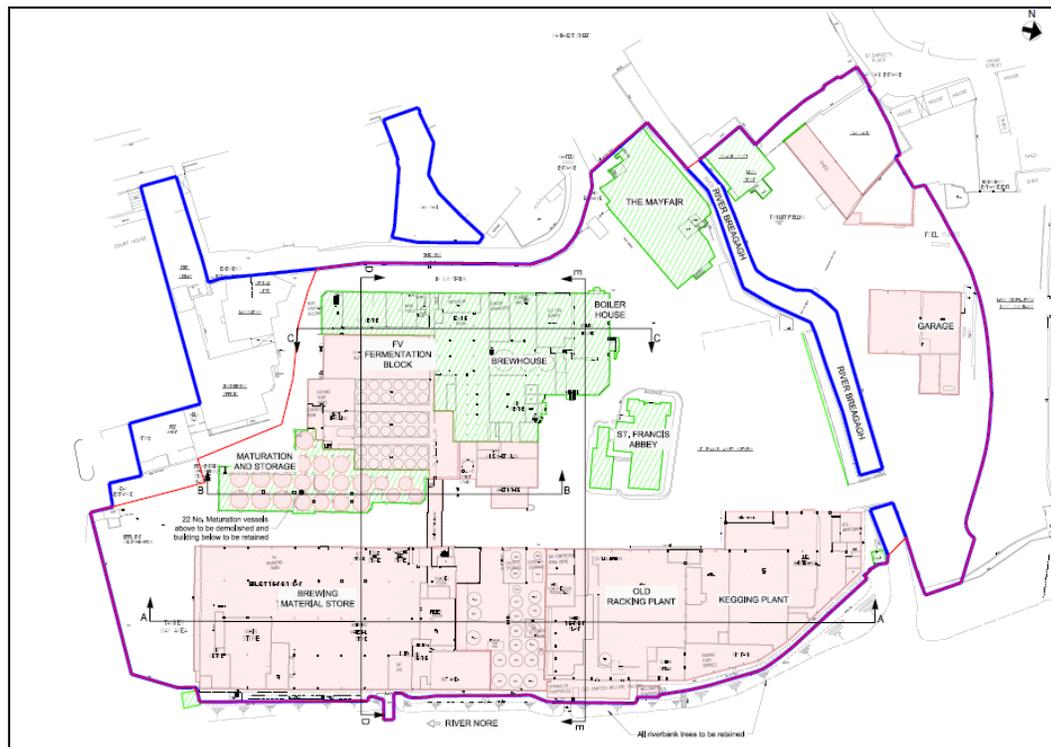
North of the Breaghagh modern buildings such as the truck wash, hop store/squash court, car parking shed and fuelling tank facility are present (Figure 24). The demolition of a number of structures to slab level on site (ie no excavation work required) will take place prior to Kilkenny County Council taking ownership of the site, these structures are highlighted in brown in Figure 24.

Figure 24 Proposed demolitions shown in brown, structure highlighted in green are to be retained

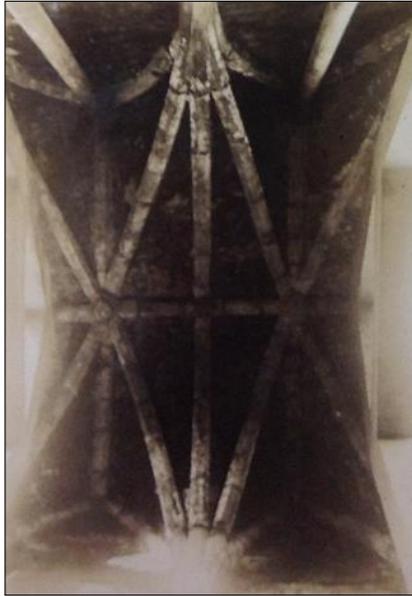
Other options were sought and it was suggested that the tower could be propped by the provision of two beams of red deal, placed beneath the vault, close by the south internal wall. Another method of stabilisation proposed was to place two pillars of cast iron, as props, in the same position as the timber beams³. While this latter solution was again outside the monetary reach of the society, an arrangement must have been agreed and additional funding secured from the Corporation of Kilkenny as it is observed in the 1869 proceedings of the society that cast-iron props had been inserted and it was hoped that work would commence on repairing the haunch of the tower. It was also noted that there was now an opportunity of having the choir windows and the sedilia opened (which had been previously bricked up). These cast iron pillars are still in place today. From photographic evidence (OPW archive) of before and after (1926-1928) it appears that the concrete supporting structure was inserted under the arch of the bell tower c. 1927 (Plates 5-6 Section I and Plates 35-37).

Plate 37 Underside of vaulting in tower Plate 38 Work in progress on the sacristy

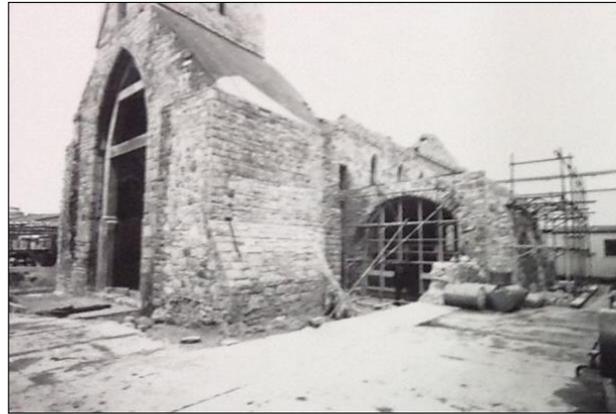
The sacristy is a single cell masonry structure that has been considerably repaired and reconstructed in the last fifty years (Plates 38 and 40). It was restored as an oratory by Smithwicks⁴. There is one door in the west wall. This structure will be retained as part of the Masterplan works and incorporated into a newly created public realm for St Francis Abbey.

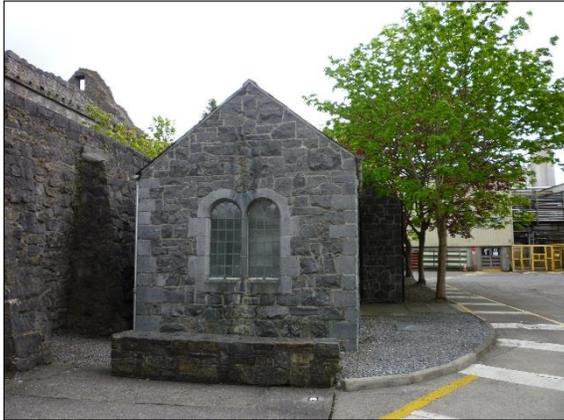
Plates 39 Sample Rooms

This building does not enhance the abbey and does not conform with the layout of a Franciscan friary or take into account of the below ground remains. Further to discussion with the Authorities it is proposed to remove this structure as part of the Masterplan process in order to reveal the southern elevation of the abbey and allow excavation works to take place.

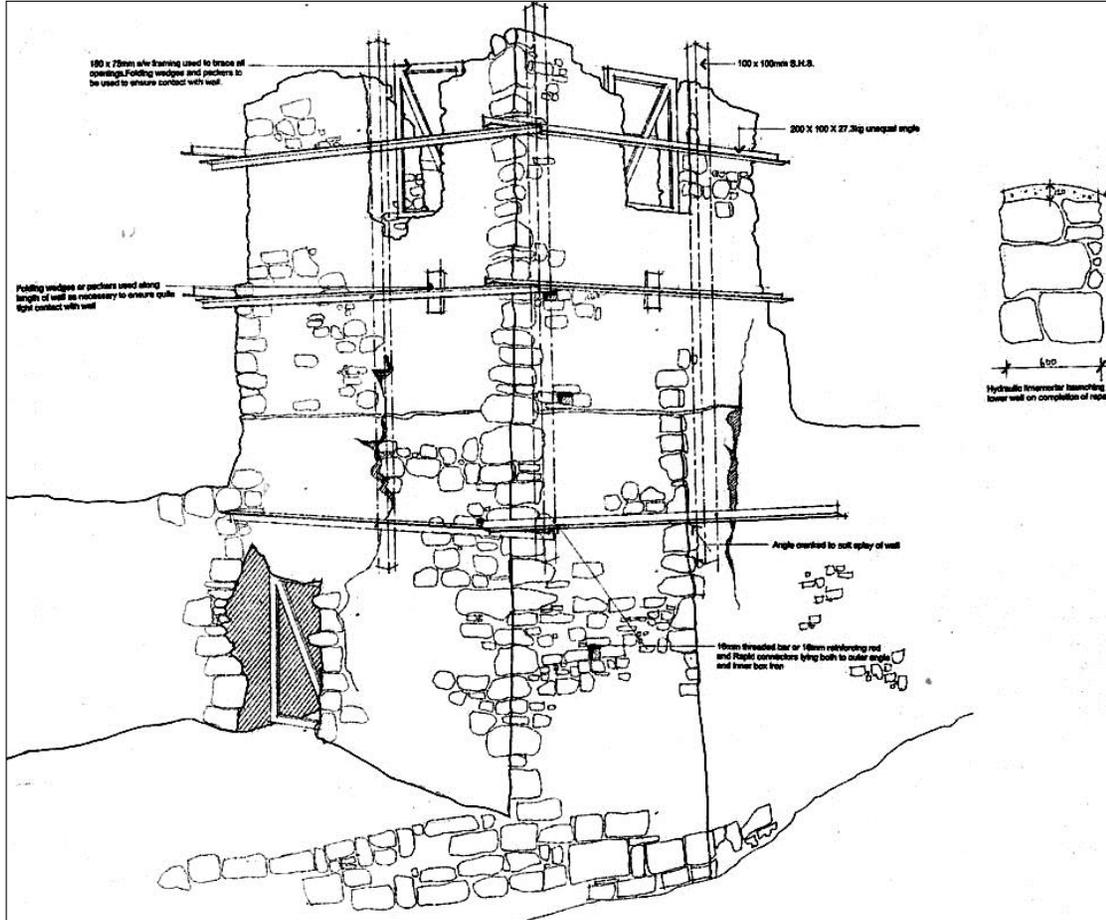
Figure 26 Plan survey of Evan's Tower by Consarc (c. 2001)

Conservation works were undertaken by Consarc (Figure 26) and entailed the erection of internal scaffolding, the infilling of the joist pockets with salvaged stone and small sneck stones were set in lime mortar. This work allowed additional Cintec anchors to be inserted on order to stabilise the structure. All work was carried out under licence to the Department of Arts, Heritage, Gaeltacht and the Islands (now DAHG) (archaeological licence no. 01E0632).

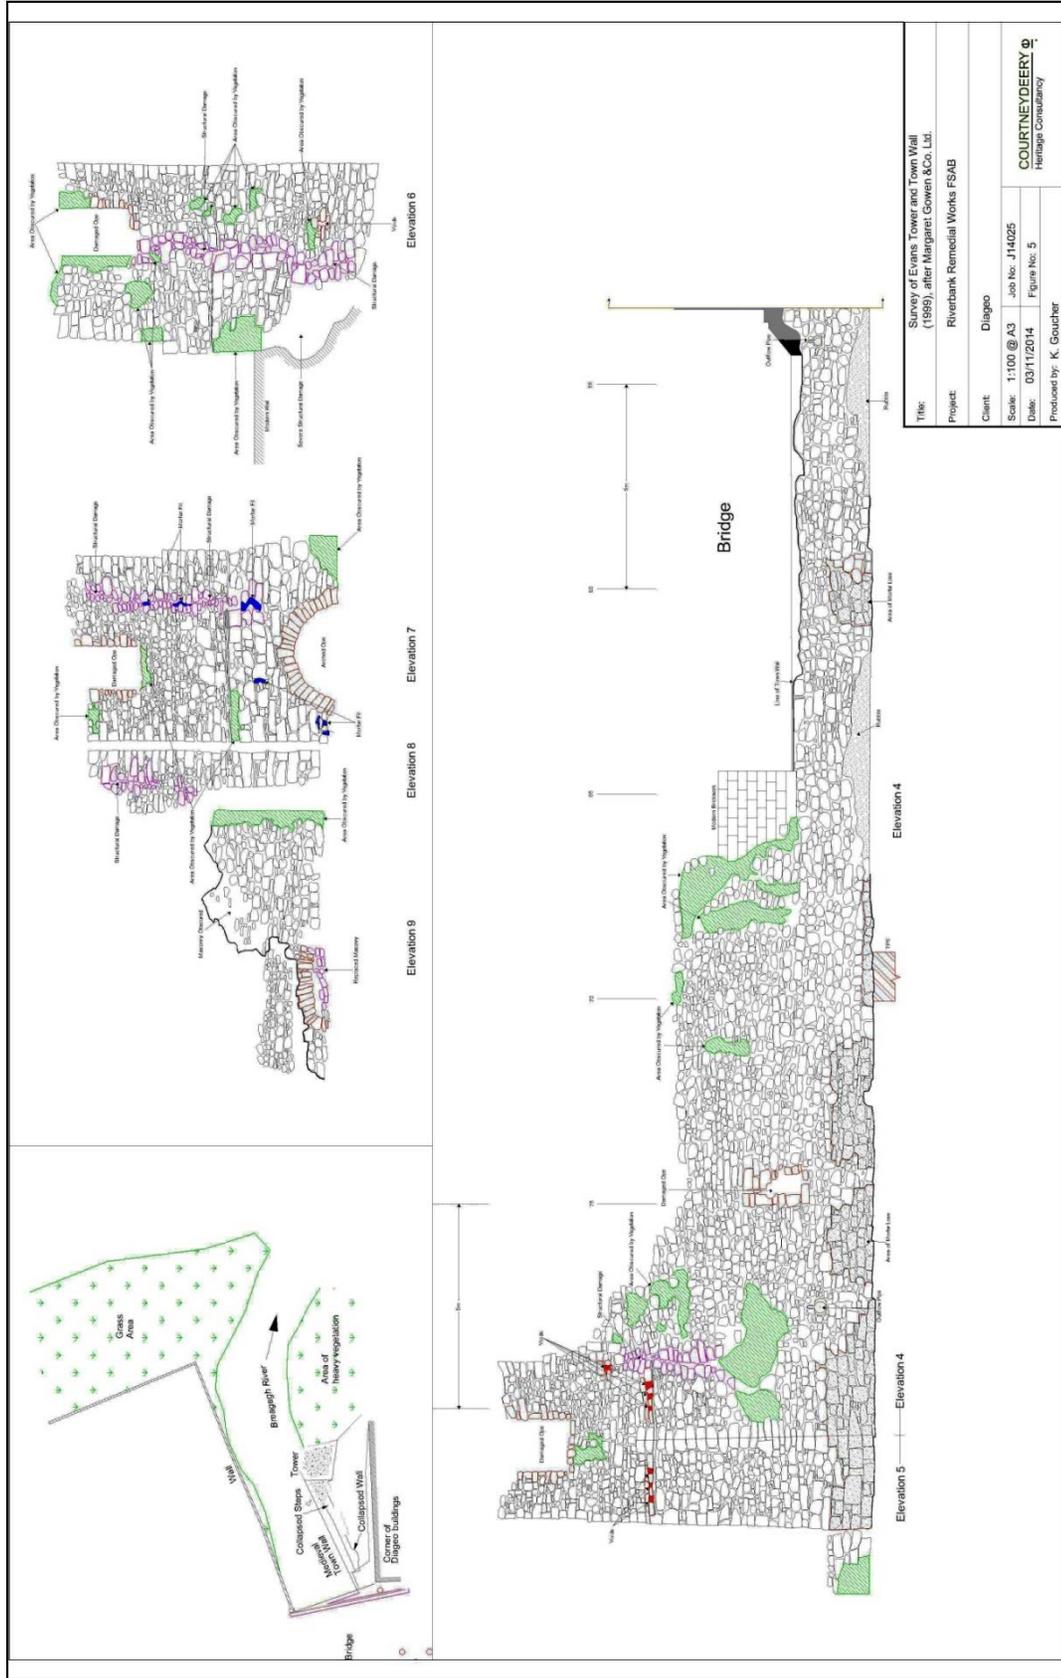
Figure 27 Geodetic Survey of Evan's Tower and Wall Walk courtesy of Margaret Gowen & Co Ltd

Inspection of written and survey details of previous works (Figure 27) and an inspection of the tower itself show that the overall stability of the structure is relatively secure. The works to the lower river levels, the stitching using cintec anchors, repointing and flaunching to the wall tops of the tower carried out in 2001 are all evident and have improved the stability of the tower compared with the pre 2001 situation.

Piling works were carried out in the vicinity of the tower and wall walk in September and October of 2014 to allow soil remediation measures to take place. These works were archeologically and structurally monitored. There was no sign of movement in the recent pointing to previous crack lines in the tower or outer face of the city wall despite the nature of the work. The un-mortared nature of the inner face of the City Wall and wall walk, makes it more difficult to confirm if any movement was experienced but there does not appear to be any degradation to the monument resulting from these piling operations.

The immediate proposals in the vicinity of Evan's Turret and adjoining City wall include a full digital survey of the remains, vibration monitoring and the installation of temporary works (wooden props) to replace those that have rotted away since 2000 (Appendix F ref LE drgs 101 & 102)

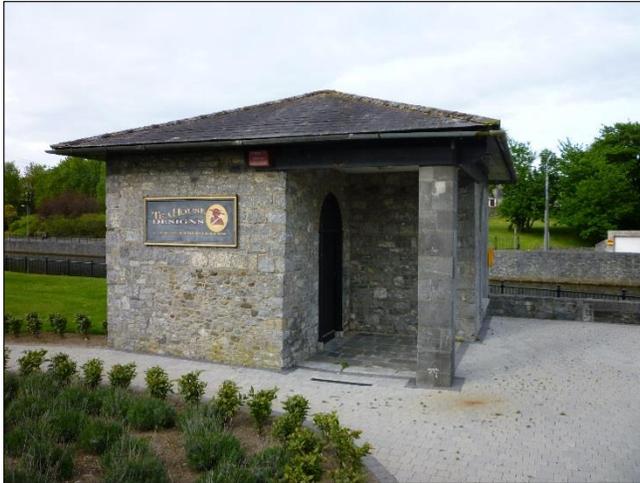
Plate 53 Tea House – consolidated

The second upstanding teahouse (Plate 53), 35m to the south of the afore mentioned structure, this has been renovated. As part of the River Nore drainage works two engineering test-pits were dug beside the river and landsides walls of this structure to assess the depths of the foundations prior to commencement of nearby engineering works and the exposed deposits and walls were recorded. The building was also surveyed as part of this scheme.

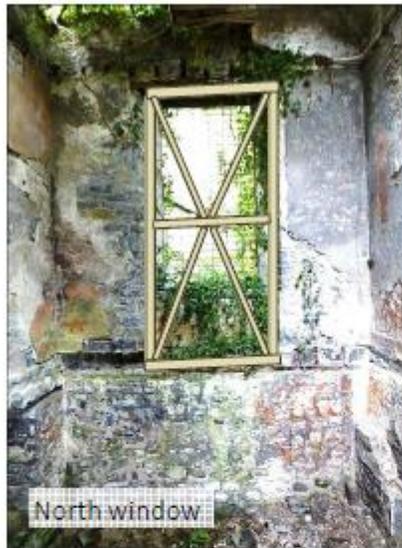
North window

The more northern Tea House is in close to its original form but in a very ruinous state. Timber elements such as the first floor have rotted away and the roof is in an extremely precarious condition. The Tea-House backs onto the Smithwick's brewery modern masonry boundary wall of the brewery. The roof and ceiling including the fine moulded ceiling decoration are in danger of complete collapse. There has been significant loss of fabric already. The degradation of the timber lintels and bonding timbers puts the wall tops and other local sections of the four external walls in jeopardy.

It is assumed that the only access gained to the interior is that need for the purposes of installing the bracing to the two large openings.
Access should only be ventured as far as the area immediately under the lintels of those openings.
Thus access to the rear north window will be from that side

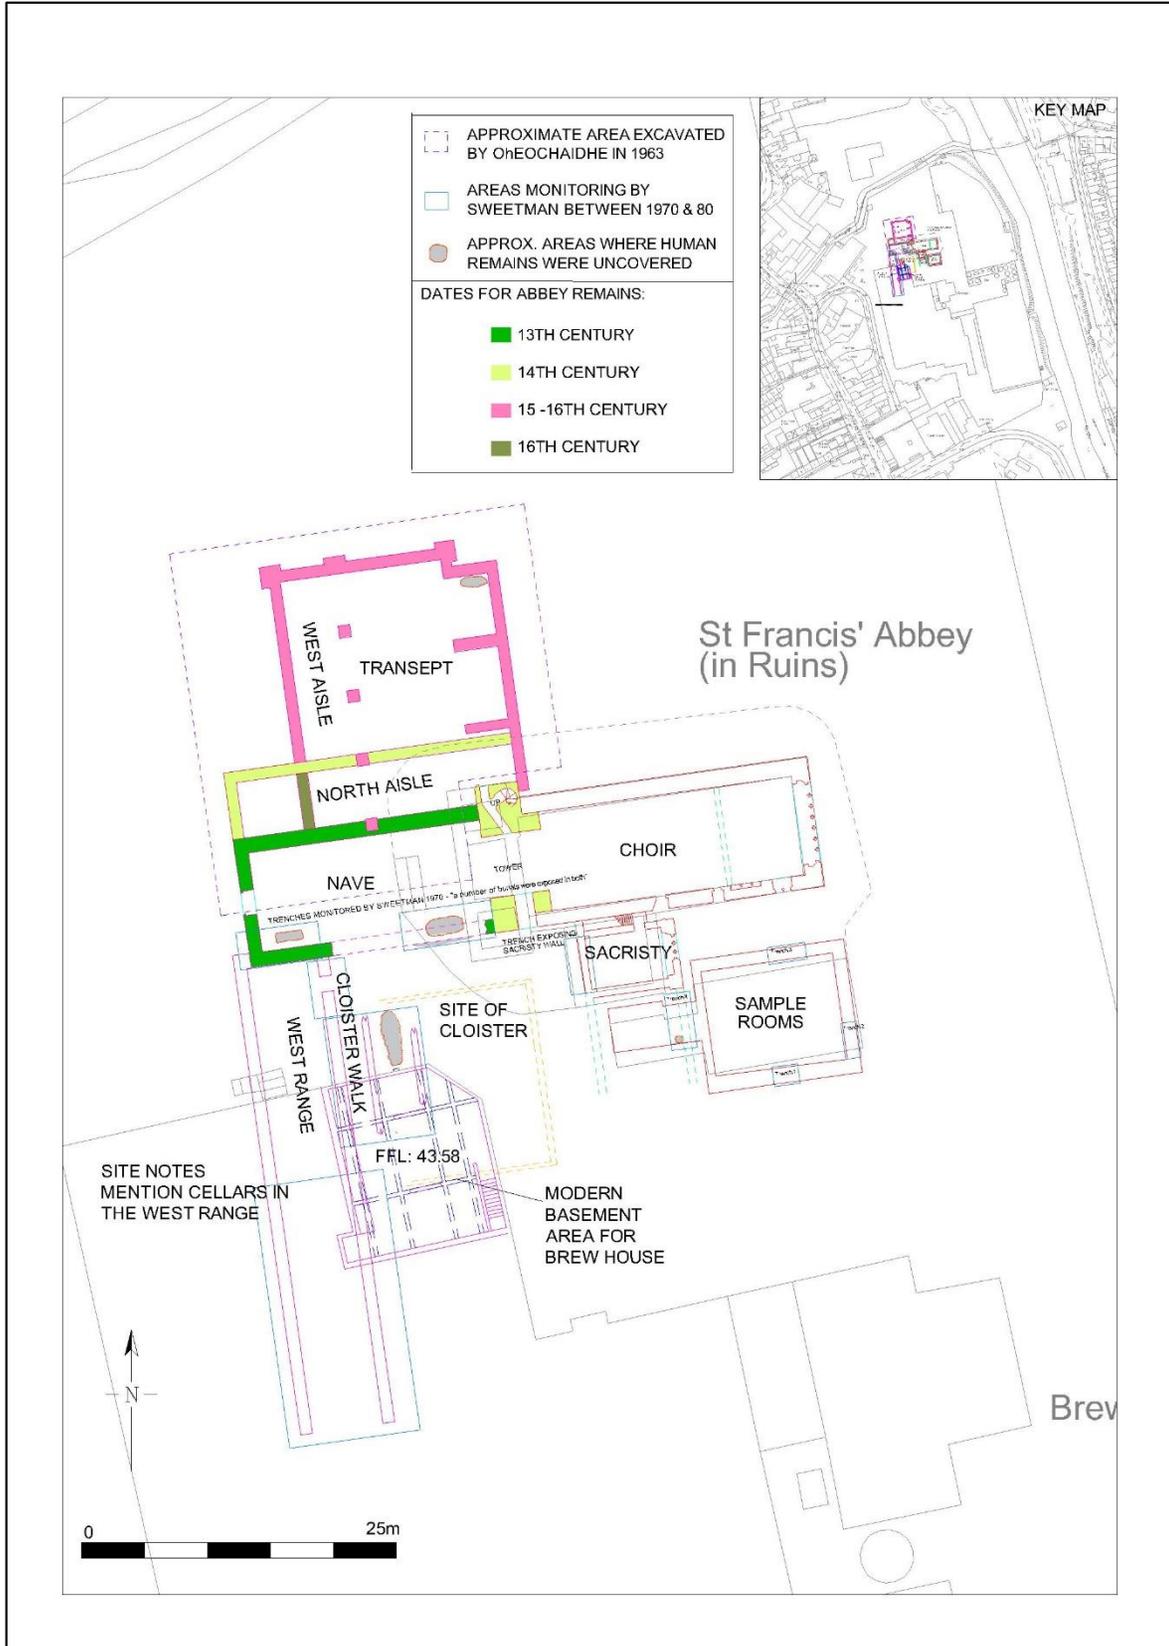
entire structure, accessed by a ladder. These present as narrow confined spaces and appear to relate to the location of the cloister walk identified by Sweetman revealed during the archaeological monitoring programme in the 1970's and would have formerly formed part of the cloister range (Figure 34). The floor level recorded for this structure is +43.58OD and the original ground level recorded on St Francis' Abbey is +44.61OD putting the cellars approximately 1.03m below the original ground level.

Fig. 34 Plan of St Francis' Abbey and investigations and subsurface plant room

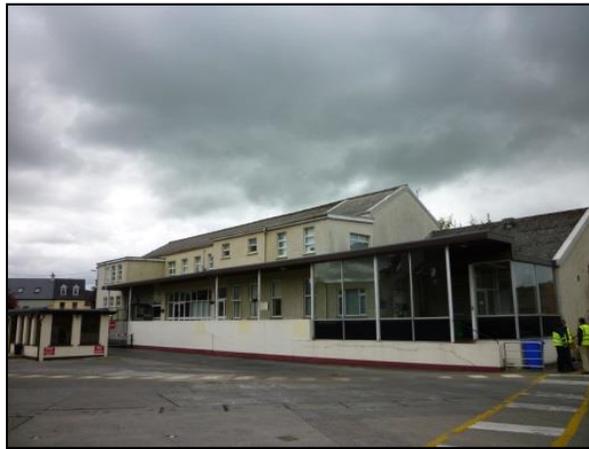
Plate 72 Mayfair Building – front elevation

The 1930's structure consists of a mass concrete frame and is two stories high to the southeast where a covered walkway provides access to offices along the front of the building, it is not considered to be of architectural heritage significance. The rear of the structure is built up against the city wall and the River Breagagh.

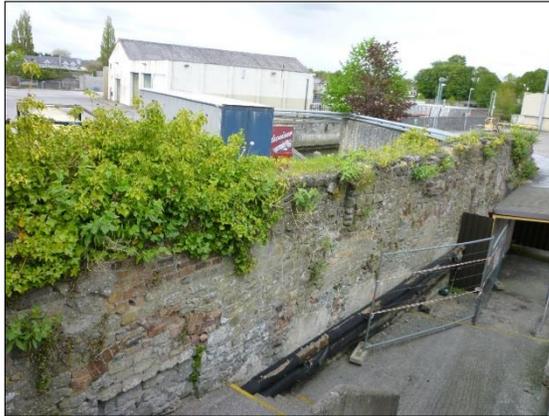
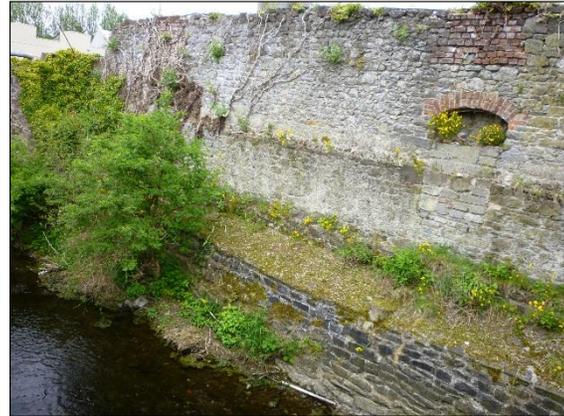
Plates 73-74 Section of walling to the immediate east of the Mayfair Building landside and riverside

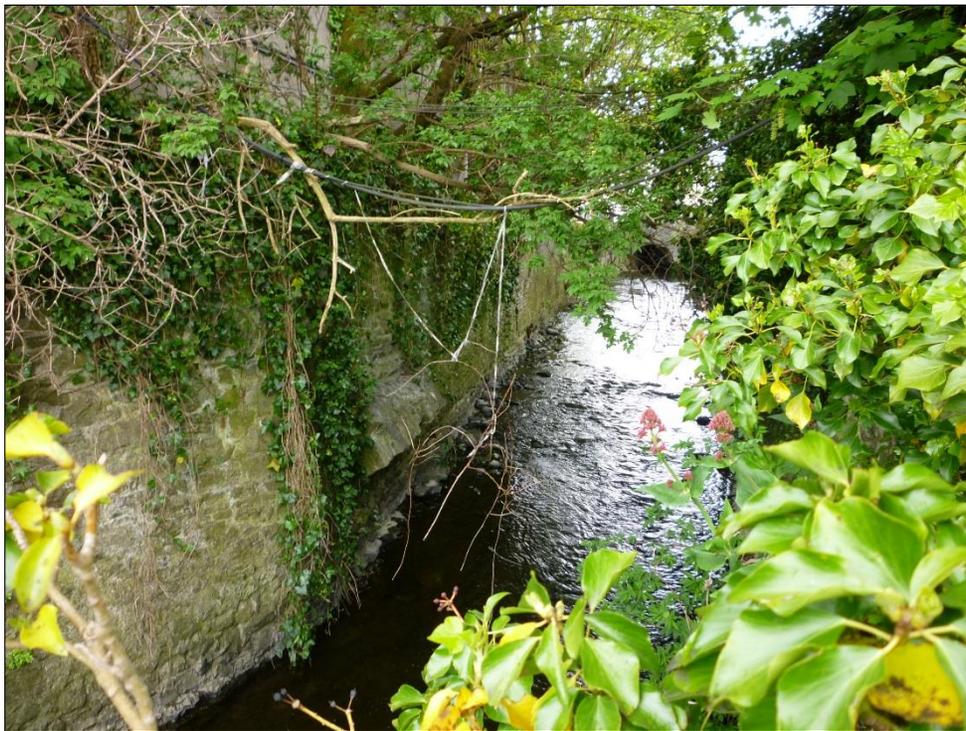
Plate 75 City Wall to the rear of the Mayfair Building taken from the east showing spring stones of a former bridge site

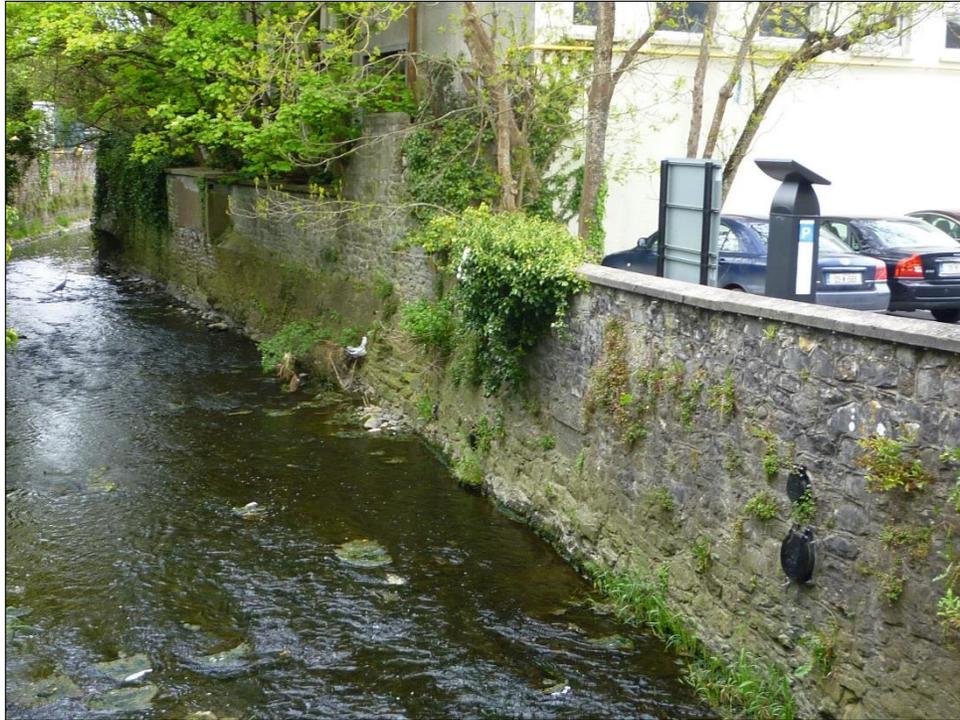
Plate 76 City Wall to the rear of the Mayfair Building taken from the west (Watergate)

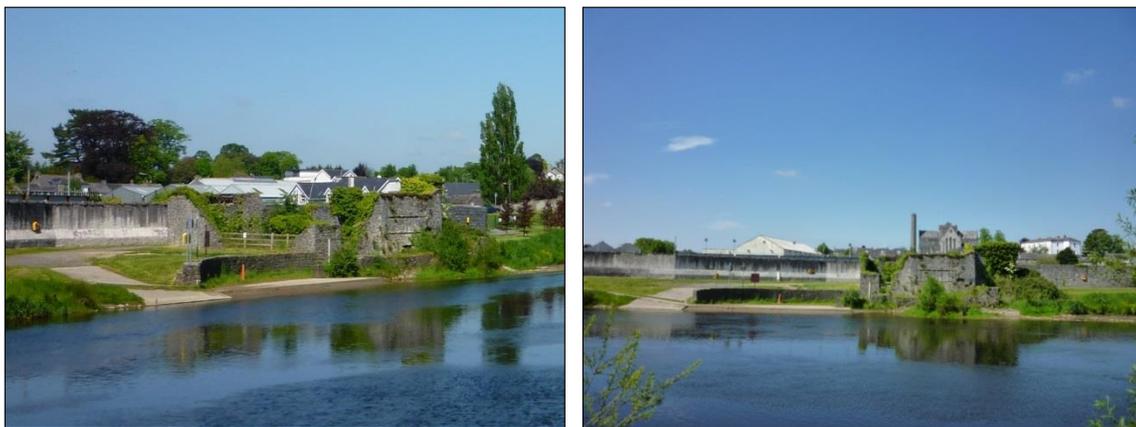
Plate 77 and 78 View to the mills taken from the eastern bank of the River Nore

The ruined Mill building is placed on the western banks of the River Nore with a slipway present to the south of the structure. The setting of the site has altered recently with the development of the KCAS. Indeed for the purpose of this report the ruin could not be accessed for a detailed assessment as hoarding has been placed around the protected structure in order to protect it from ongoing construction works.

In recent years, the structure formed part of the public realm with public access around the exterior of the structure, however no access was provided to the interior with a low wooden fence preventing entry. At a cursory inspection the remaining masonry appears to be in a reasonable condition however it is heavily overgrown with vegetation.

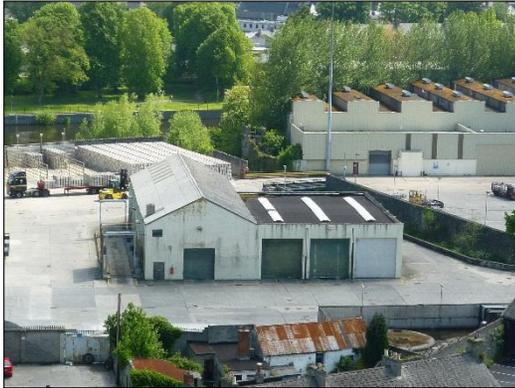
Plate 79 Truck Wash Garage

Other structures within the former brewery site, both north and south of the River Breagh are modern industrial features and without any historic or cultural recommendations. They are all scheduled for removal as part of the demolition works that are taking place in advance of Kilkenny County Council taking ownership of the site. The structures are a variety of large warehouses and mechanical stores, concrete and steel framed in construction and consist of the:

The removal of these features will enhance the overall redevelopment of the Masterplan area and provide the space required for the creation of the linear park
